Integrated Plant Safety Assessment Systematic Evaluation Program

Dresden Nuclear Power Station, Unit 2

Commonwealth Edison Company
Docket No. 50-237

Final Report

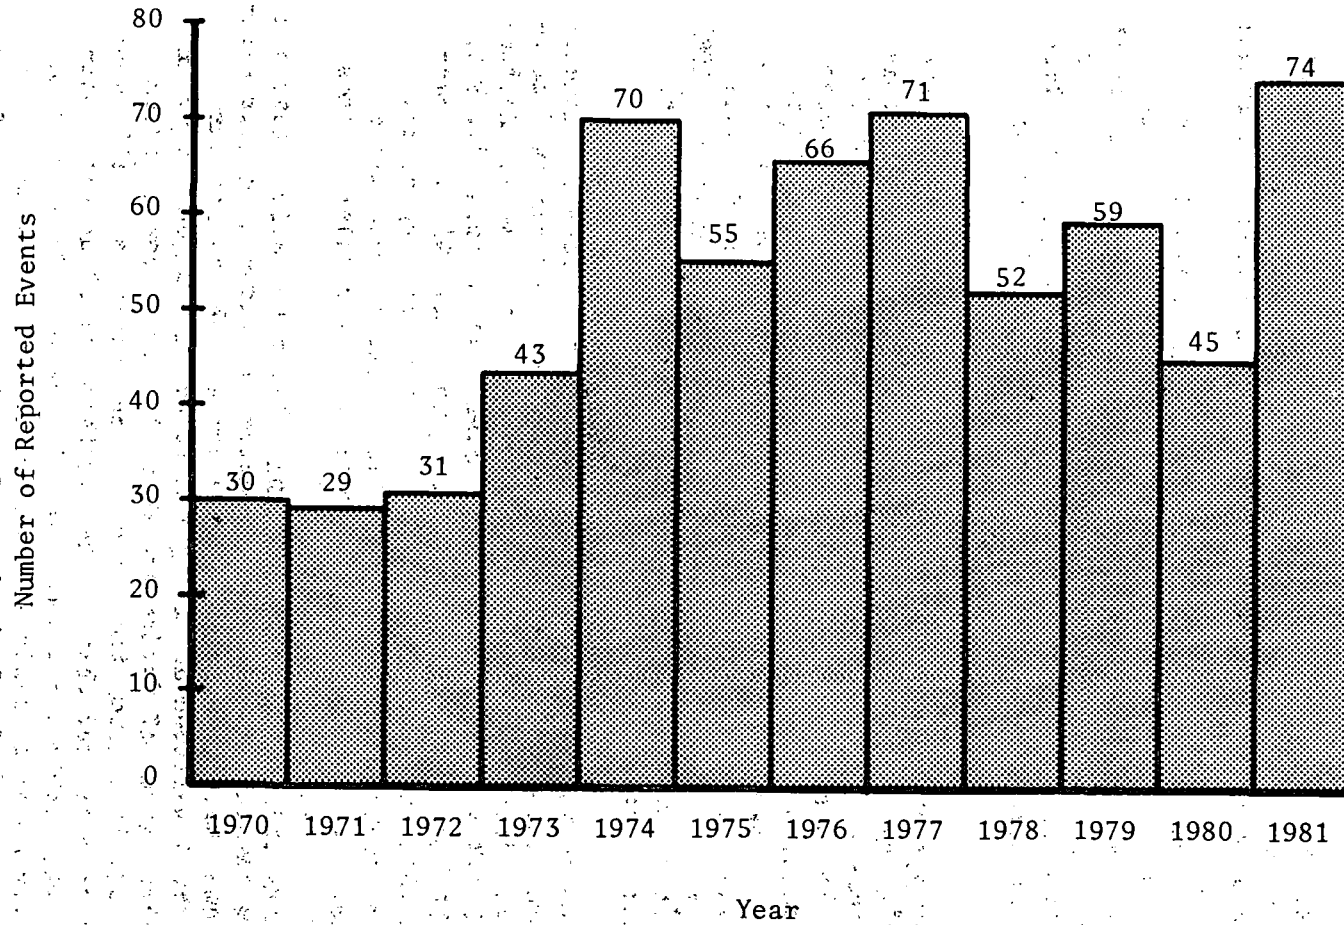
Fig. 4.1. Number of reported events at Dresden 2.

from 1974 through 1981. For this 8-year period, a low of 47 events was reported in 1980; the peak years were 1977 and 1981 with 75 and 74 events reported, respectively. For 1970 through 1973, an average of 32 events per year were reported. Inherent equipment failures caused 51% of the reportable events. Human error (including administrative, design, fabrication, installation, maintenance, and operator error) either caused or were directly related to 49% of the reportable events. Of the reports involving human error, the three dominant categories were maintenance errors (11.6%), administrative control errors (11.1%), and design errors (9.4%). There is no apparent trend in the causes of the reportable events.

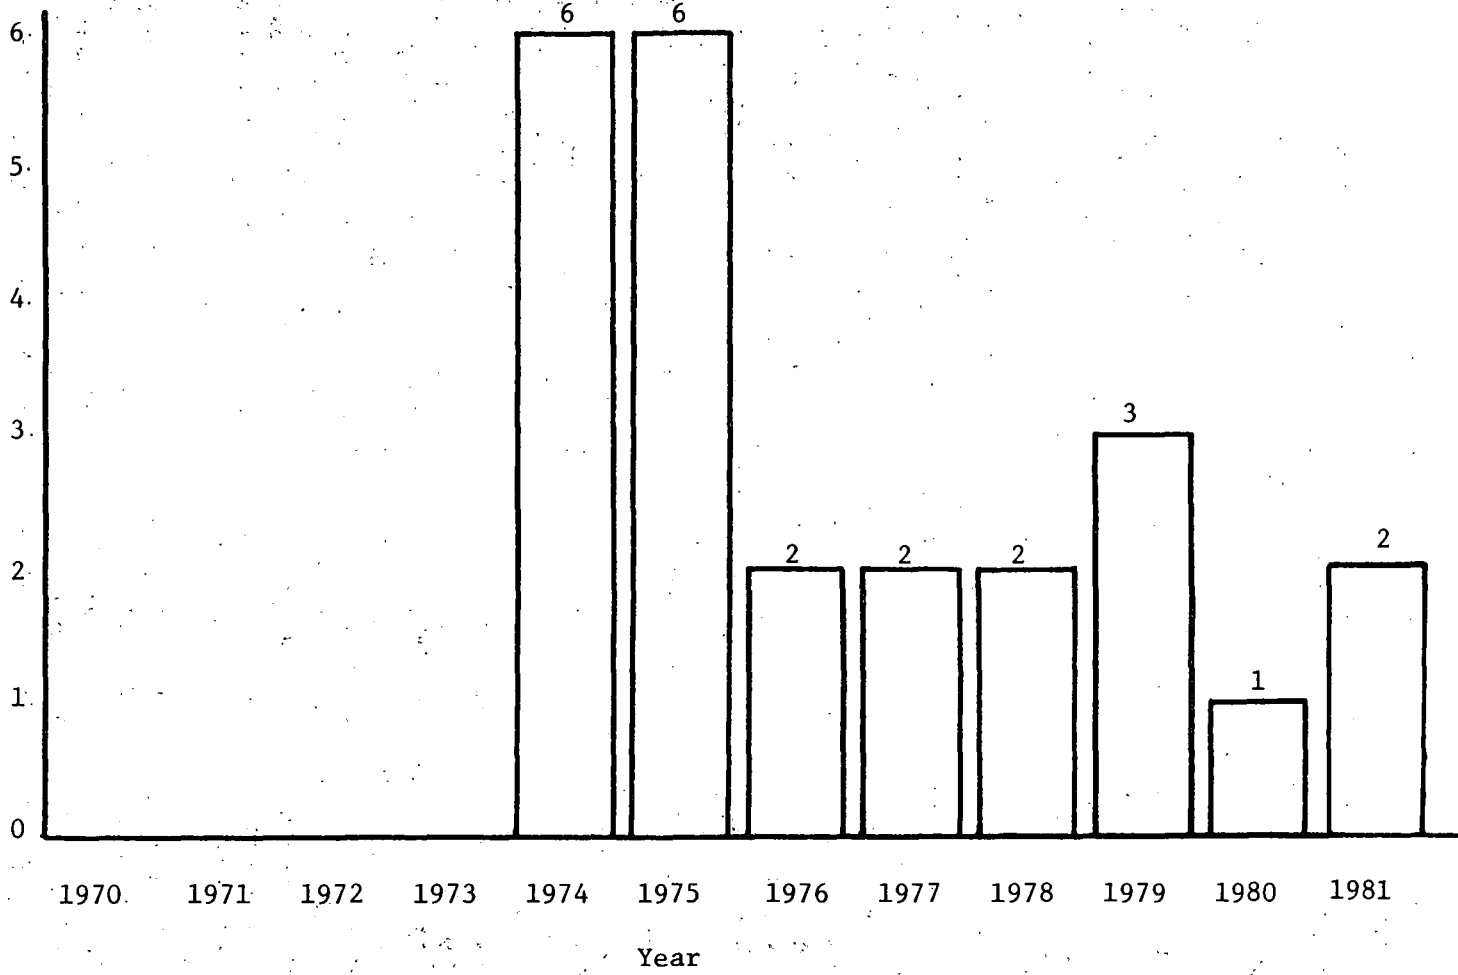
Fig. 4.3. Number of pipe cracks at Dresden 2.

The major contributor to the significant types of events was various equipment and component failures that caused nine of these events. Pipe cracks that were identified from 1974 through 1978 in assorted systems accounted for six of the significant events. Several cracks were found in the coolant recirculation system and recirculation bypass loop; cracks were also found in the core spray system, feedwater system, and containment isolation systems. Pipe cracking is a generic BWR problem and the Pipe Cracking Study Group formed by NRC has indicated stress-corrosion cracking as the cause. Three events were due to human errors--two operator errors and one fabrication error.

Three of the event types (pipe cracks, MSIV failures, and feedwater regulator valve problems) were identified either by Dresden Unit 2 or NRC staff, and corrective measures were undertaken. Three types (diesel generator failures, control rod and rod drive problems, and the radioactive waste management/health physics program problems) were identified by Dresden Unit 2 and NRC staff, and corrective actions were taken or are under consideration. These types, however, continue to recur and/or still are of concern. The remaining three types (operator errors, turbine control problems, and high-pressure coolant injection failures) continued to recur through 1981.
