Subject: Dresden Station Unit 3  
IGSCC Inspection Order List  
of Welds Not Being Inspected  
NRC Docket Nos. 50-249

## ATTACHMENT I

LIST OF 304 SS PIPING WELDS ( $\geq 4$ " N.P.S.) THAT  
WILL NOT BE INSPECTED DURING THIS CURRENT OUTAGE

TECHNICAL JUSTIFICATIONS

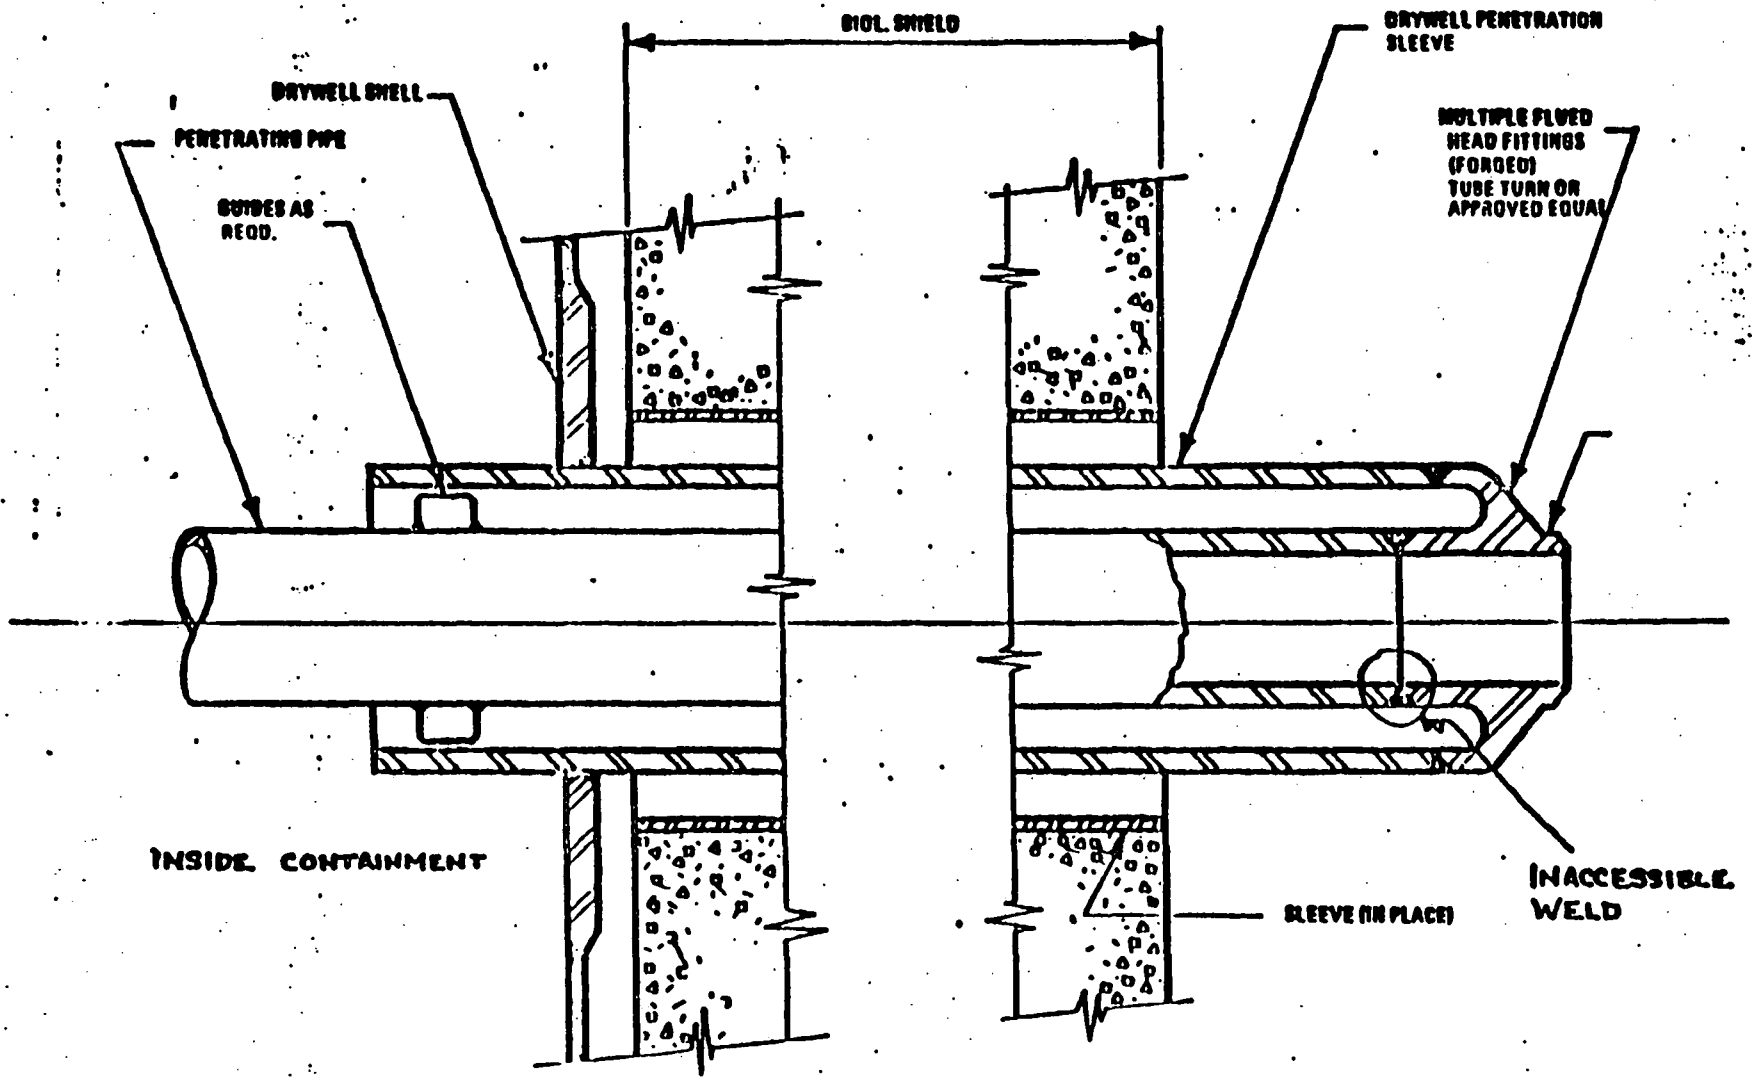
Figure 4 Center Section—Cold Fluid Piping Penetration Assembly

1. These Class 1 lines, due to the design of primary containment penetration assembly, have one circumferential pressure retaining weld that is inaccessible for volumetric examination. Figure 1 or 2 clearly illustrates the design constraints which make it extremely impractical to examine the subject welds by volumetric technique. Relief from Inservice Inspection requirement for these welds has been granted by the NRC staff.

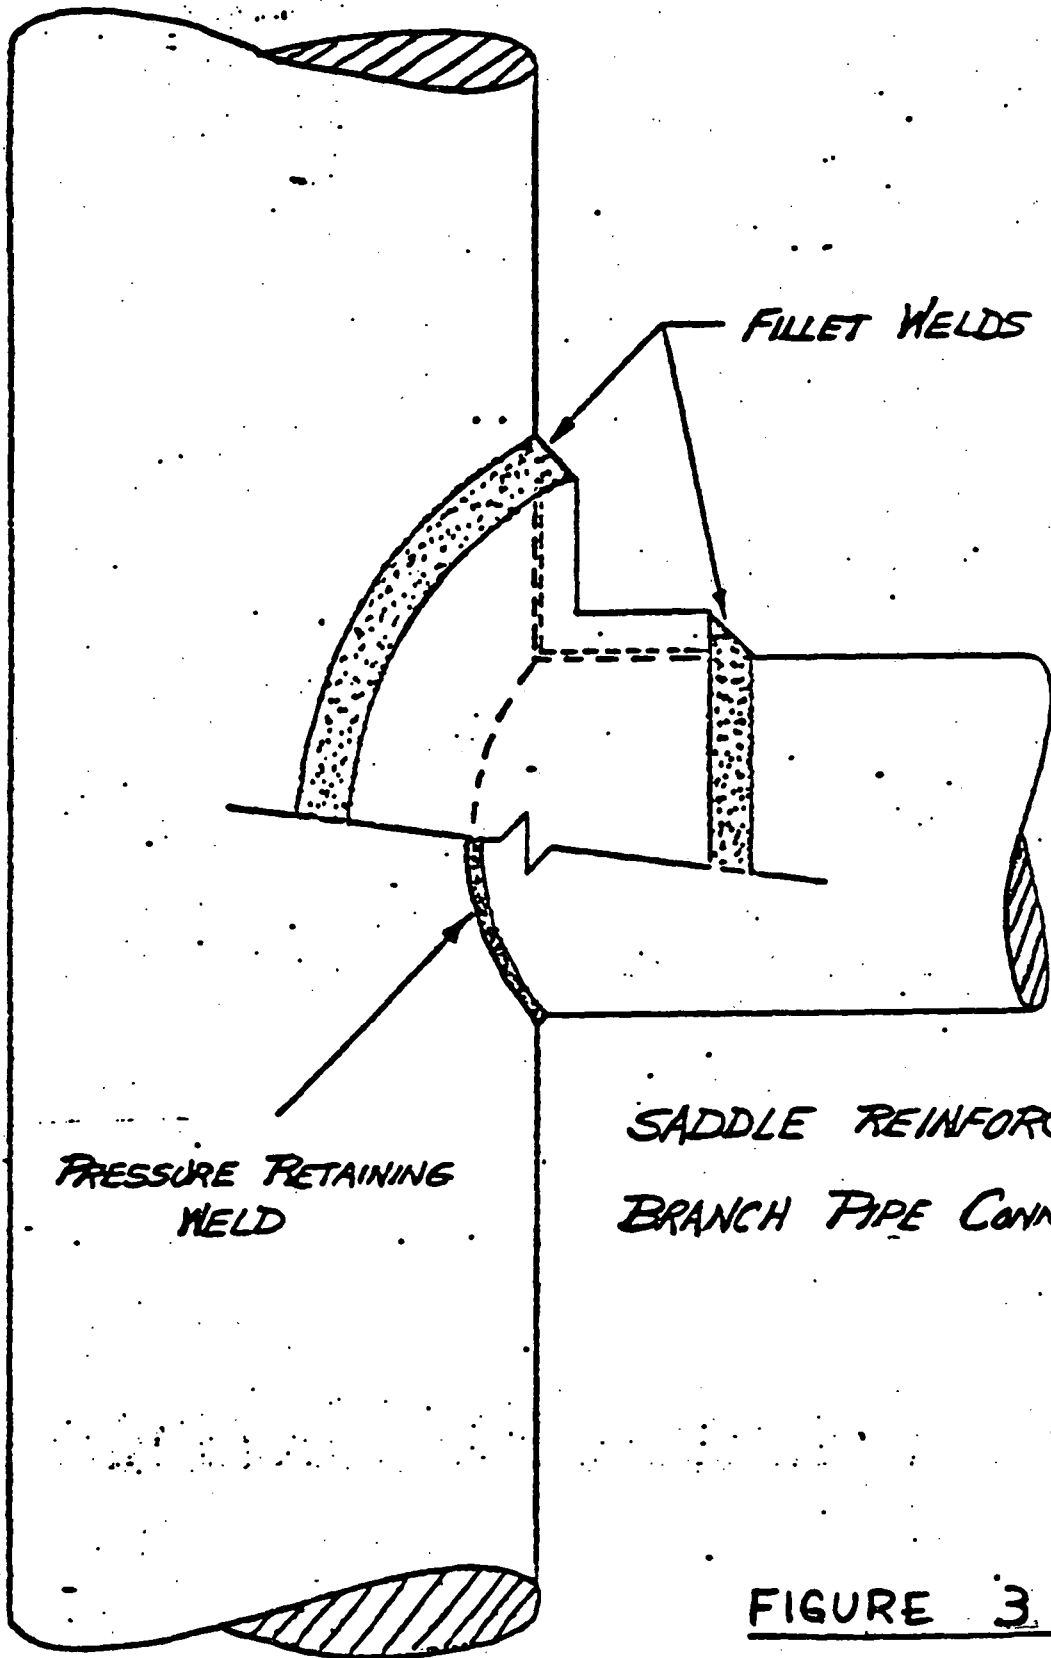
FIGURE 3

2. The design of these branch pipe connection welds calls for the use of reinforcement saddles. This saddle is fillet welded over the actual pressure retaining branch pipe to main pipe weld, completely encasing it as illustrated on figure 3. Relief from Inservice Inspection requirement for this weld has been granted by the NRC staff.
