Subject: Dresden Station Unit 2  
Stainless Steel Pipe  
Inspection Results  
NRC Docket No. 50-237

Results of Augmented Examinations

Dresden Unit 2

Fall 1984

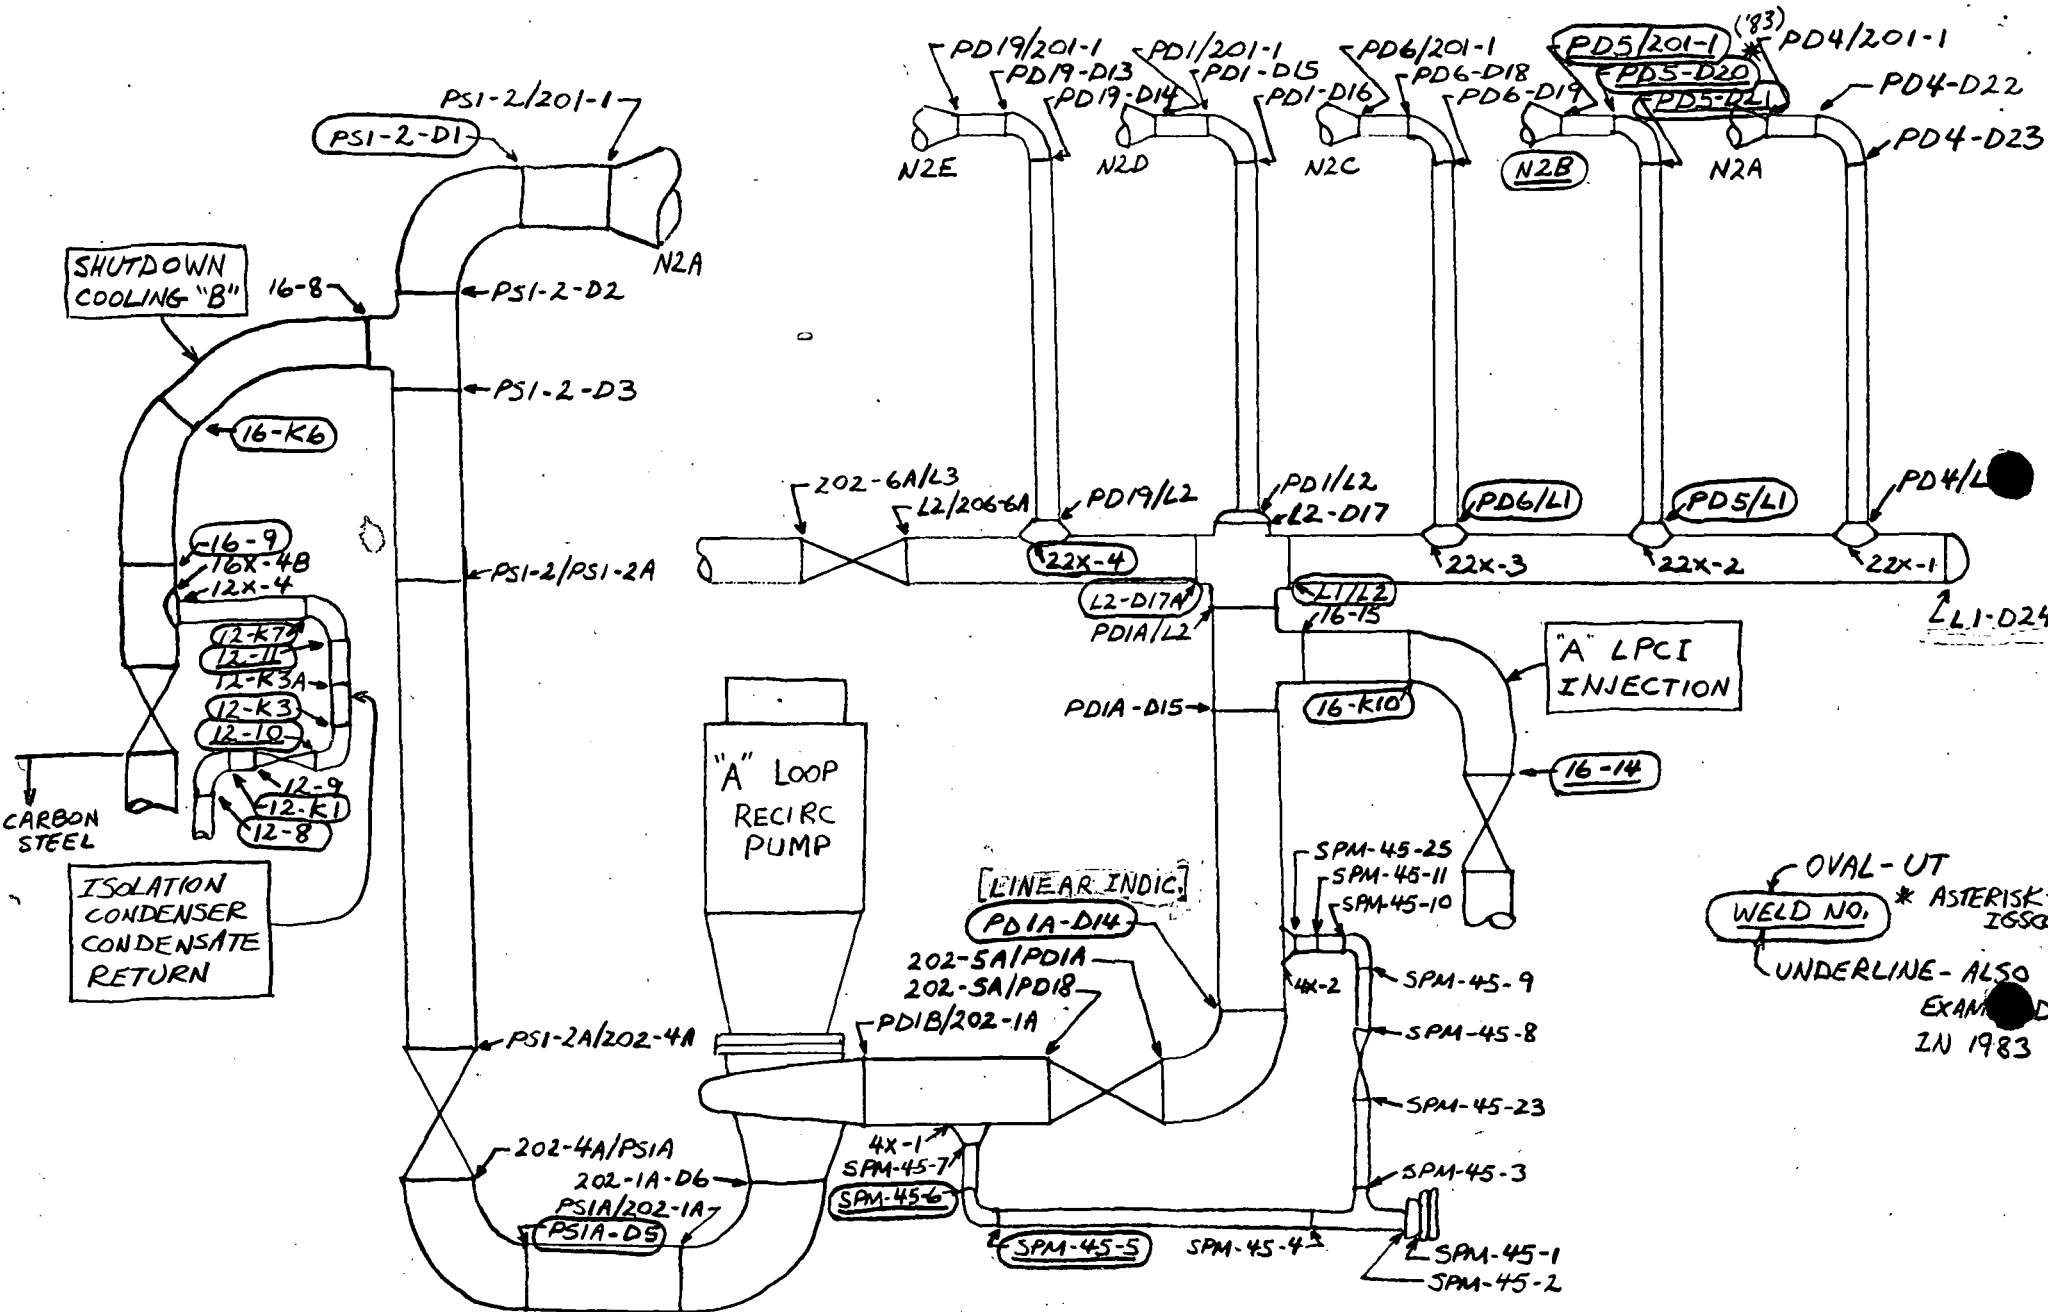
REACTOR RECIRCULATION SYSTEM "A" LOOP DRESDEN UNIT 2

Crack indications were found in the 8" and 10" portions of the RWCU piping. A small circumferential indication not believed to be IGSCC was found in one of the 28" Recirculation system welds (Weld No. PDIA-D14). The remainder of the Recirculation system and the other inspected systems were free of crack indications. The length and depth (7/8" x 4% of wall) of the indication in the 28" weld do not exceed the criteria for Allowable Planar Indications in ASME Section XI Table IWB-3514-2; therefore no extension of the examinations to additional 28" welds was done. Weld PDIA-D14 will be UT examined at the next refueling outage.

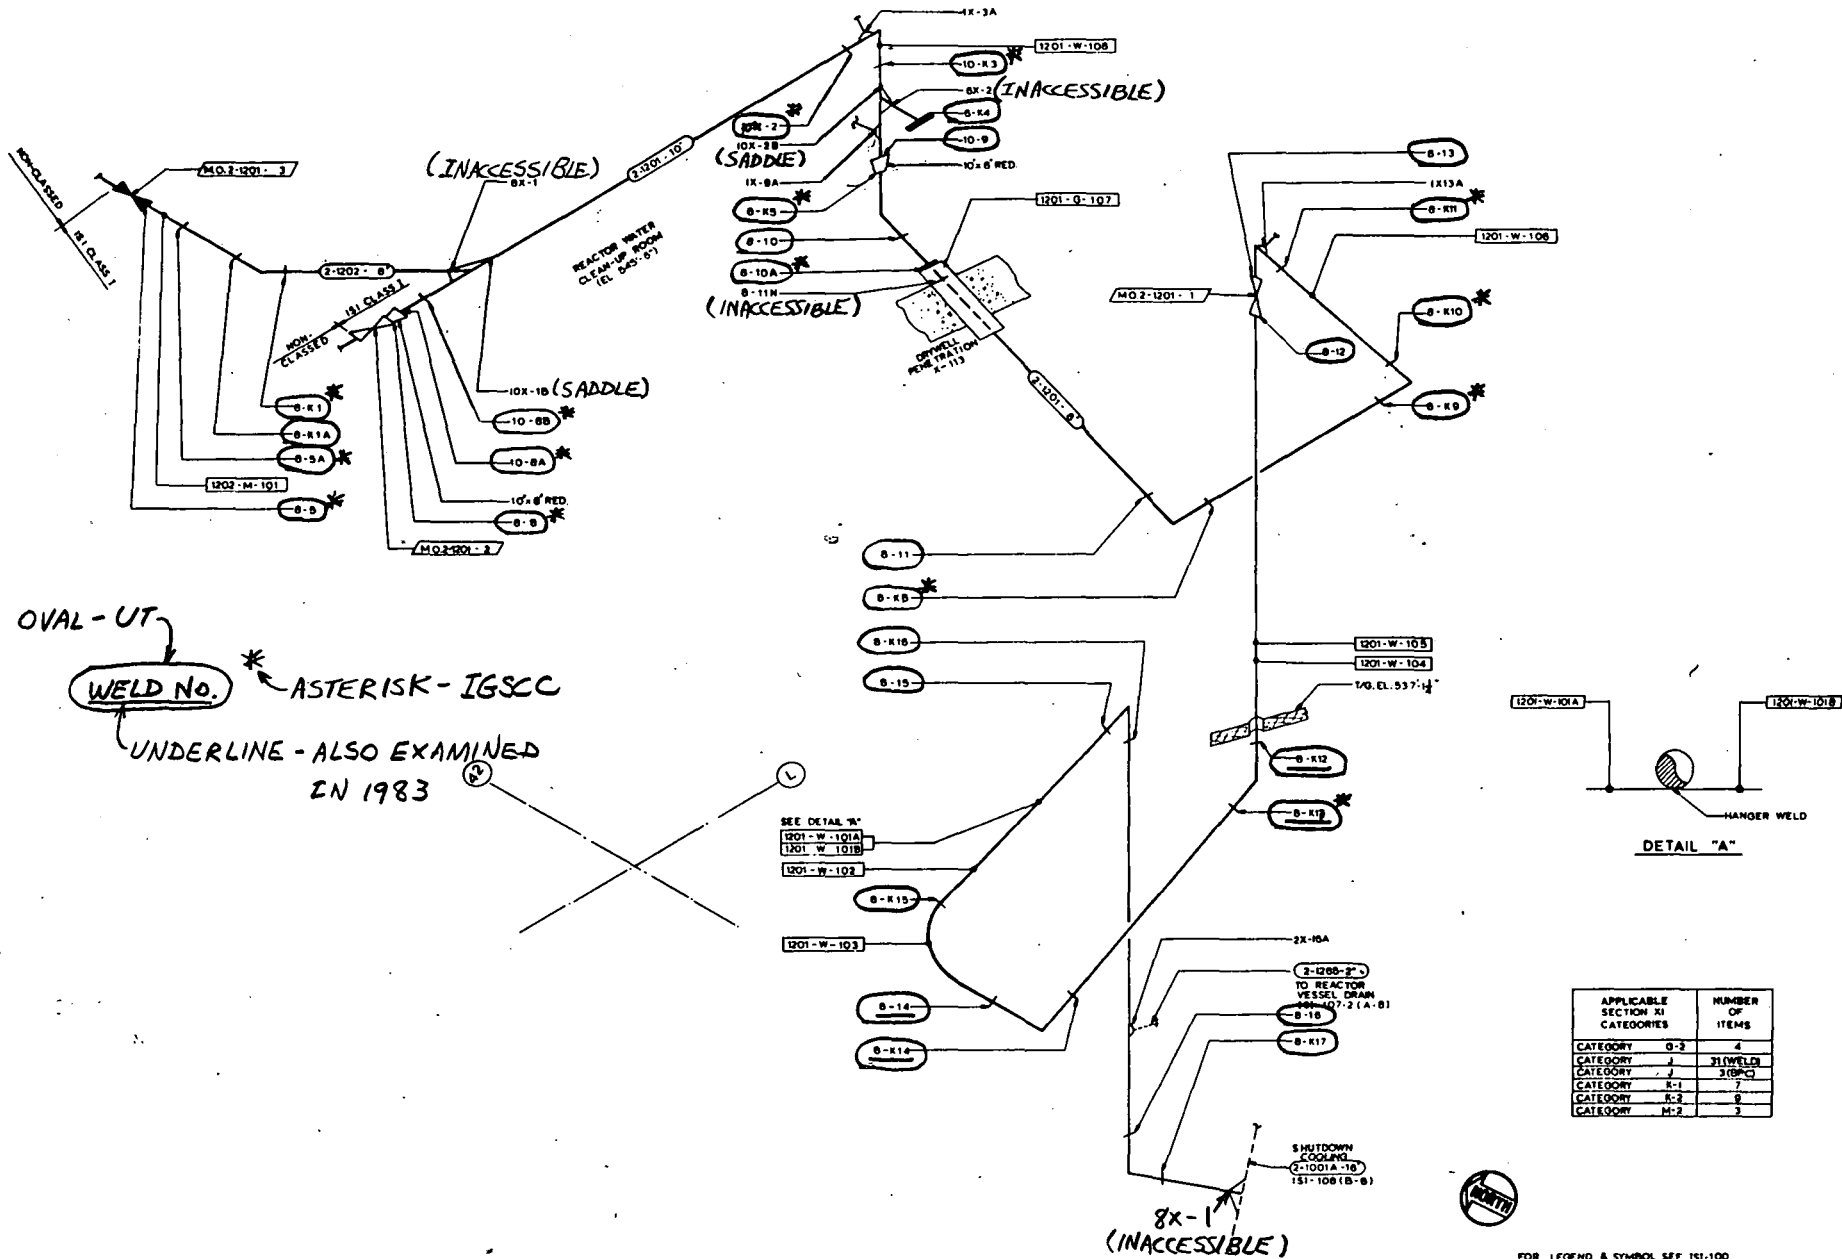
INSERVICE INSPECTION CLASS I  
 REACTOR WATER CLEAN-UP PIPING  
 DRESDEN NUCLEAR POWER  
 STATION UNIT 2  
 COMMONWEALTH EDISON CO.  
 CHICAGO, ILLINOIS

Upon finding crack indications in the original samples of the 8" and 10" RWCU piping welds, additional welds were examined as required by ASME Section XI paragraph IWB-2430. Cracking indications were found in the additional samples with the result that all 8" and 10" RWCU welds were examined. At the completion of all inspections, 11 of the 27 8" welds and 4 of the 5 10" welds in the RWCU system had crack indications. Three of the 27 8" welds were inaccessible for inspection; two of these inaccessible welds are saddle reinforced branch connections and the remaining inaccessible weld is within the flued head penetration through the drywell. A fourth inaccessible weld is a saddle reinforced connection for the 6" branch line off the 10" line.

Marked piping drawings are provided of the systems which identify the inspected welds. The very small linear indication in the 28" Recirculation piping is noted, as is the extent of the cracking in the RWCU system. The four inaccessible welds in the RWCU system are also noted on that drawing.

It is our intent, dependent on piping availability, to replace the RWCU piping outside the drywell. Replacement would eliminate two of the presently inaccessible saddle reinforced welds (Weld Nos 8X-1 and 6X-2) and also permit access for a liquid penetrant examination of the inside surface of the weld within the flued head penetration (Weld No. 8-11N). With replacement of piping outside of drywell, the only remaining inaccessible weld would be where the RWCU system branches off the Shutdown Cooling line (also designated Weld No. 8X-1). The saddle welds on this branch connection were liquid penetrant examined.
