Subject: Dresden Station Unit 2  
RCU Piping Modifications  
at Penetration and Inside  
the Drywell  
NRC Docket No. 50-237

RWCU PIPING MODIFICATIONS AT PENETRATION X-113

AND INSIDE THE CONTAINMENT

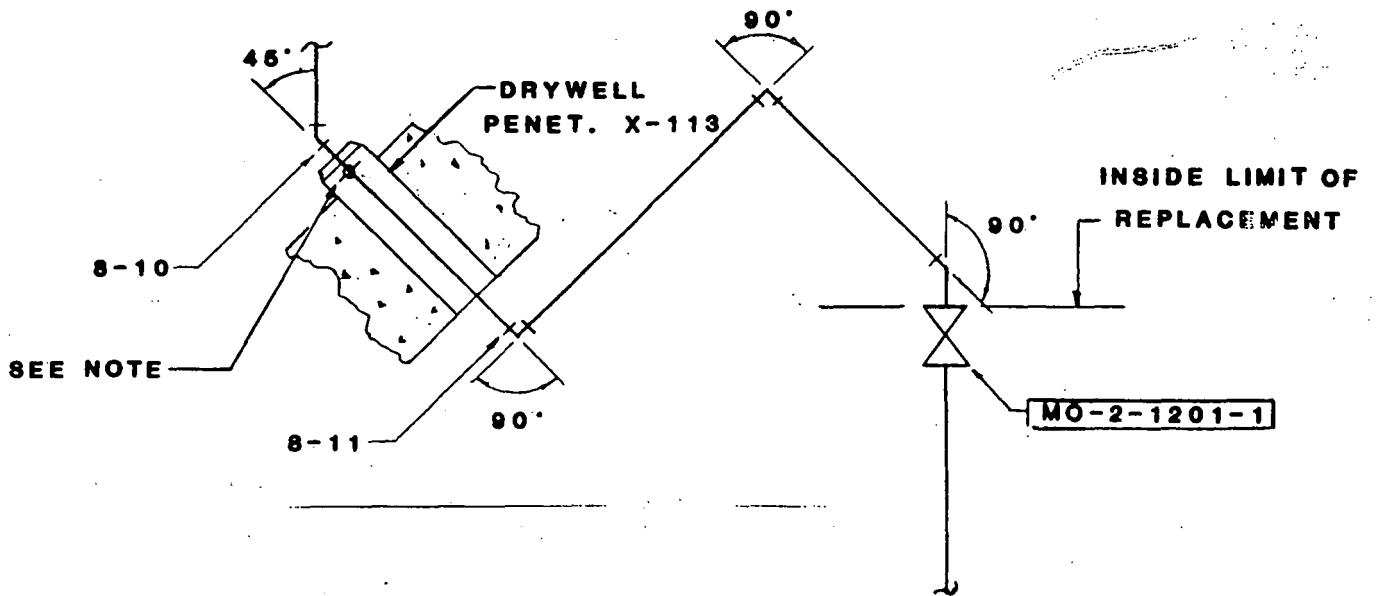
FIGURE 1

During the Dresden Unit 2 Fall 1984 outage, Reactor Water Clean-Up (RWCU) piping adjacent to the flued head at drywell penetration X-113 was replaced to eliminate flaws resulting from intergranular stress corrosion cracking (IGSCC). These flaws consisted of axial and circumferential cracks which are described in the B. Rybak letter to H. R. Denton dated December 19, 1984. Removal of this pipe permitted access to the inside surface of Weld 8-11N which was otherwise inaccessible. A liquid penetrant examination was performed to check the inside surface of that weld for IGSCC. The examination revealed seven axial flaws with a 1/2 inch maximum length on the pipe side of the weld.

The configuration of RWCU piping inside the drywell is shown in Figure 1. The modification involved rerouting the piping from the drywell penetration (X-113) to the inboard isolation valve (MO-2-1201-01) in order to avoid fabrication of a 72° elbow. A spring hanger support (2-1201-W-106) was also removed as a result of the rerouting. Adequacy of the modified pipe configuration has been confirmed by analysis. No other changes were made to the piping system inside the drywell.

RWCU PIPING REPLACEMENT INSIDE DRYWELL AND AT PENETRATION X-113.

NOTE: ORIGINAL LOCATION OF INACCESSIBLE WELD 8-11N  
(ELIMINATED BY CONTINUOUS REPLACEMENT PIPE  
BETWEEN WELDS 8-10 AND 8-11).

The flaws in weld 8-11N were removed and the accessibility problem was resolved by eliminating the joint. This was accomplished by replacing the process piping between welds 8-10 and 8-11 with a continuous run of IGSCC-resistant pipe which passes through the flued head and is welded to it.

The piping inside the drywell included five joints for which weld overlay repairs were planned. It was decided to replace the penetration pipe which made replacement of adjacent internal piping a more practical option for four of the five planned overlays. The remaining joint, 8-K13, could not be readily isolated and was weld overlay repaired, as originally planned. Therefore, the RWCU piping replacement project, both inside and outside the drywell replaced all but one weld with crack indications.
