**Commonwealth Edison**  
One First National Plaza, Chicago, Illinois  
Address Reply to: Post Office Box 767  
Chicago, Illinois 60690

Subject: Dresden Station Units 2 and 3  
Quad Cities Station Units 1 and 2  
Review of Fire Protection Requirements  
NRC Docket Nos. 50-237, 50-249,  
50-254 and 50-265

CATEGORY 1 DISCREPANCIES - DRESDEN

QUAD CITIES DISCREPANCIES  
SUMMARY OF ALL CATEGORIES

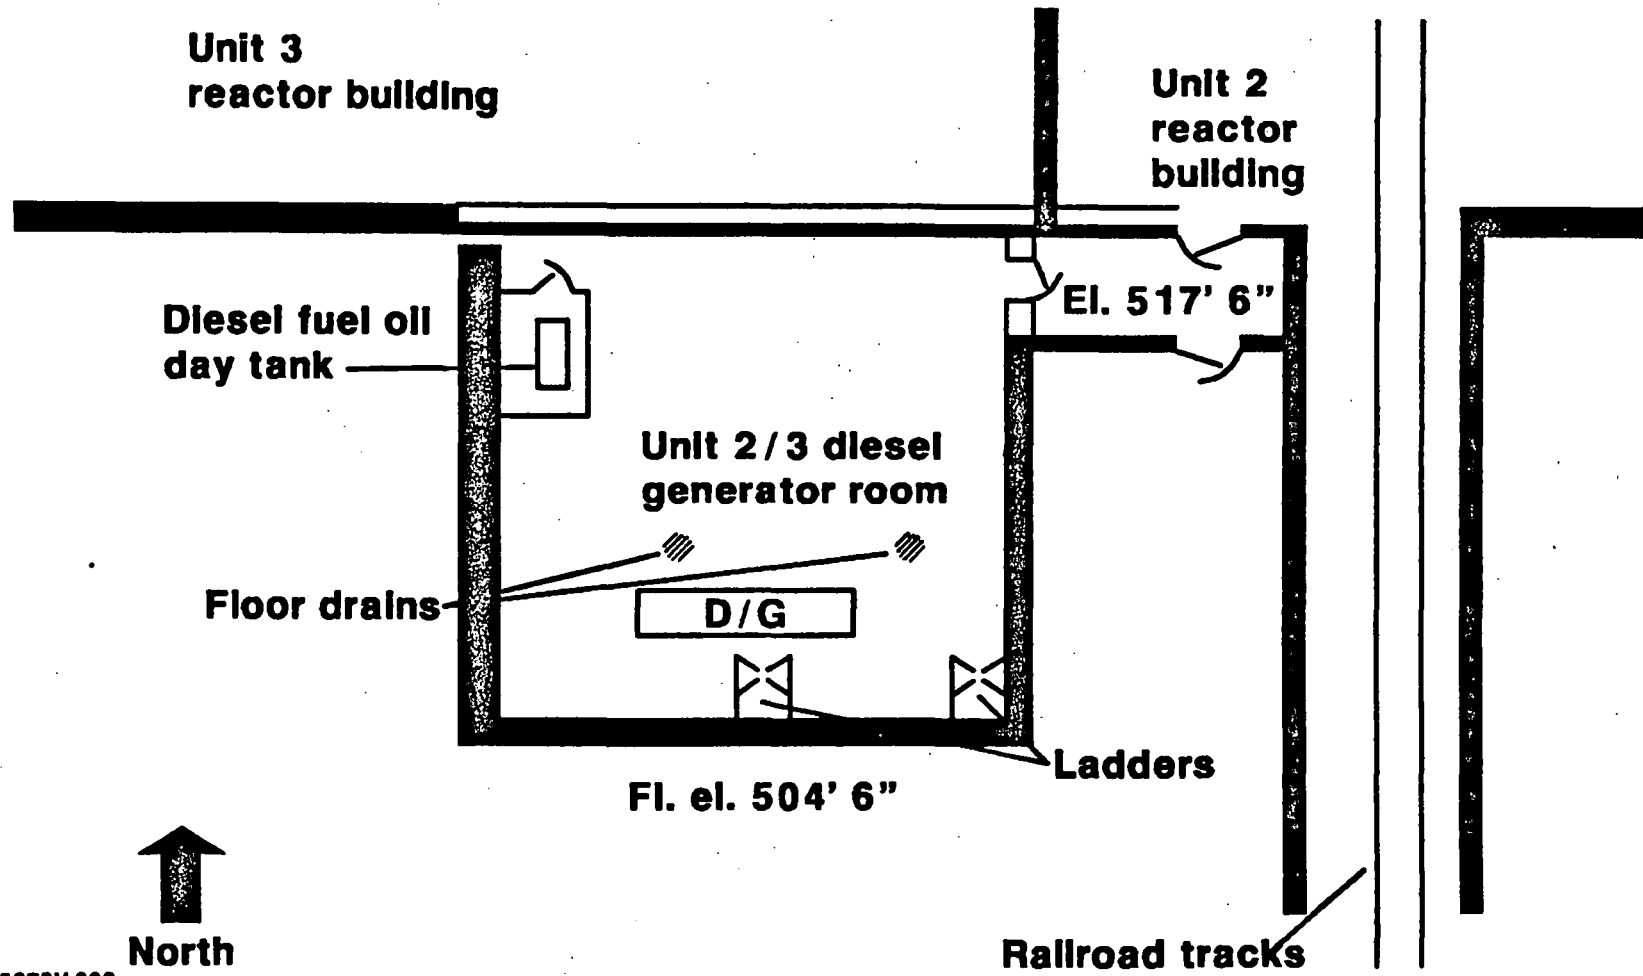
FIGURE 1

<u>ITEM</u>	<u>SER REFERENCE</u>	<u>DESCRIPTION</u>
3.1(a)	3.1.8	SER Section 3.1.8 states, "Fire doors will be provided...at the....diesel generator rooms." Fire doors were installed at the Turbine Building entrances to the DG2 and DG3 rooms. A fire door was not installed for the reactor building entrance to the 2/3 DG room through the secondary containment interlocked access corridor (heavy metal interlocked doors exist). Based on the brief description in the SER and previous correspondence, we believe a fire door was not intended here since this is an external door with no external combustible loads. The general policy used in the 1977 FHA was to install fire doors in external walls only when there was a clearly identified hazard outside. See Attachment 5 page 3 for the fire hazards analysis. See Figure 1.

3.1(b)	3.1.8	SER Section 3.1.8 states, "Fire doors will be provided...at the...diesel generator rooms." Since suppression exists in both the 2/3 DG and HPCI rooms, and two heavy metal doors are in place, a fire door was not intended and therefore not installed between the 2/3 DG room and the HPCI rooms. Refer to Section 2.3.9.7 of the 1977 FHA. See Attachment 5 page 3 for the fire hazards analysis. See Figure 1.

3.2	3.1.15	SER Section 3.1.15 states, "Curbs will be provided for the diesel generator room..." All doors in the DG rooms and Day Tank rooms have been provided with curbs except the entrance to the 2/3 DG room. A curb was not intended for this location since the entrance is 13 feet above floor level. See Attachment 5 page 3 for the fire hazards analysis. See Figure 1.

The diesel generator 2/3 room north wall separates this room from the Reactor Building (See Figure 1). This is a 3-hour rated fire barrier. The east, west and south walls and roof are exterior boundaries. These walls and roof are not fire rated. An unrated substantial metal door from the 2/3 diesel generator room eastwall opens to the secondary containment interlock corridor (See Figure 1). A door from the Unit 2 reactor building and from the exterior also opens into this corridor. The floor is a secondary containment boundary which separates the diesel generator 2/3 room from the Units 2 and 3 HPCI rooms. The floor is not fire rated. Unrated double doors provide access from the 2/3 diesel generator room to each HPCI room. The safety-related equipment in the diesel generator 2/3 room includes the 2/3 diesel generator, fuel oil transfer pump, and vent fans.

The Unit 2 reactor building door and 2/3 diesel generator east door, which open into the secondary containment interlocked access corridor, are considered exterior doors. These are heavy metal doors which are electrically interlocked. There is no continuity of combustibles across the access corridor. Furthermore, the access corridor is 13 feet above the 2/3 diesel generator room floor. This difference in elevation prevents any possibility for combustible liquid from communicating from the DG 2/3 room to the Reactor Building. Finally, the DG 2/3 room is protected with complete thermal fire detection and total flooding CO<sub>2</sub>. Consequently, it is unlikely that a design basis fire in the 2/3 diesel generator room would spread from the DG 2/3 room to the Unit 2 reactor building.

There are two hollow metal doors in series leading from the 2/3 diesel generator room into each HPCI room (4 doors total). These doors are normally closed and provide a secondary containment boundary. There is no continuity of combustibles through these double doors. The maximum flooding height due to 750 gallons (day tank capacity) of oil being discharged into the room would be approximately one-half inch. This assumes both four inch drains are completely blocked. The existing one-half inch threshold at the HPCI access doorways in conjunction with the existing drains provide adequate protection in the event of an oil spill. Figure 1 shows that an oil line break could not directly impinge an access door. The two four inch drains divert oil into the HPCI room trench which empties into the HPCI room sumps. However, the 2/3 diesel generator rooms and each HPCI room have complete automatic detection and suppression. The HPCI rooms are protected by a preaction water system. Consequently, a fire originating in either room would be promptly detected and suppressed. Additionally, the existing separation between these rooms provides a substantial barrier to fire spread.

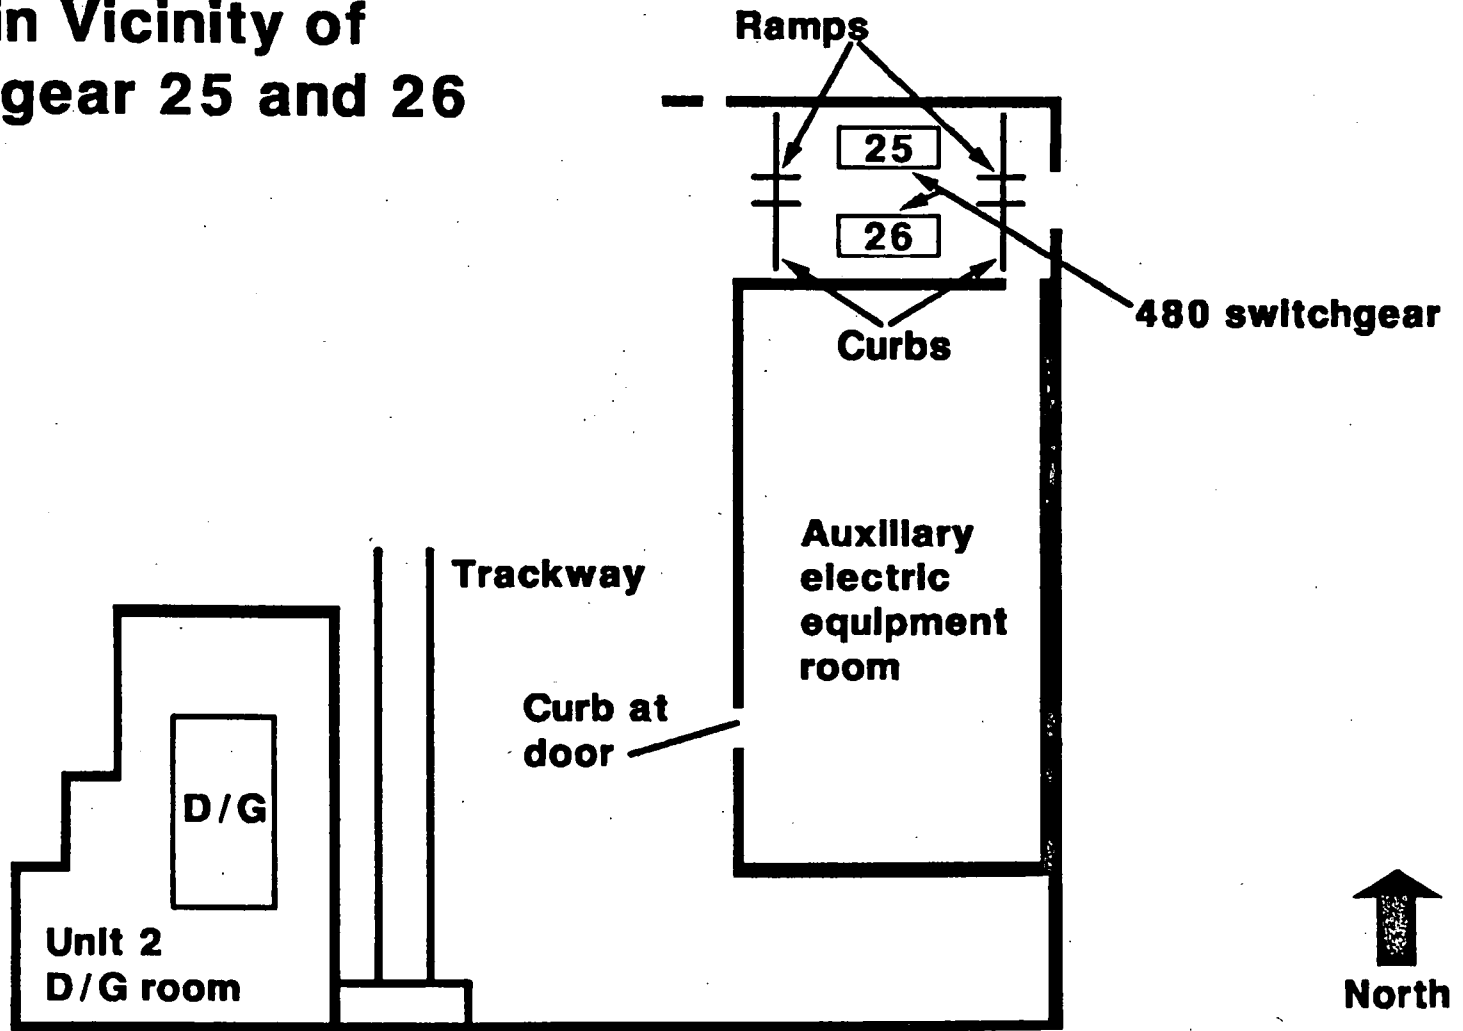
FIGURE 2

<u>ITEM</u>	<u>SER REFERENCE</u>	<u>DESCRIPTION</u>
3.4	3.1.15	SER Section 3.1.15 states, "Curbs will be provided at the entrance of the AEER room." The required curb was installed at the West door to the AEER to protect from potential transient combustibles in the Unit 2 trackway. A curb was not installed at the North door since curbs exist around adjacent 480V bus 25 and 26 transformers. These transformers are curbed and are the only fixed hazard in the vicinity. The north door does not access the Unit 2 trackway. See Figure 2.

# Curbs in Vicinity of Switchgear 25 and 26

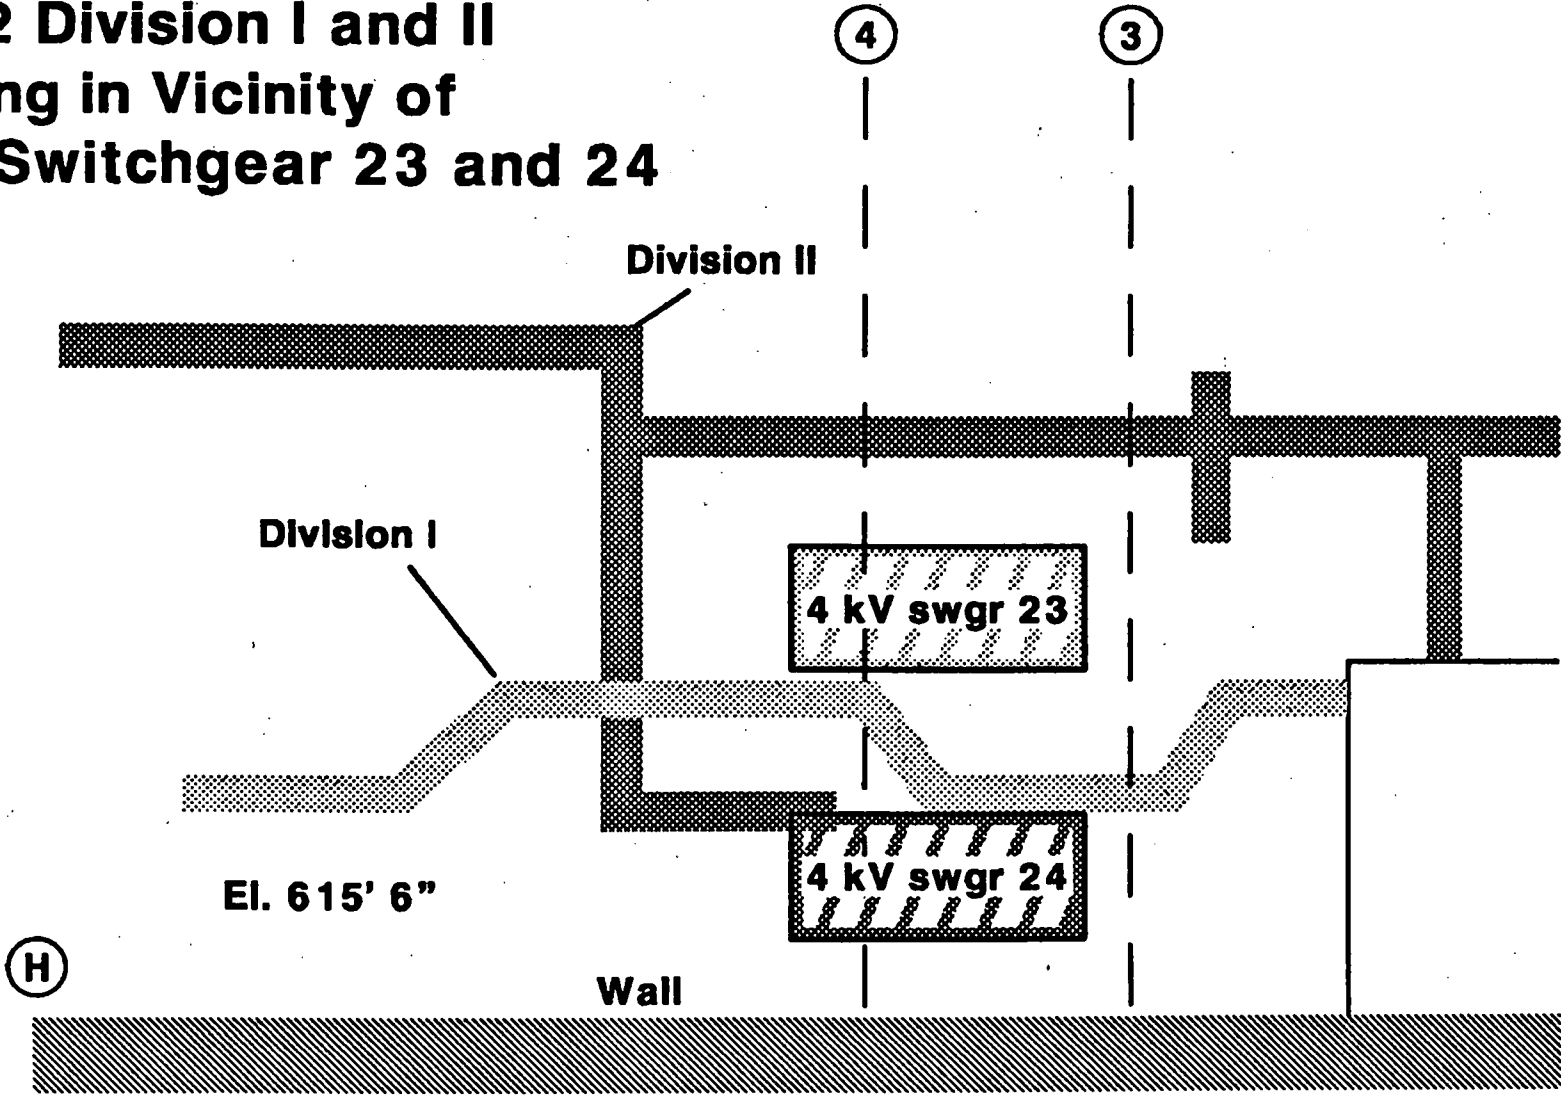
FIGURE 3

# Unit 2 Division I and II Cabling in Vicinity of 4 kV Switchgear 23 and 24

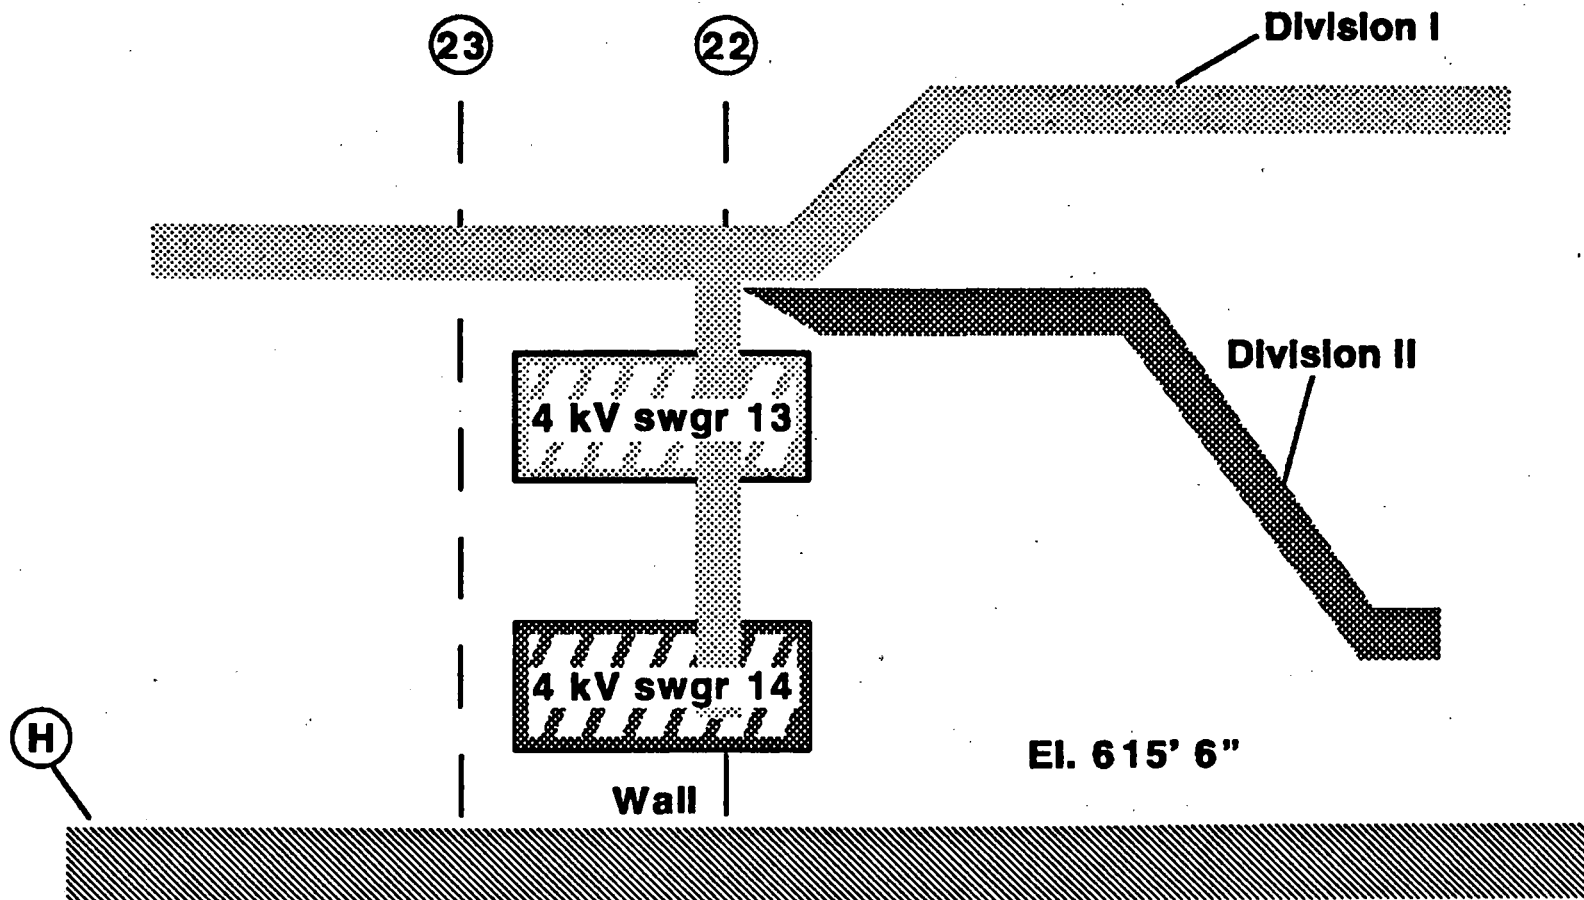
FIGURE 4

# Unit 1 Division I and II Cabling in Vicinity of 4 kV Switchgear 13 and 14
