**UNITED STATES
ATOMIC ENERGY COMMISSION**

THE CADWELD PROBLEM -- ADDITIONAL INFORMATION

SUBJECT Report - Failure of #8 Size Cadweld Sleeves

SUBJECT: FAILURE OF SIZE 3 CADWELD SLEEVES - SALEM NUCLEAR
GENERATING STATION

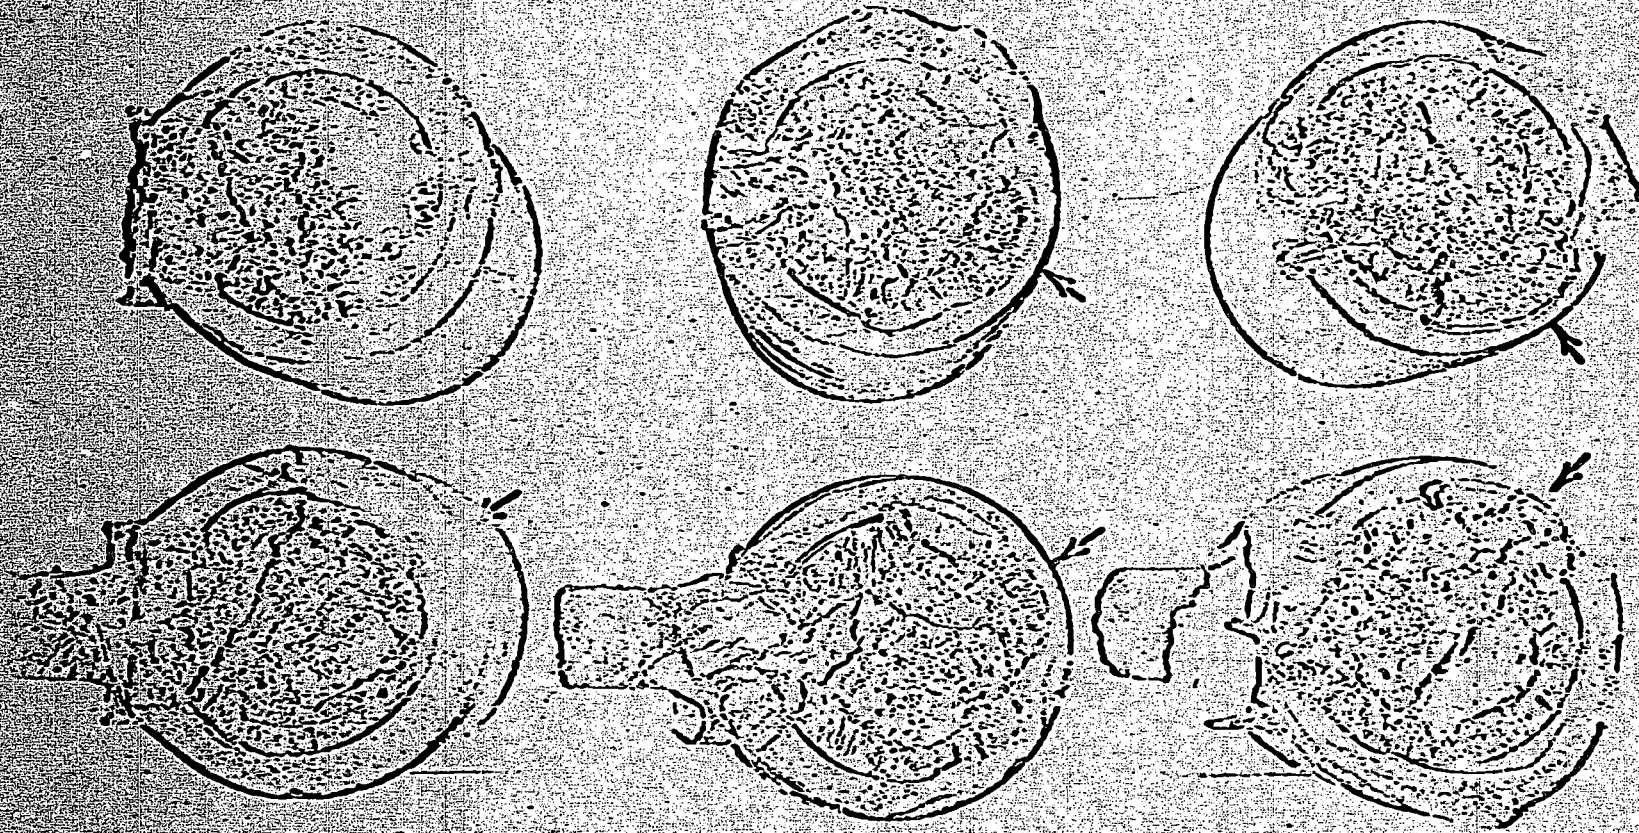
FIGURE 1

Of the six cadwelds which failed to meet minimum ultimate tensile strength requirements on tensile testing, two (cadweld No. 3-560H and 23-15HT) had a fracture which extended through an internal groove on the back side of the sleeve (Figure 1).

Visual examination of the six sleeves which failed below the required 90,000 psi minimum ultimate strength (Table I) showed evidence of a thin wall in three of the sleeves (Cadweld No. 23-13H, 23-17H and 23-20H) as shown in Figure 1. All six failed sleeves were cut longitudinally through the tap hole and visually examined after macro etching the cross-section. Etch inspection verified the presence of thin wall areas in three of the cadweld sleeves (Figures 2 and 3) at circumferential distances of approximately 120 degrees to 130 degrees (directly opposite) the tap hole. The wall thinning appears to have resulted from a washing out of sleeve material caused by the hot liquid metal entering the tap hole during cadwelding. Microscopic examination of samples taken through the thin wall area showed evidence of undercutting of the sleeve wall and rebar material by the cadweld metal (Figure 4).

Three of the cadweld splices which failed below the required minimum ultimate strength showing the thin sleeve wall (arrows) at the fracture through the sleeve in Cadweld 23-13H and 23-20H. Cadweld 3-560H fractured through an internal groove on the back side of the sleeve (arrows).

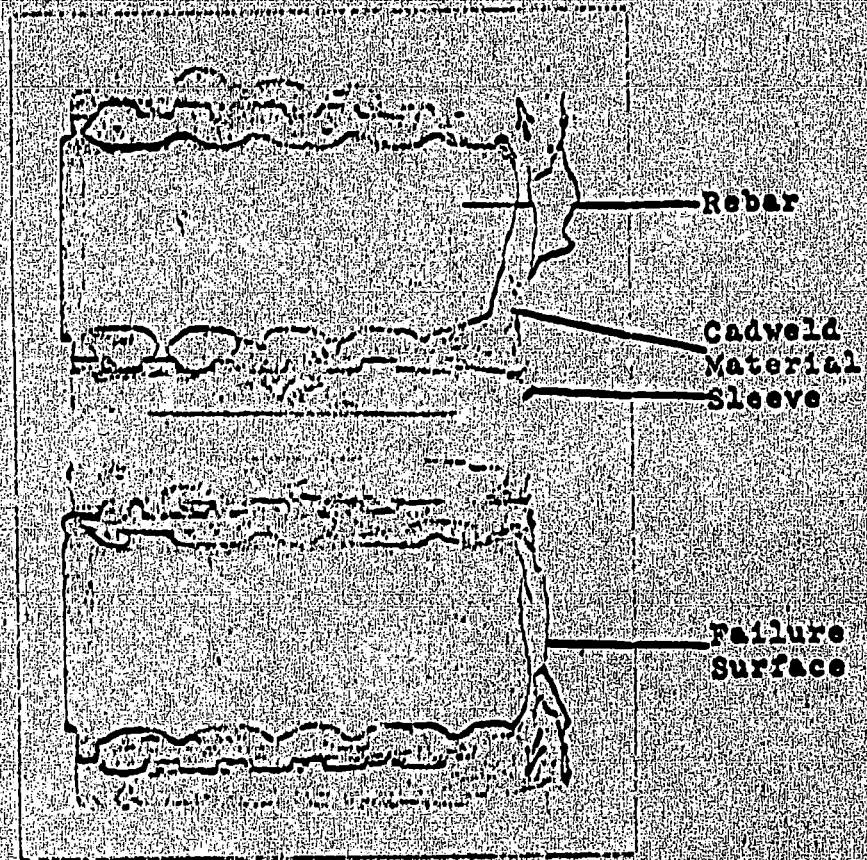
FIGURE 2

The two halves of longitudinally split cadweld splice No. 23-20H. Note the thin wall of the sleeve (arrows) in the area of the failure.

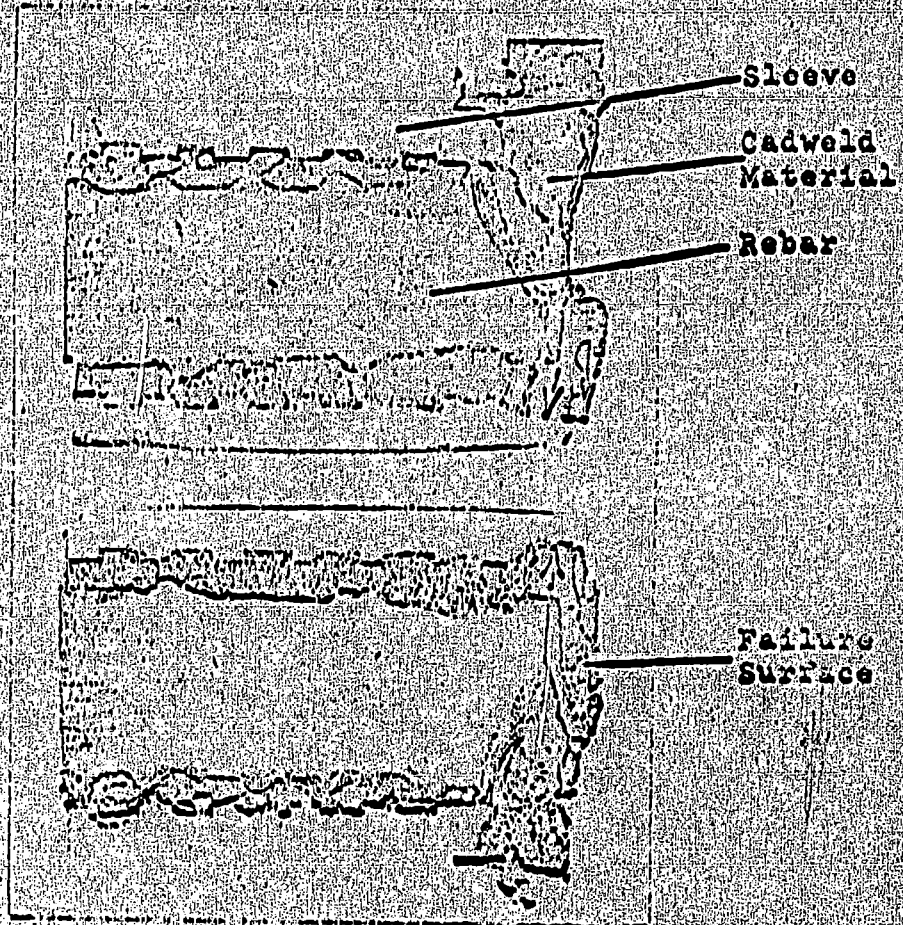
FIGURE 3

The two halves of longitudinally split cadweld splice No. 23-13H. Note the thin wall of the sleeve (arrows) in the area of the failure.

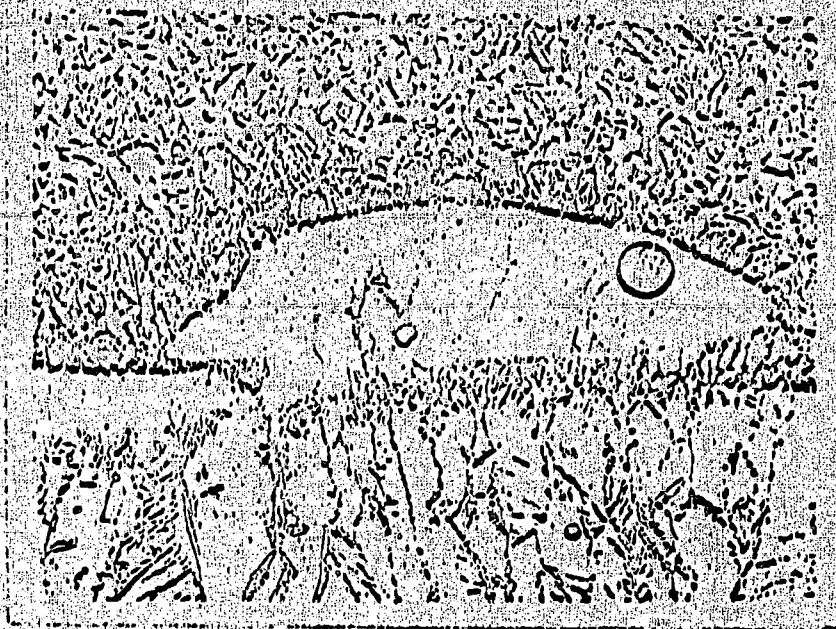
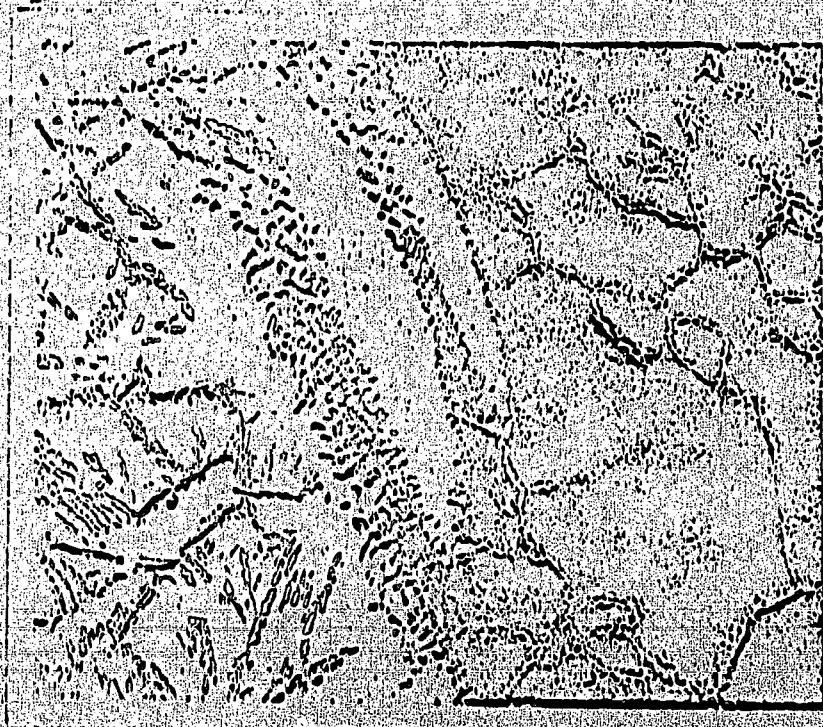
FIGURE 4

Photomicrographs showing the undercutting and welding of the cadweld material to the sleeve material (top photo) and rebar material (bottom photo) in the area of the thin sleeve wall.

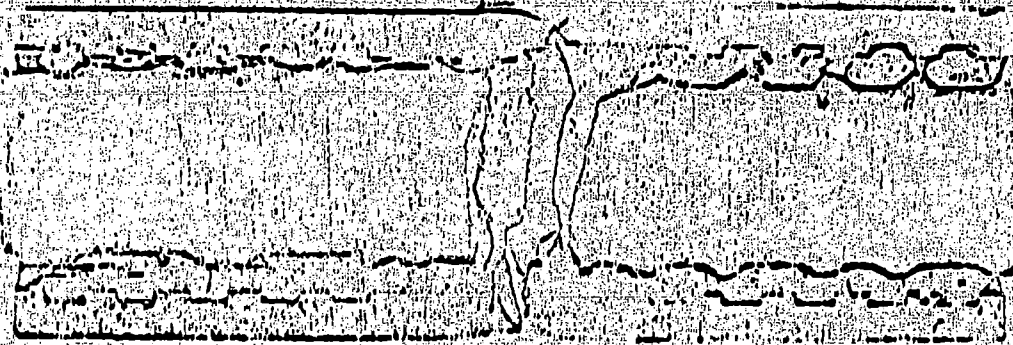
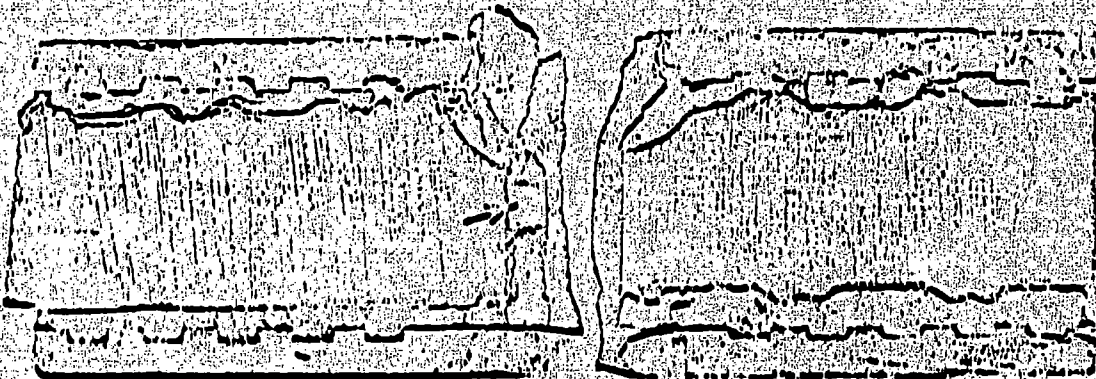
FIGURE 5

It was also desired to establish if the spacing between rebars in the sleeve was a factor in the premature failure of the cadweld splices. When making the cadweld a 3/16" square by 1" long spacer key is placed in the sleeve between the bars being joined. The six failed cadweld splices and three of the not tension tested production cadwelds having known thin wall areas (splice 1, 5 and 6) were split longitudinally to measure the distance between the ends of the rebars in the sleeve. In addition the ten remaining production cadweld sleeves were split longitudinally, at locations where sleeve washouts were suspected, to measure the distance between rebar ends. No washouts were found in the ten sleeves in the areas chosen for sectioning. The results tabulated in Tables I and II show that of the six failed cadwelds examined, the gap between the rebars being joined was excessive (greater than 0.100") in two cadwelds. Of the sixteen production cadwelds not tension tested, the spacing was excessive in three. The distance between the ends of the rebars in the failed cadwelds ranged from 0.140" to 0.250" (Figure 5). The distance in the production cadwelds having known washout areas (splice 1, 5 and 6) ranged from 0.050" to 0.290" and in the ten production splices where no washouts were found ranged from 0.020" to 0.250". It is probable that where the gap was very small (below 0.100") that no spacer key had been placed between the bars prior to welding. The spacer key was found in only five of the examined joints. Misalignment of one or both of the rebars being joined was found in three of the production cadwelds (No. 1, 5 and 13).

- Top - A longitudinal cross-section through failed castweld sleeve No. 23-20H. The spacing between rebar was 0.240" which is excessive.
- Bottom - A longitudinal cross-section through failed castweld sleeve No. 23-18H. The spacing between rebar was 0.190" which is normal. Note the spacer key (arrow).

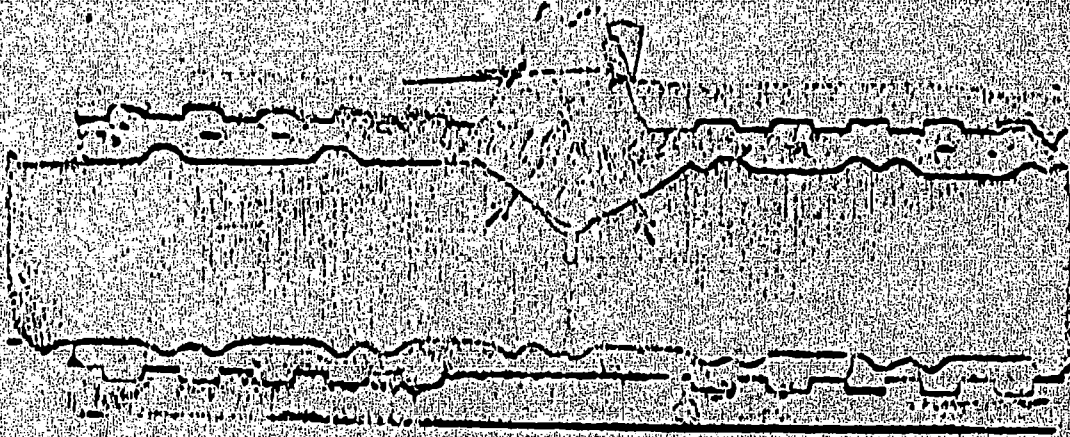
FIGURE 6

Visual examination showed that considerable metal had been removed from the ends of the rebars adjacent to the tap hole due to impingement of the hot liquid metal in all of the examined cadwelds (Figure 6). The condition which is unavoidable due to the nature of the cadweld process will further tend to increase the spacing of the rebars being joined.

A longitudinal cross-section of production cadweld No. 3-551H. Note that considerable metal has been removed from the ends of the rebars (arrows). Note also the very small gap between the rebars indicating that the spacer key may have been absent.
