Commonwealth Edison Company

Dresden Nuclear Power Station
R. R. #1
Morris, Illinois 60450
March 19, 1973

SUBJECT: LICENSE DPR-19, DRESDEN NUCLEAR POWER STATION, UNIT #2,
SECTION 6.6.C.(1) OF THE TECHNICAL SPECIFICATIONS.

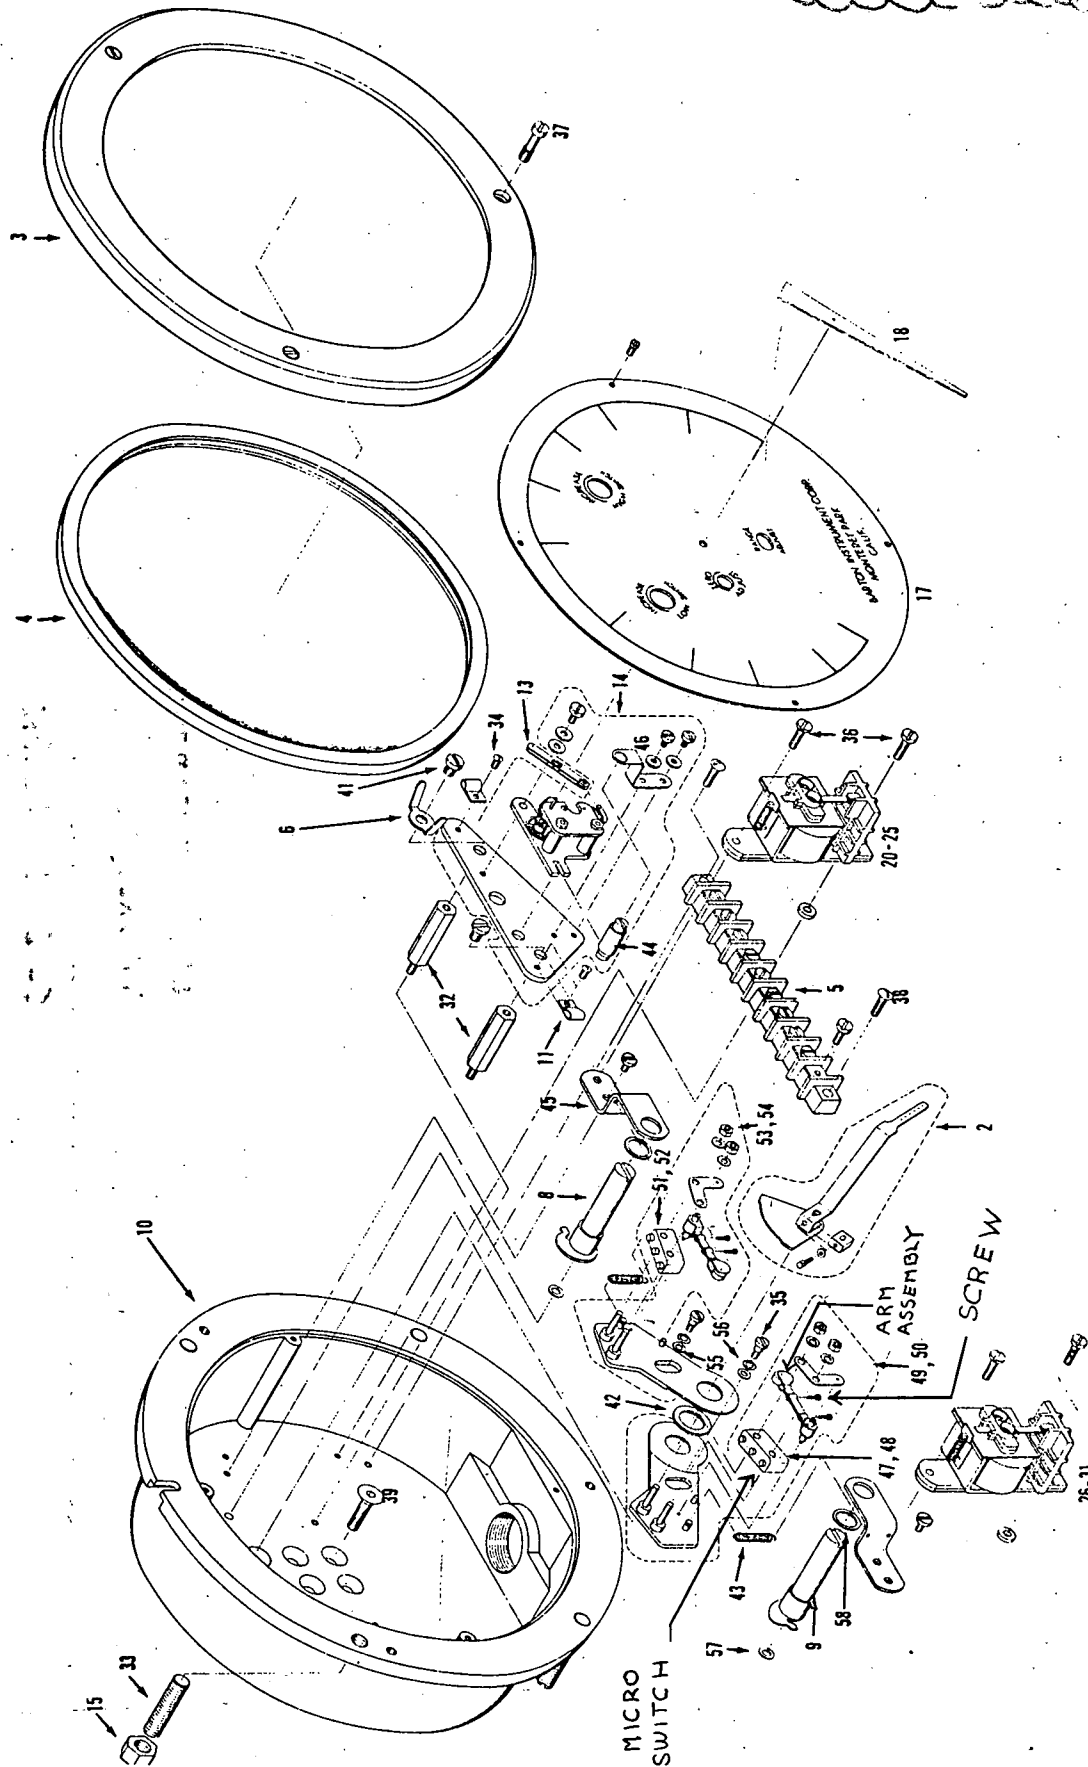
DPIS 2-261-34A

Switch DPIS-2-261-34A failed to operate due to a loose screw on the micro-switch actuating arm. (Figure #1). The function of the screw is to strike the micro-switch plunger when the actuating arm is moved upward by the diaphragm driven cam. The screw apparently vibrated out of position and could no longer make contact with the micro-switch. The records on this particular switch indicate that this screw was found to be loose on one previous occasion. At that time, the screw was tightened.

No record exists of a similar loose screw on any other Barton switch at this site, and in fact the screws are normally very tight and must be moved with a wrench. It was concluded that the loose screw in DPIS-2-261-34A was the result of a defective arm assembly which holds the screw.

The safety function of the system was not impaired as a result of this switch failure because redundant switch DPIS-2-261-34C would have performed the selectivity function in the event of a LPCI pipe break.

The arm assembly and screw for DPIS-2-261-34A were replaced and the switch tested satisfactorily. To further assure the screw will not vibrate out, finger-nail polish will be applied to the threads and the screw will be tested for tightness at the next surveillance.
