Commonwealth Edison Company

Dresden Nuclear Power Station
R. R. #1
Morris, Illinois 60450

SUBJECT: LICENSE DPR-19, DRESDEN NUCLEAR POWER STATION, UNIT #2, SECTION 6.6.C.1 OF THE TECHNICAL SPECIFICATIONS, FOLLOW UP LETTER.

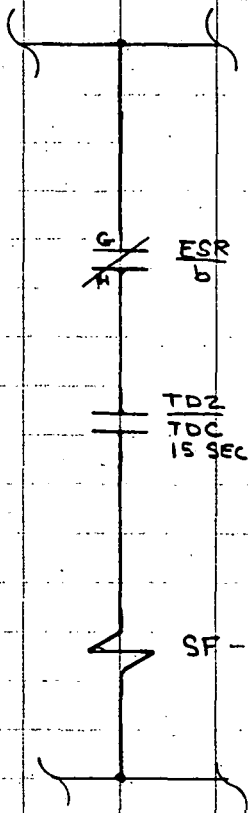
FIGURE 1

- b. ESR (G-H) opens when diesel reaches 200 rpm (Fig. 1)
- c. 15 sec. after auto start signal is initiated, TD2 closes (Fig. 1) TDC
- d. When the control switch is placed in the stop position, ESR (G-H) closes immediately (Fig. 1)

- f. ECR relay is de-energized-starting the time out sequence. ECR (3-5) closes. TD2 (N-P) opened when the TD2 relay was de-energized.
- g. When the control switch is returned to the AUTO position, the start signal is again initiated, but due to the SF (C-D) contacts being open, the TD2 relay can not be re-energized and consequently the ECR relay shutdown sequence takes precedence.

Placing the new TD2 relay with the faster drop out time in the system, eliminated step e. Since the start-failure relay is not energized, returning the control switch to the "auto" position will re-energize the TD2 relay and not allow the engine shutdown sequence to take precedence.

At present, a request for modification of the diesel generator start-failure circuitry is being directed to our station electrical engineering department with the intent of decreasing the effect that a slow opening TD2 contact will have on the overall performance of the system. In the interim, we will continue to operate under the new procedure referenced in our letter of October 3, 1972.

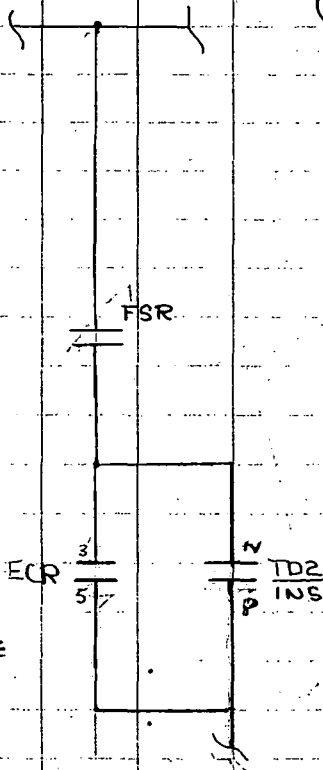
FIGURE 3

- a. on auto start signal, TD2 relay is energized closing TD2 and FSR (Fig. 3)
INS

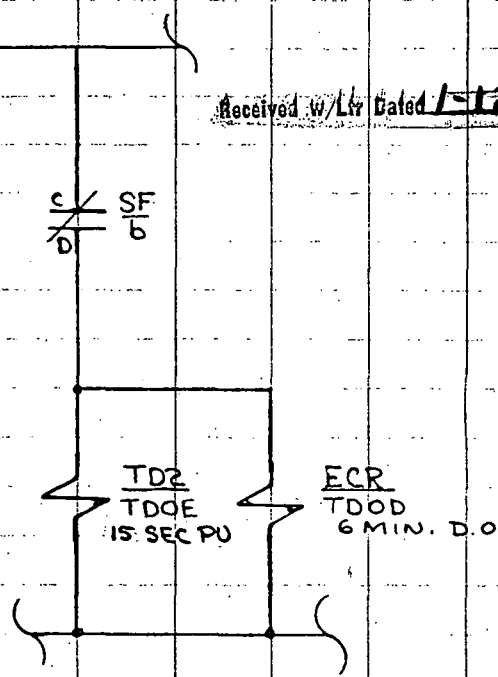
FIGURE 2

- e. Due to the finite amount of time required for the slow TD2 relay to open before the TD2/TDC contacts can open the SF relay is energized and the SF (C-D) contacts (Fig. 2) open and must be manually reset at the engine panel.

- h. The Diesel generator trips (shuts down with a locked in auto start signal) and cannot be restarted until the SF (C-D) contacts are manually reset at the engine control panel.
