SUBJECT: REPORT OF ABNORMAL OCCURRENCE PER SECTION 6.6.A OF THE TECHNICAL SPECIFICATIONS CORE SPRAY INJECTION LINE THROUGH-WALL CRACKS

Report Number: 50-237/1975-11

Facility: Dresden Nuclear Power Station, Morris, Illinois

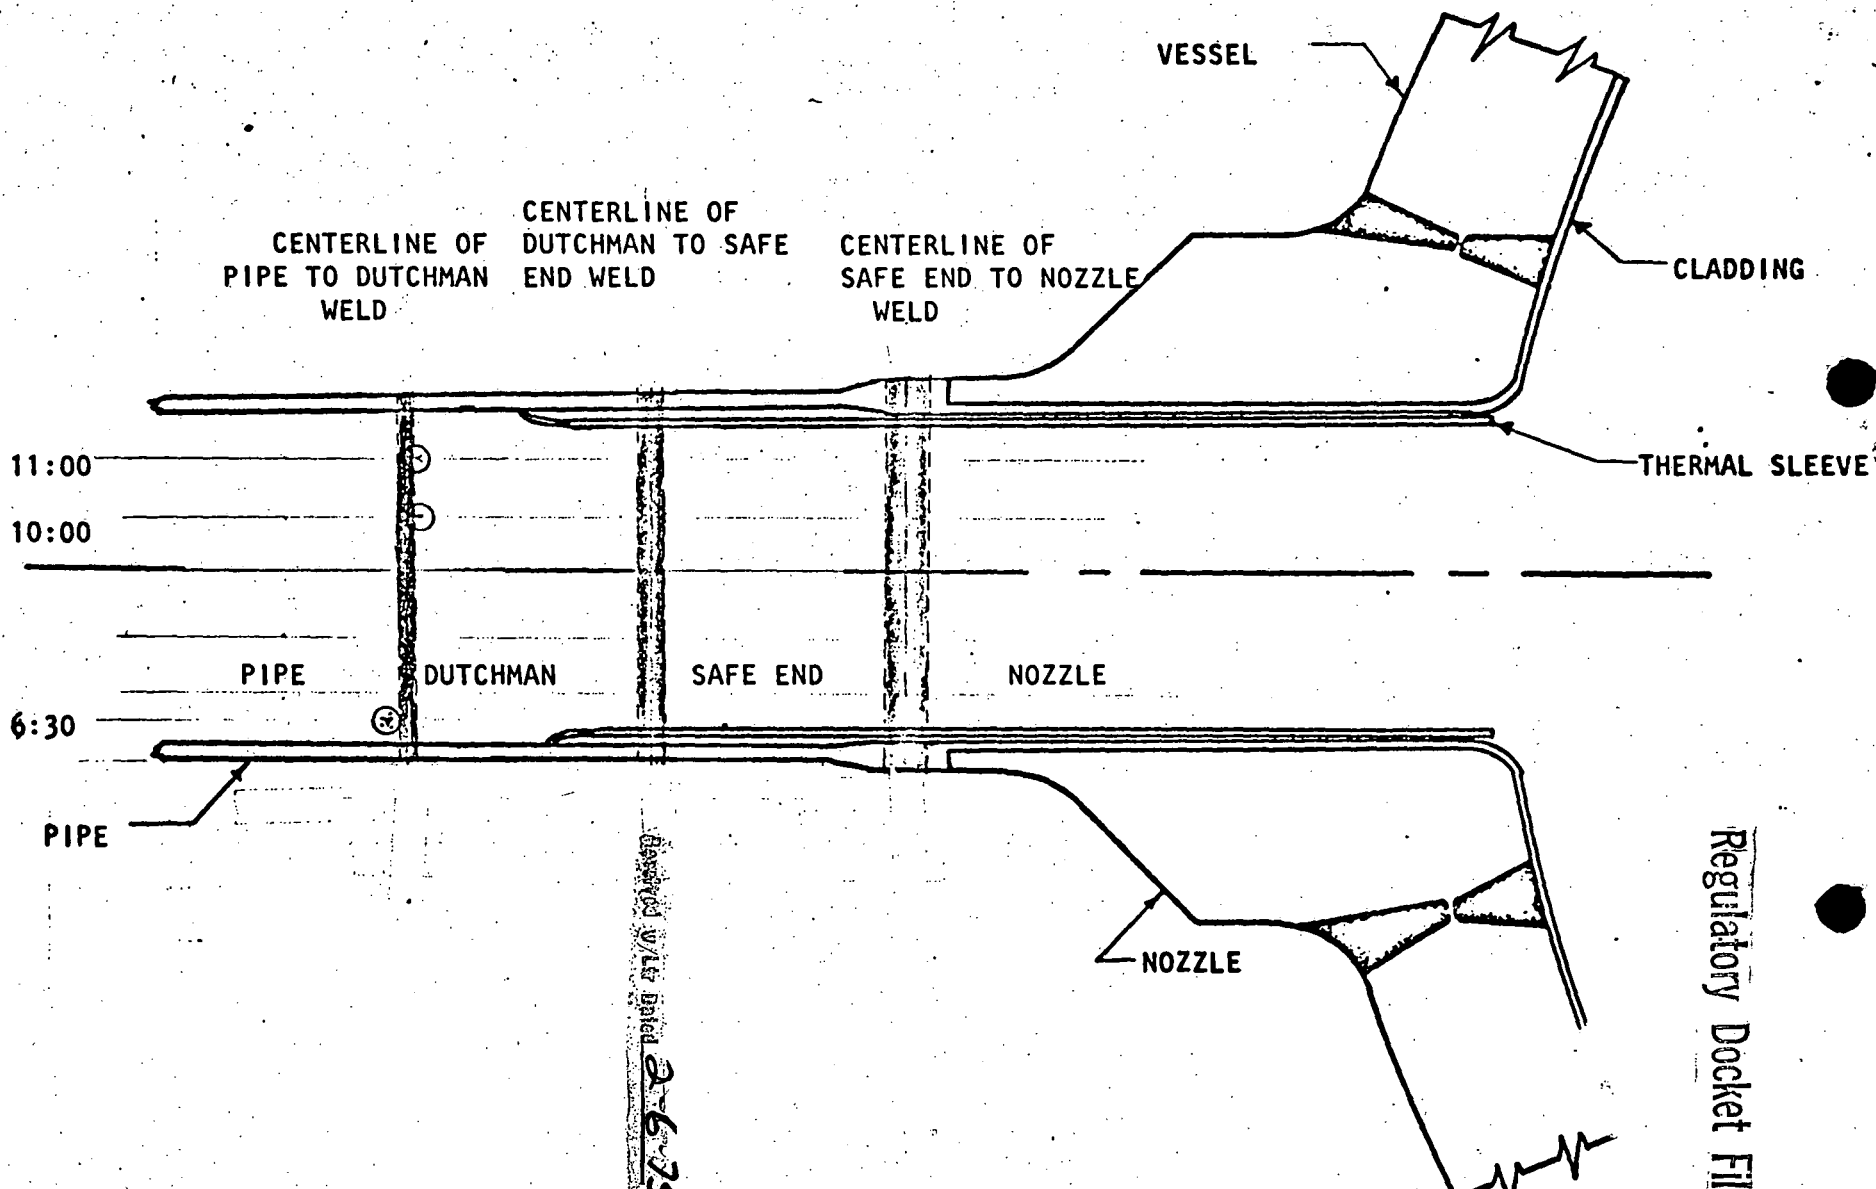
Attachment #2

⊖ Location of weeper indication approx. 5/16" from centerline of pipe to dutchman weld on Dutchman.

⊙ Location of PT Indications approx. 5/8" from centerline of weld on pipe side.
