SUBJECT: REPORT OF ABNORMAL OCCURRENCE PER SECTION 6.6.A OF THE TECHNICAL SPECIFICATIONS
CORE SPRAY INJECTION LINE THROUGH-WALL CRACKS

Report Number: 50-237/1975-11

Facility: Dresden Nuclear Power Station, Morris, Illinois

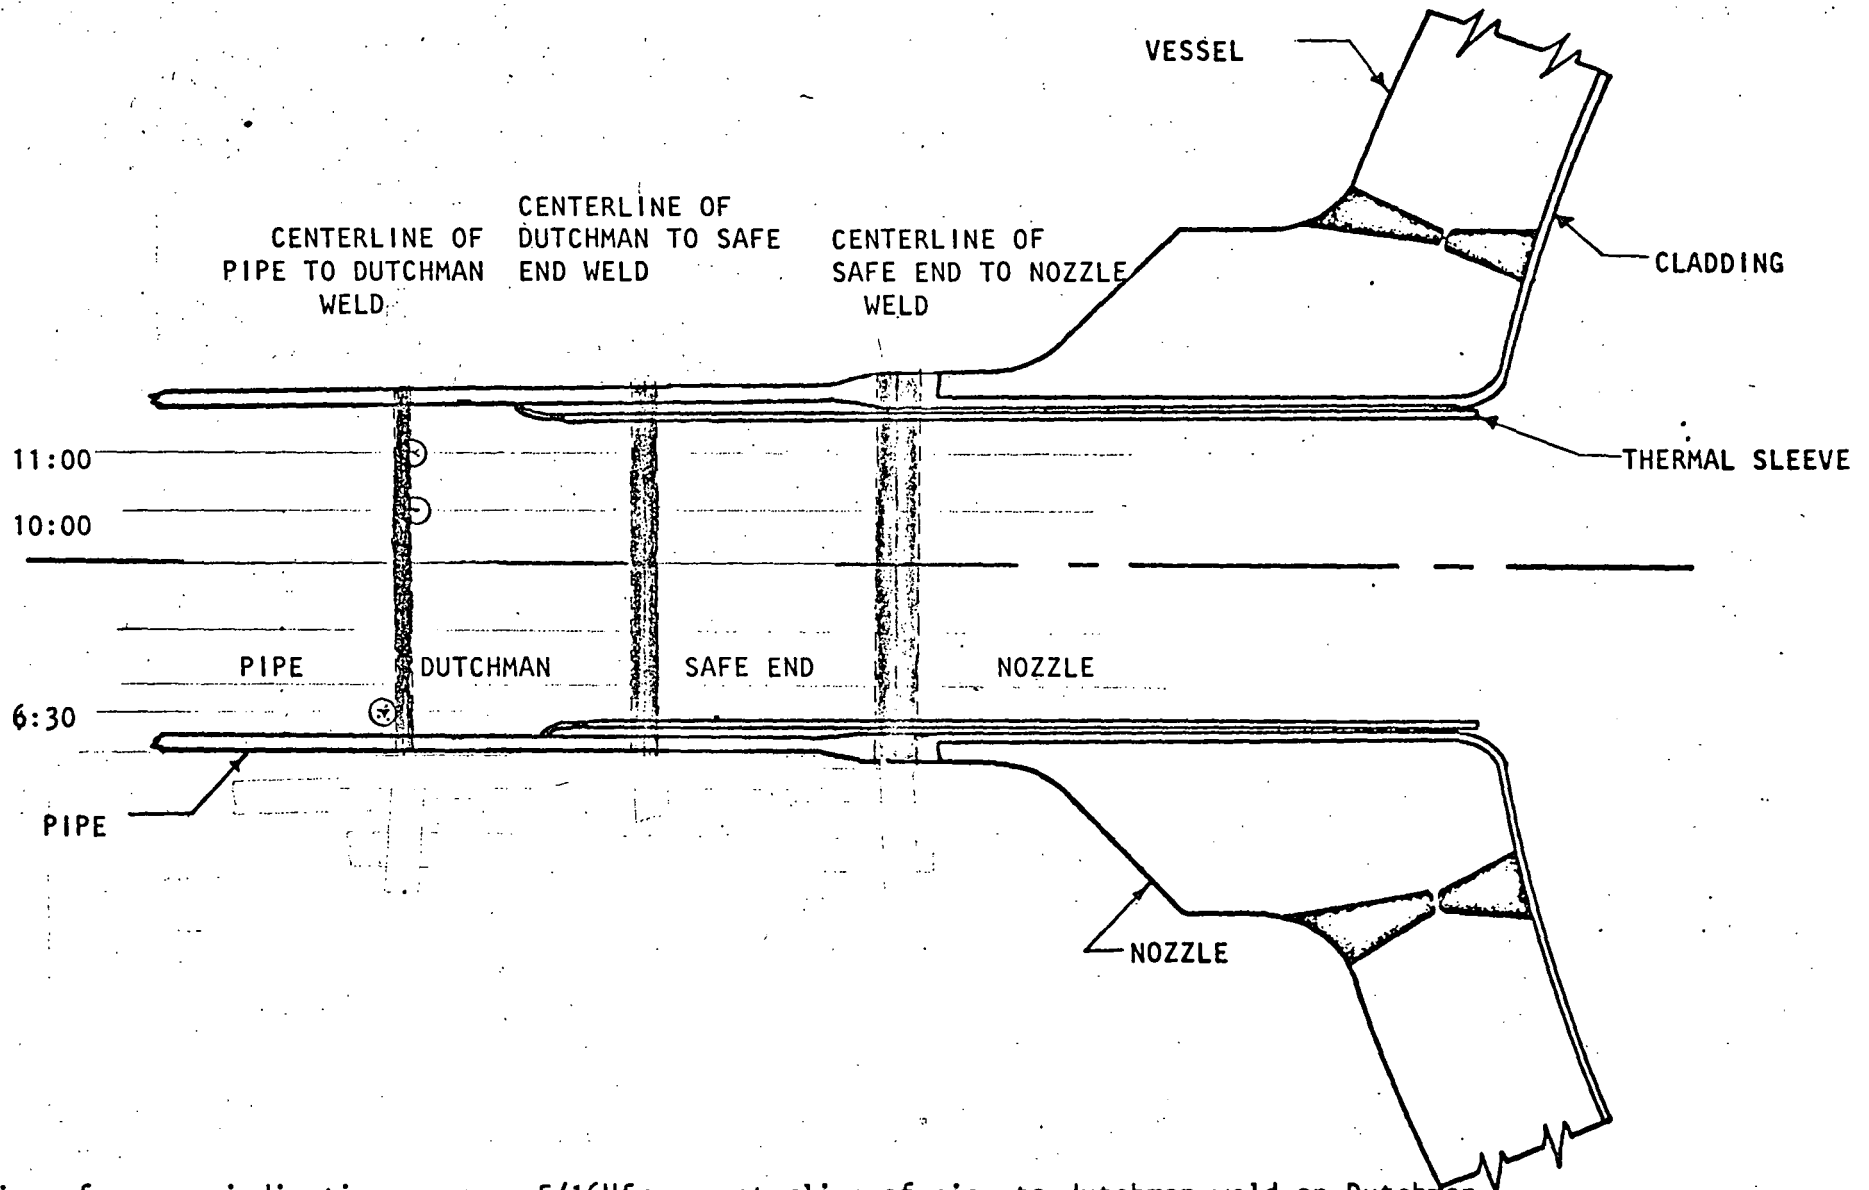
Attachment #2

⊗ Location of weeper indication approx. 5/16" from centerline of pipe to dutchman weld on Dutchman.

⊙ Location of PT indications approx. 5/8" from centerline of weld on pipe side.
