50 - 237

April 7, 1975

**SUBJECT: REVISION TO ABNORMAL OCCURRENCE REPORT ON DRESDEN UNIT 2 CORE SPRAY INJECTION LINE THROUGH-WALL CRACKS**

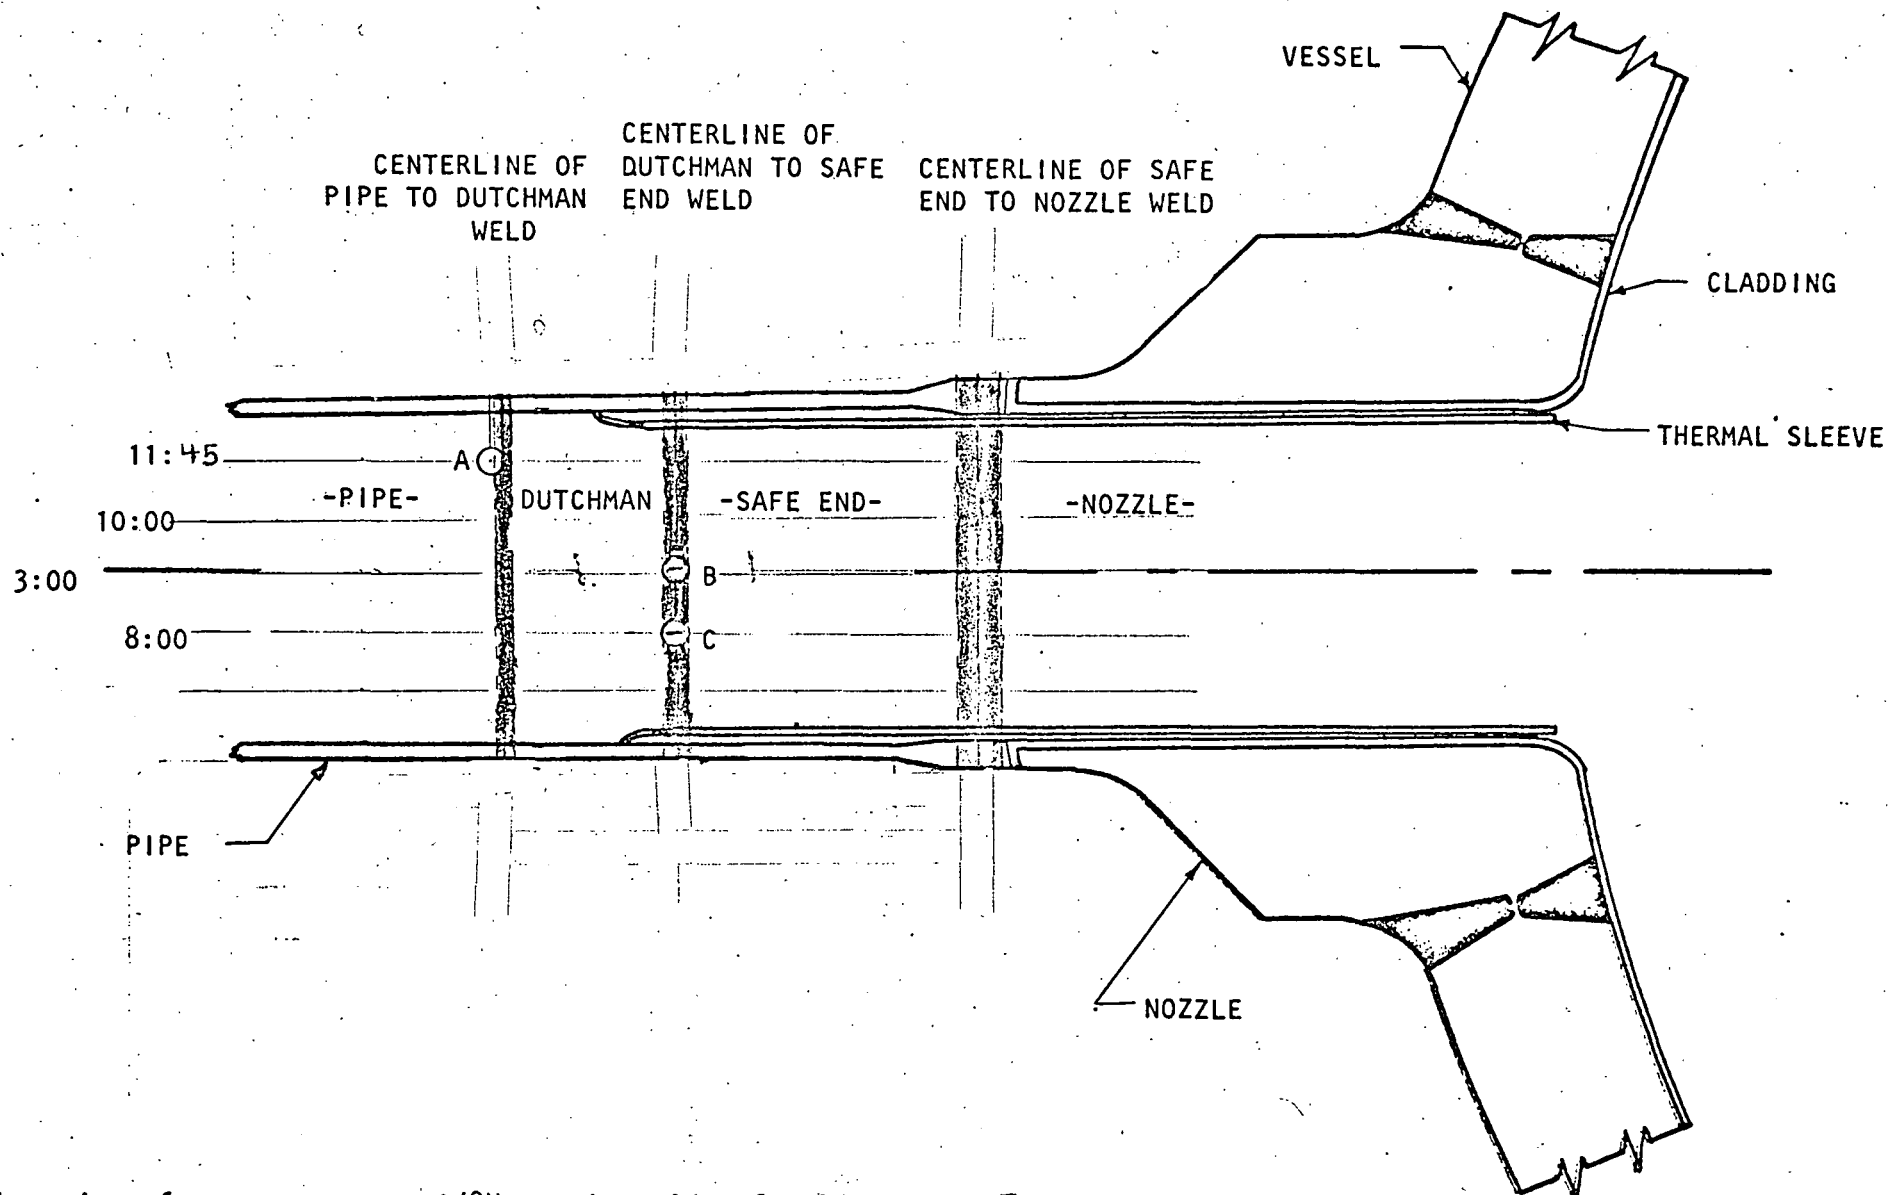
"A" LOOP

A⊕ - Location of weeper approx. 1/8" on pipe side of weld at 11:45

B⊖ - Location of crack approx. in centerline of Dutchman to Safe End weld at 3:00-9/16" in Length.

C⊖ - Location of crack approx. in centerline of Dutchman to Safe End weld at 8:00-5/8" in Length.

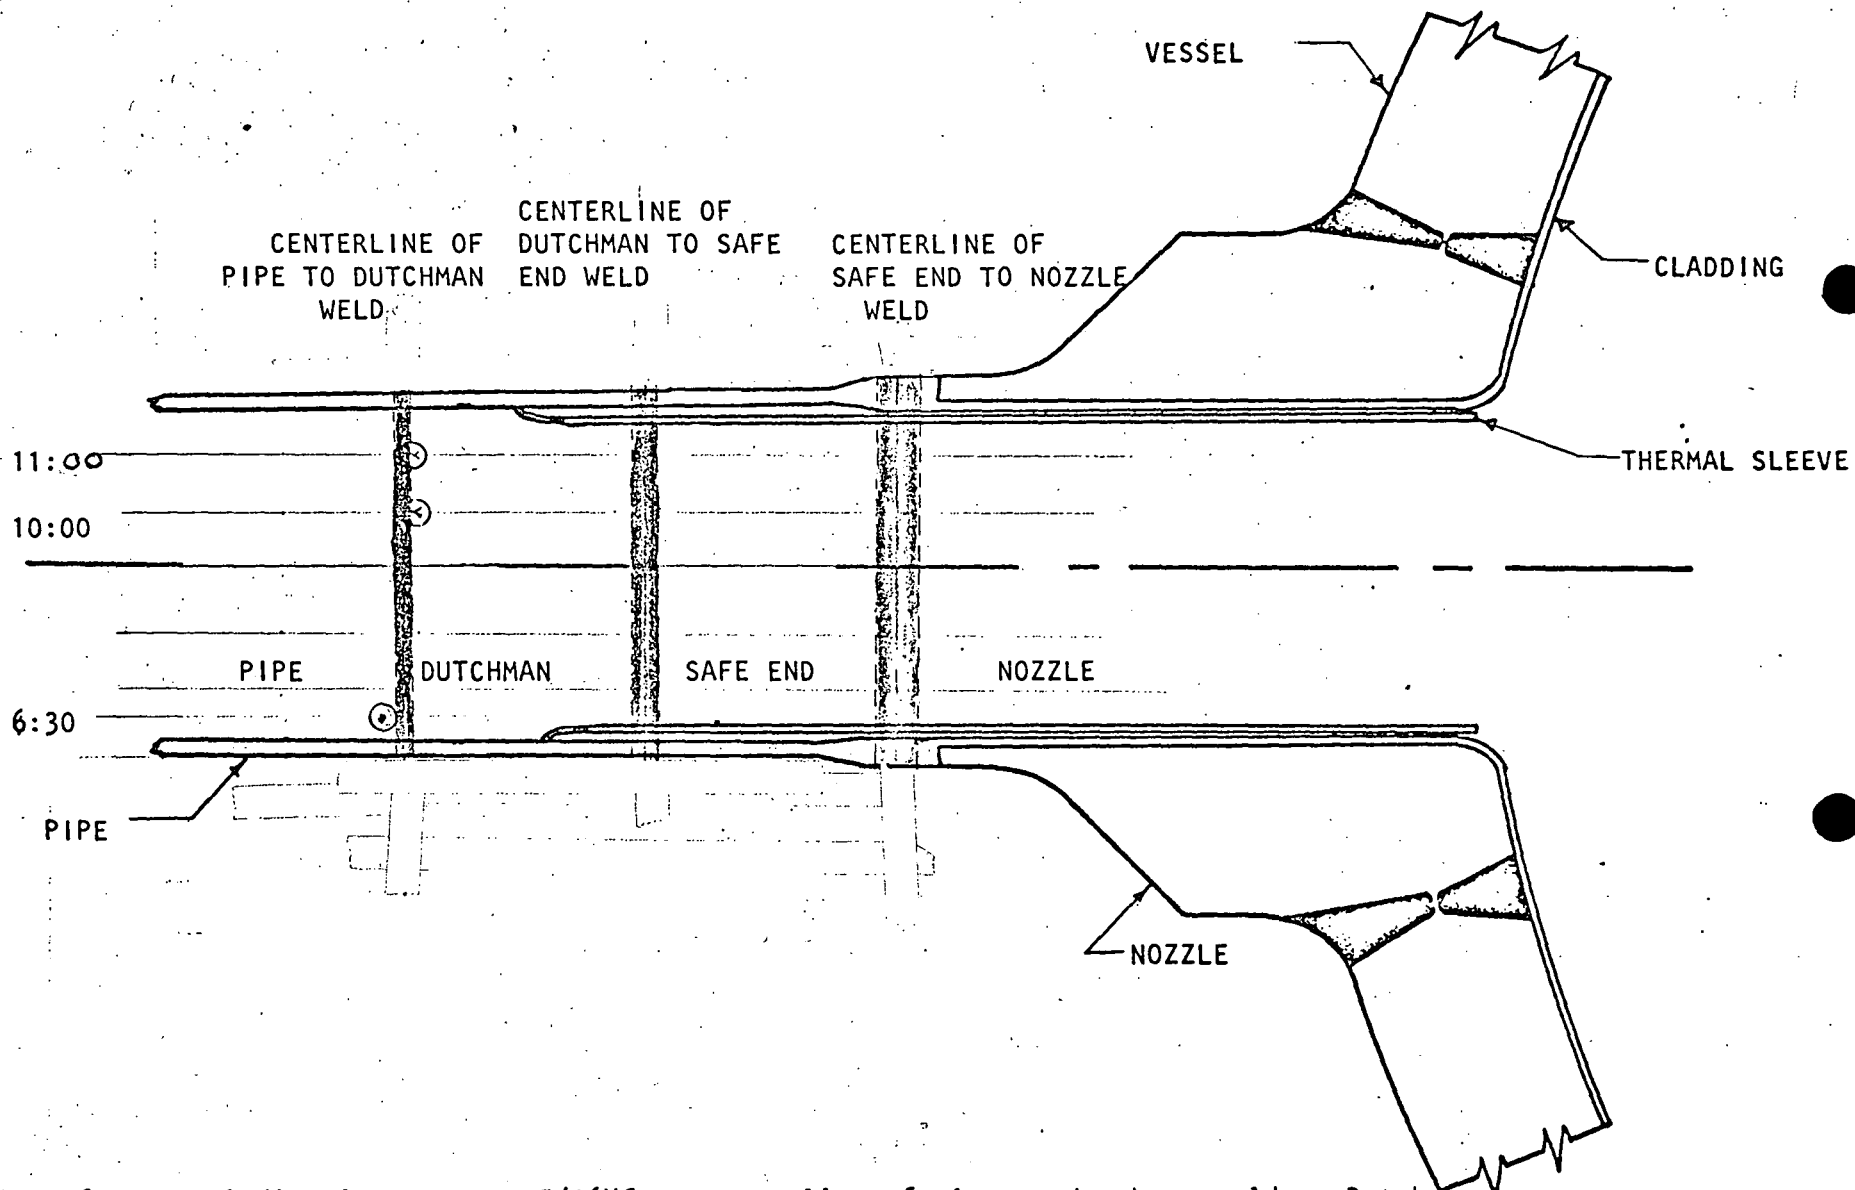
"B" LOOP

① - Location of weeper indication approx.  $5/16$ " from centerline of pipe to dutchman weld on Dutchman.

② - Location of PT indication, approx.  $5/8$ " from centerline of weld on pipe side.
