SUBJECT: REPORT OF ABNORMAL OCCURRENCE PER SECTION 6.6.A OF THE TECHNICAL SPECIFICATIONS
FAILURE OF 2-203-3C ELECTROMATIC RELIEF VALVE TO OPERATE

Report Number: 50-237/75-41

Facility: Dresden Nuclear Power Station, Morris, Illinois

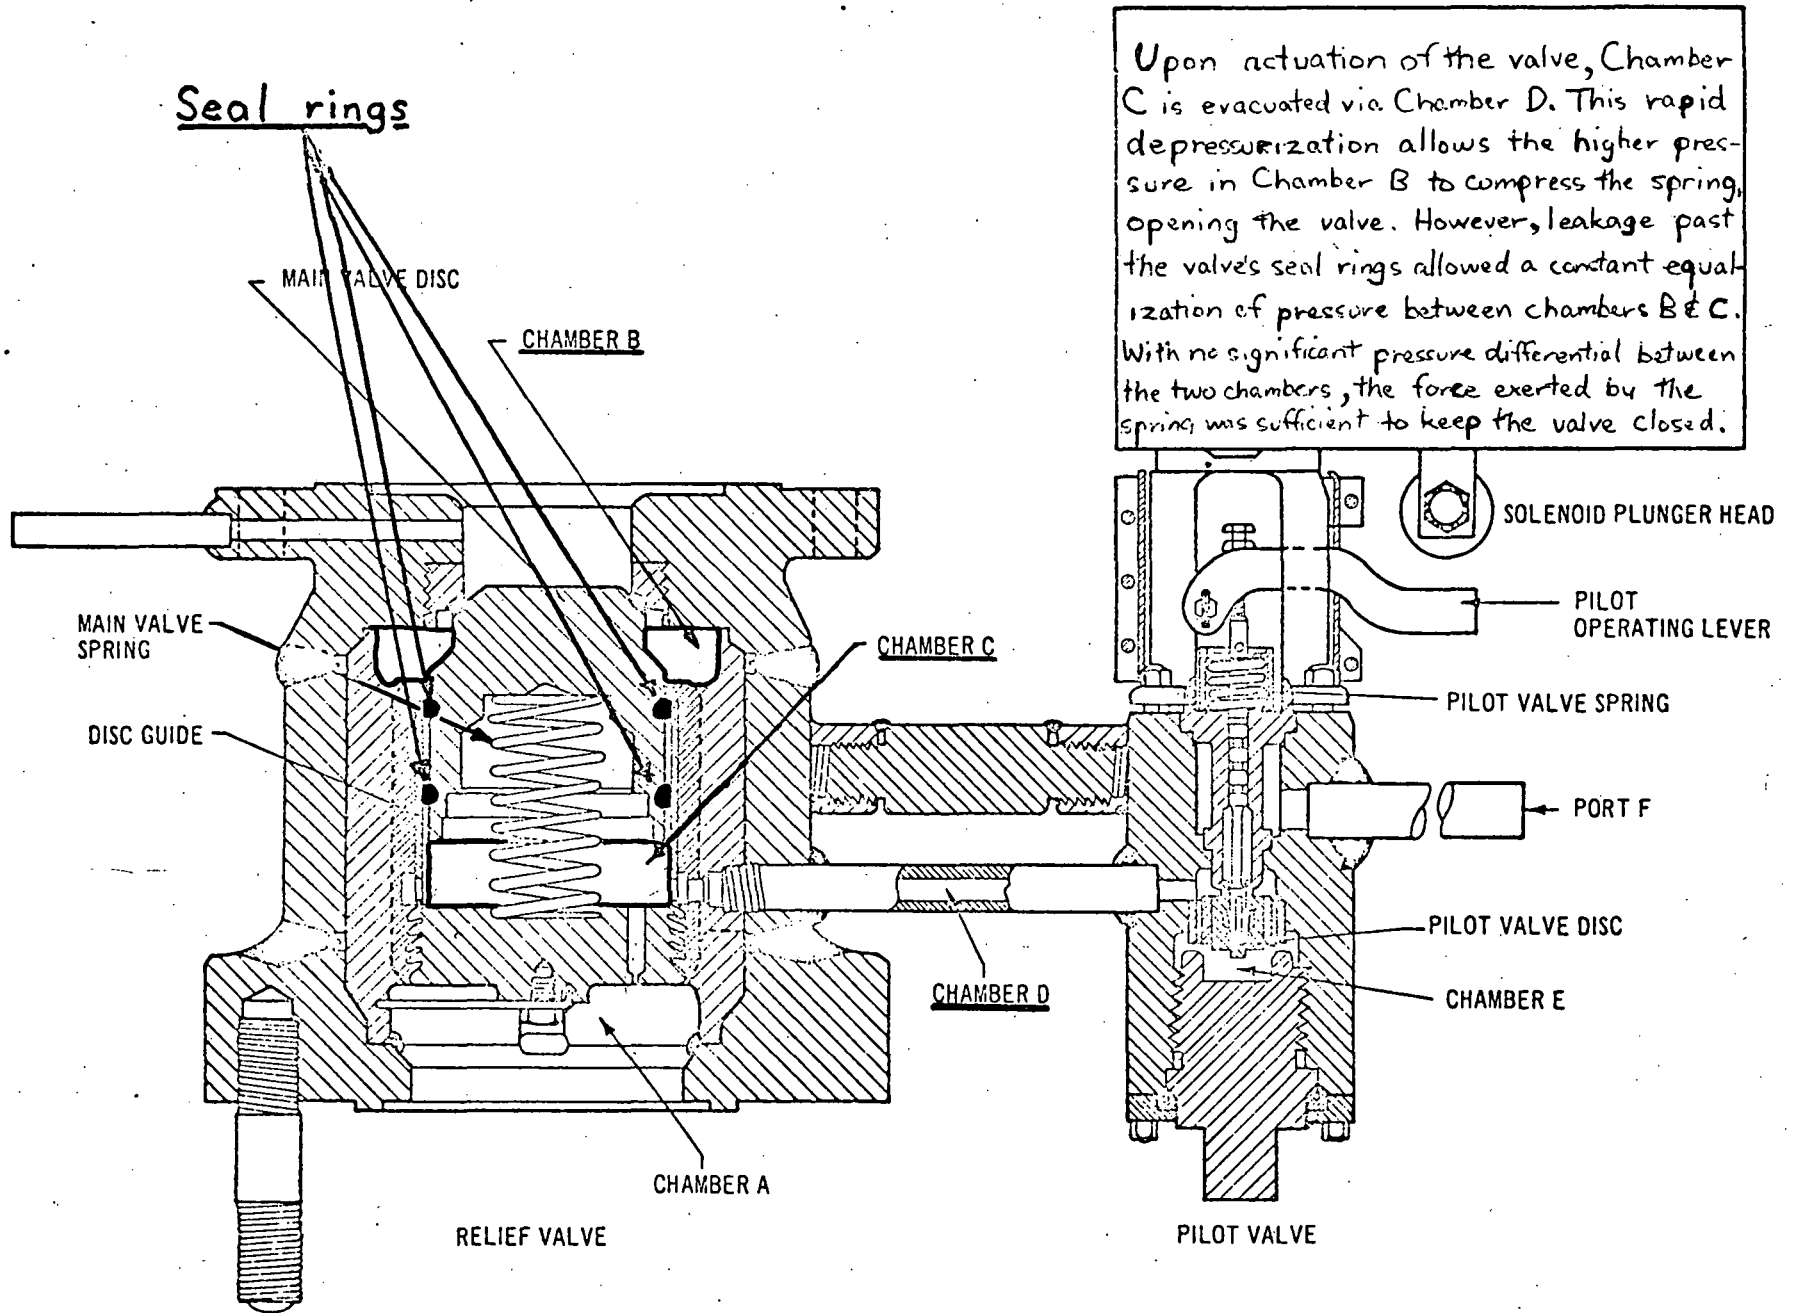
Figure 27-3. RELIEF VALVE (CROSS SECTION)

The failure of both electromatic valves 3C and 3B appeared to be due to leaking seal rings in the valve. This leakage caused a loss of pressure differential within the valves, eliminating the motive force necessary for valve operation (see enclosed diagram). A Dresser Valve representative was present during disassembly of the failed valves, and he concurred with the opinion that the worn seal rings were the probable cause of failure on both valves.

Both electromatics were replaced with rebuilt valves. Successful surveillances on these valves were performed at 150 psig and at rated reactor pressure as the unit was brought back up on June 16, 1975.

Dresser Valve is currently evaluating a new type of seal ring material to prevent recurrences of this nature. Since the cause of failure for valve 3B has now been identified and corrected, this letter will be submitted in lieu of the follow-up report referred to in report no. 75-32.
