Flow Control Division
Anchor/Darling Valves
BW/IP Valves
Edward Valves
Valtek Control Products
Worcester Valves

Subject: Stem-Wedge Separation of an Anchor/Darling Double Disc Gate Valve at Exelon, LaSalle County Station, Unit 2, February 2017.

Reference: Flowserve, Raleigh 10CFR Part 21 Notification Letter dated February 25, 2013, Wedge Pin Failure of Anchor/Darling DD Gate Valve.

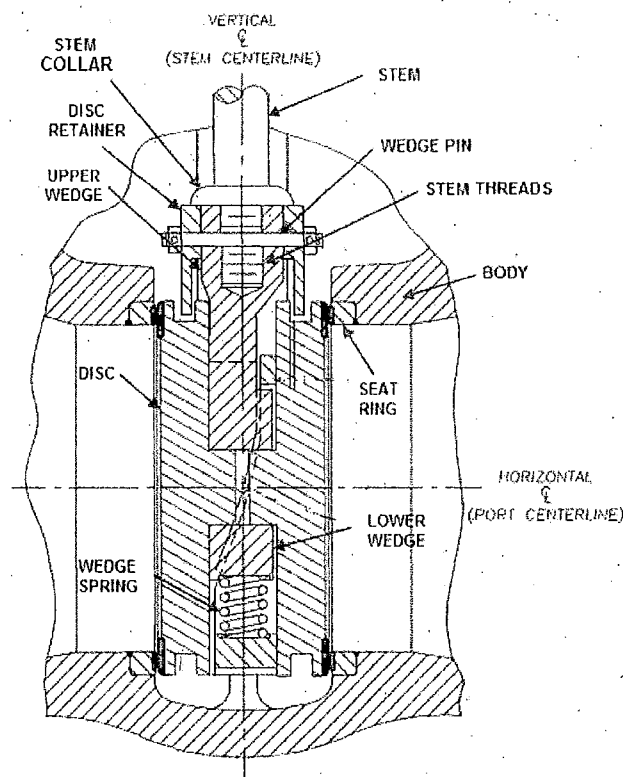
Figure 1
Typical Double-Disc Gate Valve Trim

Flowserve has been working with Exelon and nuclear industry groups to investigate and evaluate the stem-wedge separation in a size 12 class 900 Anchor/Darling motor-operated double disc (DD) gate valve. The valve stem was completely separated from the upper wedge, the wedge pin was sheared, the wedge threads stripped away and the pressed-on stem collar was pushed up leaving the valve inoperable. The valve operating thrust and torque is transmitted through the stem-wedge assembly, therefore separation of the stem and wedge will prevent the valve from opening and can adversely affect closing. See Figure 1 for a sketch of the stem-wedge joint.

Review of the LaSalle incident concluded repeated valve cycles at high actuator loads eventually wore the wedge threads to the point of failure in shear during a valve closing cycle and subsequent separation of the stem from the wedge. Before thread failure the wedge pin sheared which allowed stem to wedge movement with accompanying wedge thread wear and degradation. In addition the pressed-on collar was pushed up out of position, which would reduce or eliminate any existing preload in the joint. Wedge pin failure is attributed to both limited preload on the stem threaded section and exposure to actuator torques higher than the limit of the pin material. Since stem-wedge preload can be reduced or removed by a stem thrust which exceeds the stem-wedge joint capability, high thrust can be a precursor for wedge pin shear for applications with wedge pins that cannot independently withstand the actuator stem torque. The capability to maintain the preload is much less for stems with pressed-on collars than for stems with integral collars.

A loose connection is the result of inadequate stem thread preload whether not applied initially during assembly or not maintained during operation. The initial stem preload can be reduced if the stem closing thrust in service is high enough to cause local yielding of the joint. Stems with integral collars typically have allowable thrusts which do not govern the thrust limit of the valve however a stem with a pressed-on collar, supplied with many of the originally supplied valves, has a thrust limit which is less than the typical maximum allowed thrust values previously determined by weak-link or maximum thrust analyses.

- Torque the stem into the wedge to the maximum joint capacity.
- Replacement stems should have integral collars in lieu of press-on.
- Replacement wedge pins are manufactured from high strength material.
- Verify the actuator stem thrust is less than the maximum allowed to maintain the stem preload.
