SAFETY EVALUATION BY THE OFFICE OF NUCLEAR REACTOR REGULATION

SUPPORTING DRESDEN UNITS 2 AND 3 COMPLIANCE WITH GDC-17

DRESDEN NUCLEAR POWER STATION, UNIT NOS. 2 AND 3

DOCKET NOS. 50-237/249

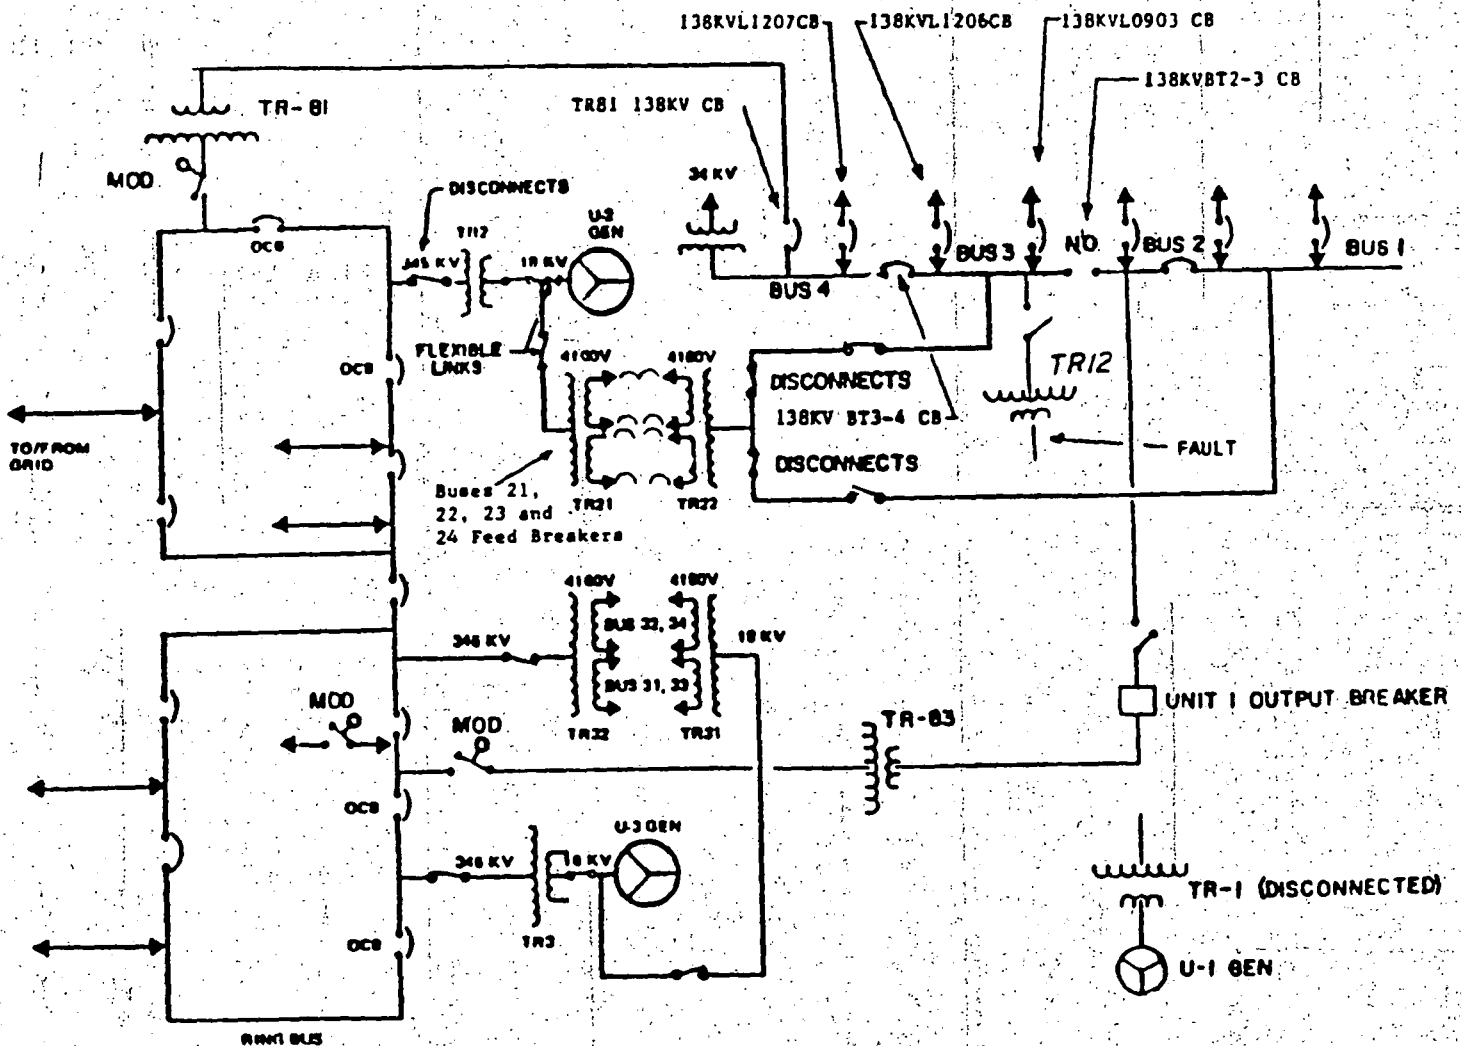
FIGURE 1. 345kV AND 138kV DISTRIBUTION

Figure 1 illustrates the configuration of offsite power at the switchyard. The electrical system for the Dresden station is shown in Figure 2. During normal power operation of each unit, one division of the safety-related electrical distribution system is energized from the plant's main generator via the unit auxiliary transformer (e.g., TR-22, for Unit 2). The design includes a feature to fast transfer the loads on the reserve auxiliary transformer to the unit auxiliary transformer in the event of a power loss.

The event caused the staff to question the acceptability of plant operations with Unit 2 reserve auxiliary transformer TR-22 aligned to 138KV bus section 3 in addition to Unit 1 transformer TR-12 aligned to the same bus section. At issue is the increased vulnerability to loss of the GDC-17 immediate-access offsite power circuit for Unit 2 (TR-22) caused by electrical faults on Unit 1 equipment (TR-12) due to not feeding these transformers from separate bus sections of the 138 KV switchyard. The plant licensing basis (i.e., Final Safety Analysis Report (FSAR)) shows the Unit 1 transformer TR-12 powered from bus section 3 and the Unit 2 transformer TR-22 powered from either bus section 1 or 3, with the connection to section 1 being "normally closed". The staff's review of the August 1985 event revealed that the plant is operated with TR-22 energized preferentially from bus section 3, which is the same source used for TR-12. The licensee responded to staff concerns by letters dated August 22, December 13, and December 31, 1985. The licensee has described its basis for concluding that the offsite power alignment that was and is currently in use provides the best reliability and flexibility.

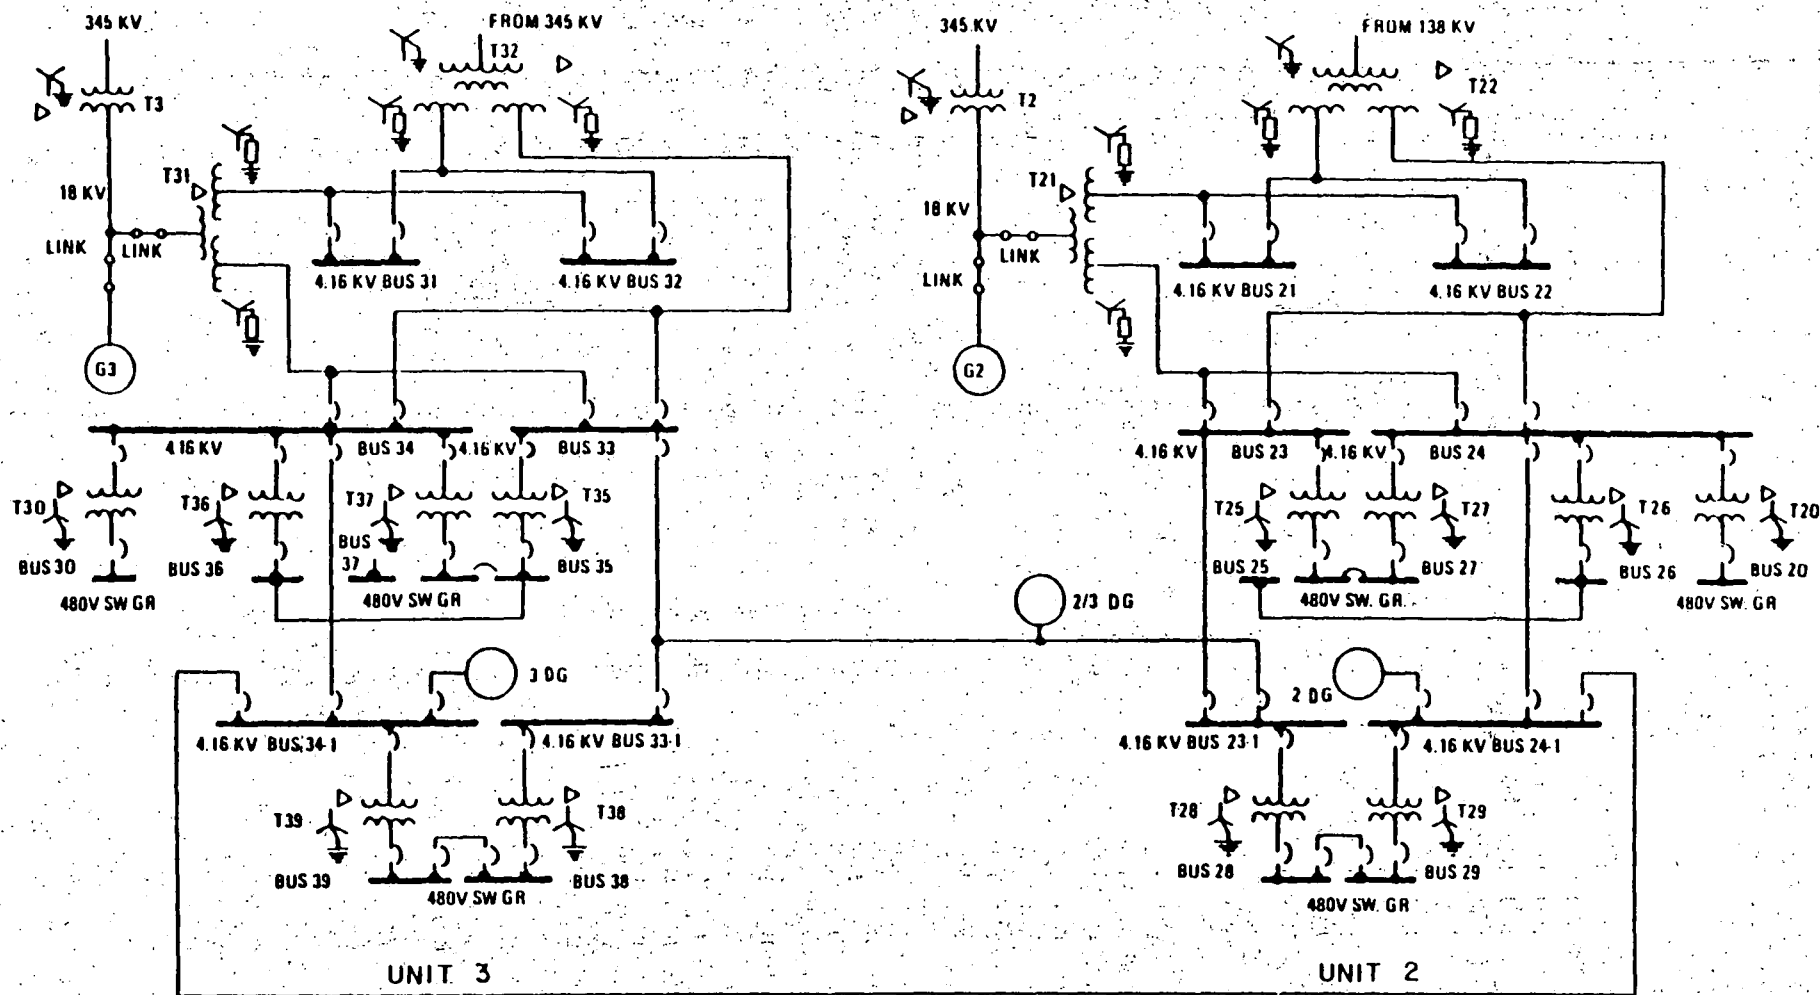
FIGURE ..2 AUXILIARY ELECTRICAL SYSTEM - 4160 VOLT AND 480 VOLT

Licensee investigation of the 4KV breaker control circuitry determined that the feeder breakers for 4KV buses 22 and 24 were not designed, as believed, to automatically transfer power feed from the normal supply, reserve auxiliary transformer TR-21. Licensee review identified a design error in the closing control circuits of certain bus 22 and 24 feed breakers which prevented the automatic power transfer from TR-22 to TR-21. The design error resulted from a previous modification. Specifically, the modification was intended to cause a fast transfer of certain buses from the TR-22 as the source of power to TR-21; however, the design of the transfer logic assumed (and required) that any loss of TR-22 would involve a fault which would lead to the electrical lockout of the transformer. During the August 1985 event the transformer output ceased simply because of loss of incoming power, without an actuation of the lockout relay for the transformer. Therefore, the transfer did not function. This transfer feature is necessary to satisfy the portion of GDC-17 which requires that the loss of an offsite circuit not cause the loss of the plant main generator, which could happen if power is lost to certain equipment such as feedwater pumps which in turn cause a plant trip.

The licensee's GDC-17 analysis states that the Unit 2 second access source of offsite power required by GDC-17 consists of a 4KV cross-tie between Unit 2 and Unit 3 via bus-tie 24-1/34-1. The second source of power is normally supplied from the Unit 3 345KV switchyard. The second source of offsite power can be activated from the main control room via two breaker control switches and was available during the August 16, 1985 event. The analysis states that the load carrying capability of the bus-tie has been evaluated and determined to be adequate to support the necessary emergency loads. The licensee load analysis includes only one division of emergency loads. This design satisfies the interpretation of GDC-17 that was used when Dresden 2 and 3 were licensed.

The design error has been corrected and the transfer scheme has been tested satisfactorily. NRC Region III has reviewed the modification and observed post-modification testing of the automatic transfer function from TR-22 to TR-21. The results of the Region III review were published in a letter to the licensee dated September 27, 1985.
