FACILITY NAME (1) Dresden Nuclear Power Station, Unit 3		DOCKET NUMBER (2) 0 5 0 0 0 2 4 9	PAGE (3) 1 OF 06
------------------------------------------------------------	--	--------------------------------------	---------------------

TITLE (4)
Primary Containment Structural Steel Connections Outside Final Safety Analysis Report Design Criteria Due to Apparent Original Construction Oversight

87-005-00

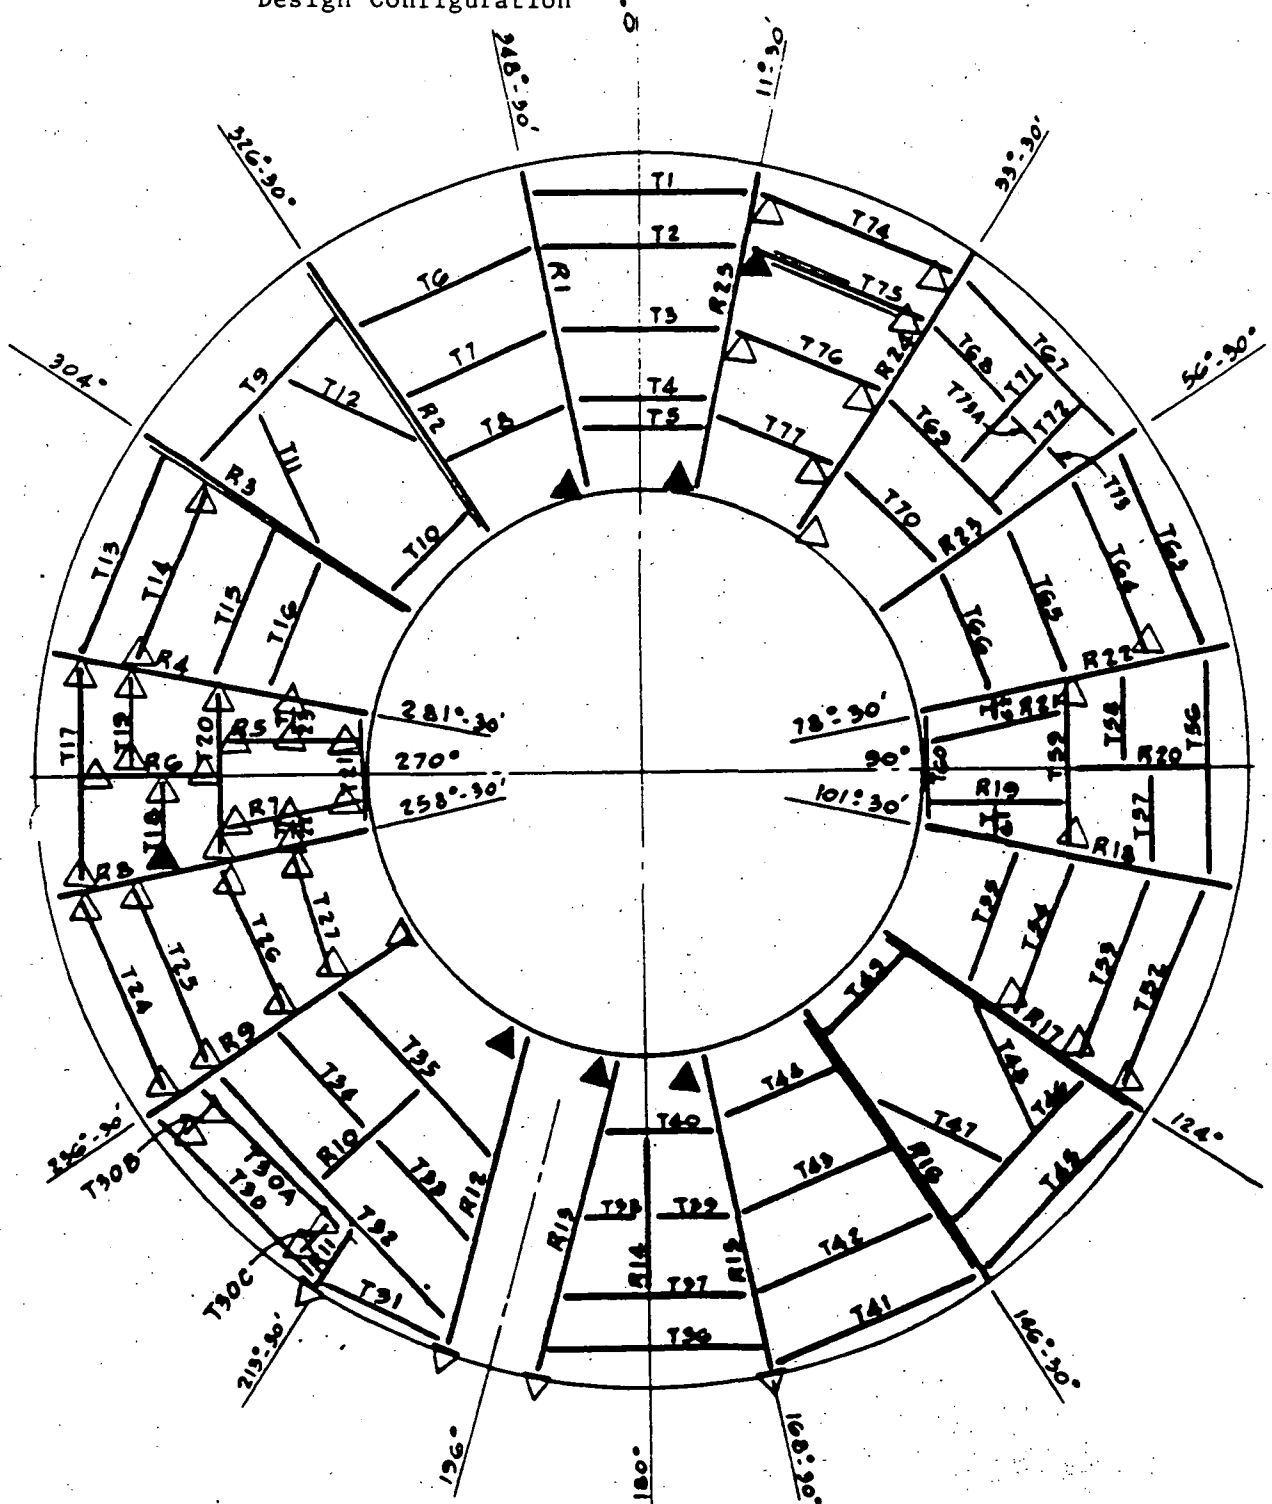
FIGURE 1

▲ = Connection Differs From Design Configuration △ = No Deficiencies

FRAMING PLAN AT EL 915'-4 1/2"
DRESDEN UNIT 3

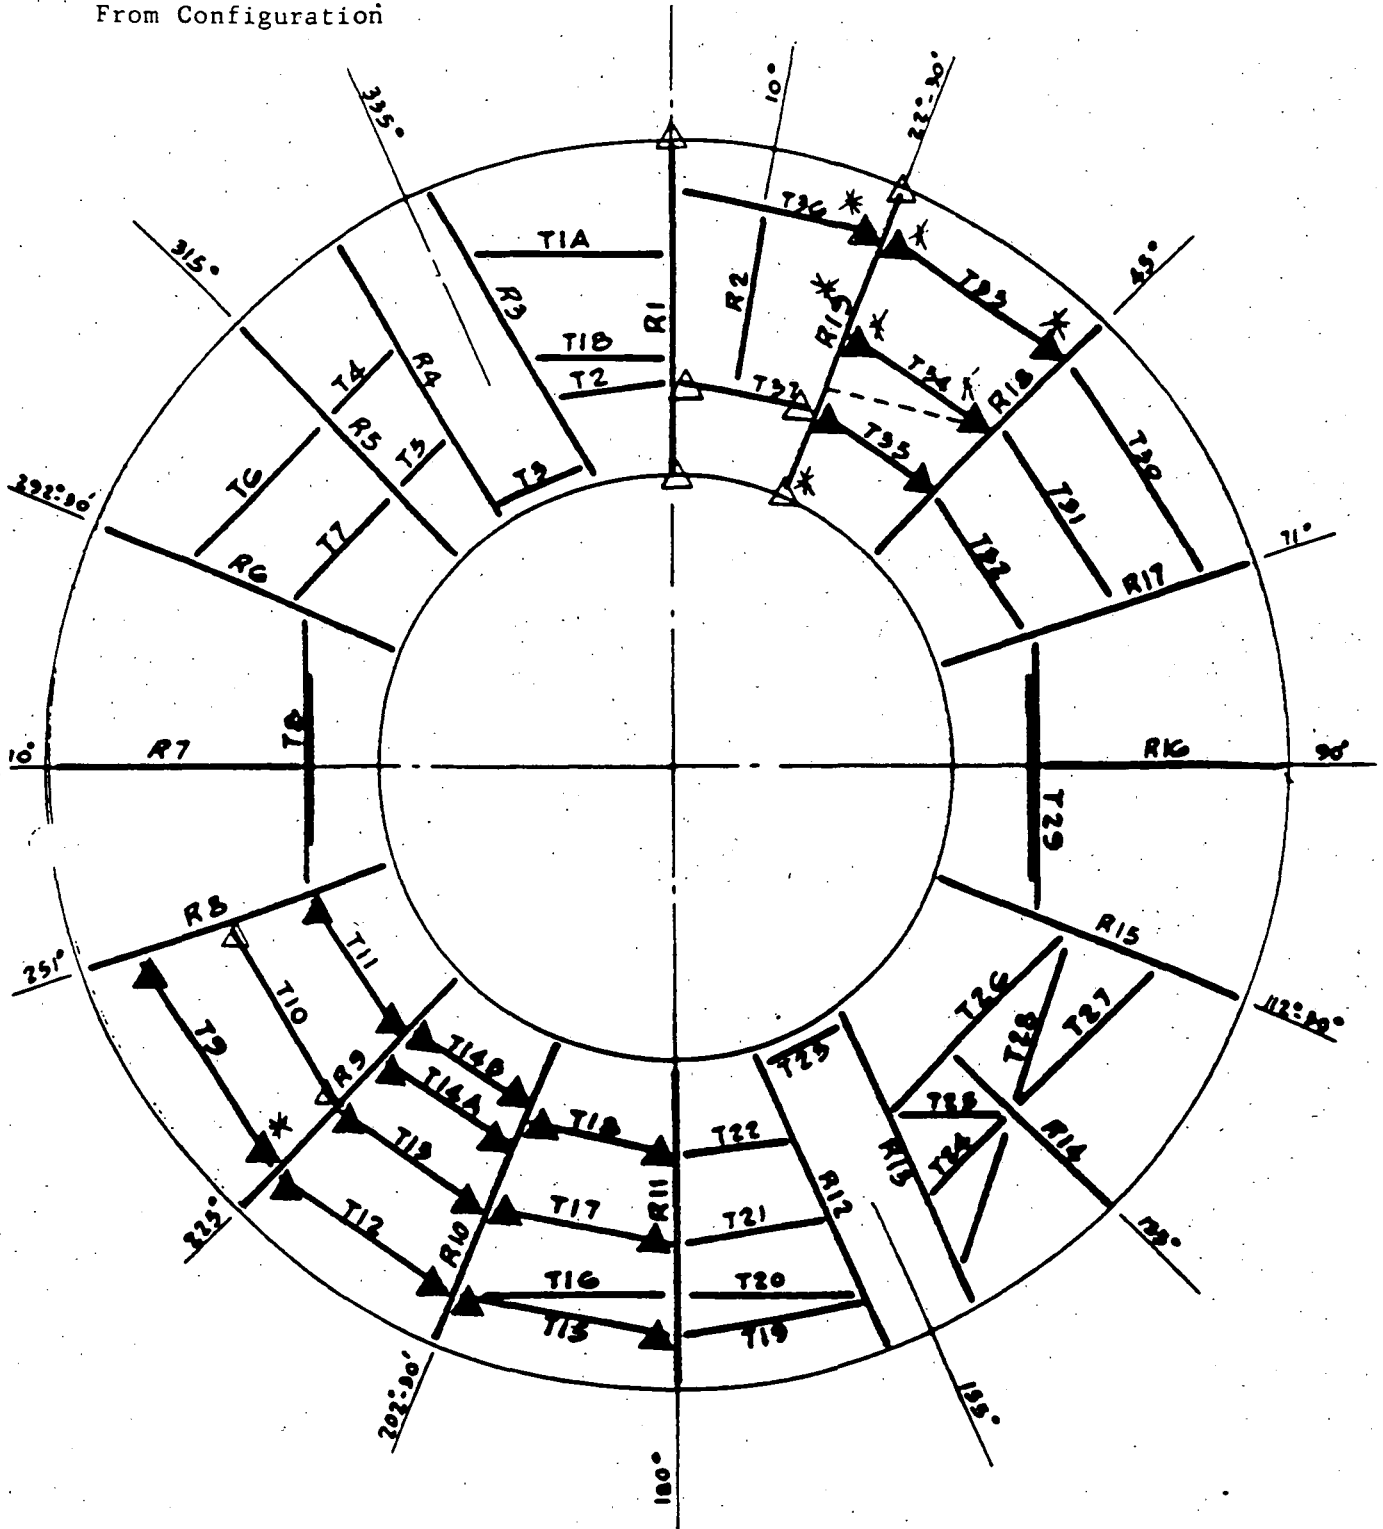
FIGURE 2

A data assessment of the Unit 3 sample inspection completed on March 16, 1987 indicated that the connections for tangential beams T9 (left side only), T33, T34 and T36 (right side only) were in excess of FSAR criteria. Because of the deficiencies in these connections, radial beam R19 at azimuth 22° - 30' and the connection at the biological shield also do not meet the highly conservative FSAR design criteria. However, analysis performed indicates that all these connections meet operability limits for all design basis events. A safety evaluation performed by the Station Nuclear Engineering Department (SNED) in accordance with 10 CFR 50.59 determined that sufficient data had been collected at this time and Unit 3 could return to service to complete its operating cycle. At the next refueling outage, a comprehensive examination of the Unit 3 Drywell Structural Steel [NH] will be performed and a repair program implemented to ensure FSAR compliance. For these reasons, the safety significance of this event is minimal.

FRAMING PLAN AT EL. 597.0'

A repair program has been developed to assure the drywell Structural Steel [NH] will meet the FSAR design requirements. These repairs will be completed during the next Unit 3 refueling outage. A comprehensive inspection will also be performed at this time.
