LICENSEE EVENT REPORT (LER)

FACILITY NAME (1) Dresden Nuclear Power Station, Unit 2	DOCKET NUMBER (2) 0 5 0 0 0 2 3 7	PAGE (3) 1 OF 0 5
--	--------------------------------------	----------------------

TITLE (4) Failure of the Unit 2 Diesel Generator Output Breaker to Close During Surveillance Due to a Failed Auxiliary Contact Switch

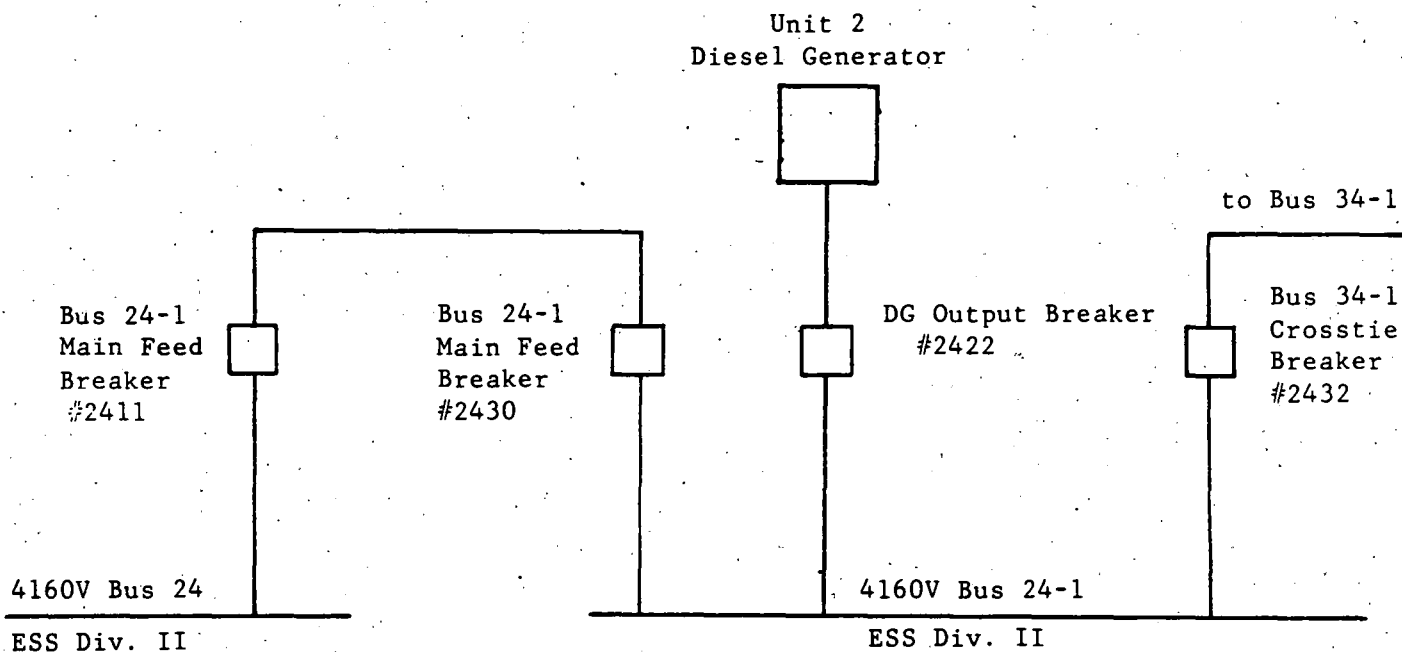
Dresden Station Unit 2
4160V Busses 24 and 24-1

partial one line diagram
