LICENSEE EVENT REPORT (LER)

FACILITY NAME (1) Dresden Nuclear Power Station, Unit 2 DOCKET NUMBER (2) 0 5 0 0 0 2 1 3 7 1 OF 0 1 7

TITLE (4) Reactor Scram During Refueling Due to Motor Control Center (MCC) 28-2 Main Feed Breaker Trip From an Unknown Cause

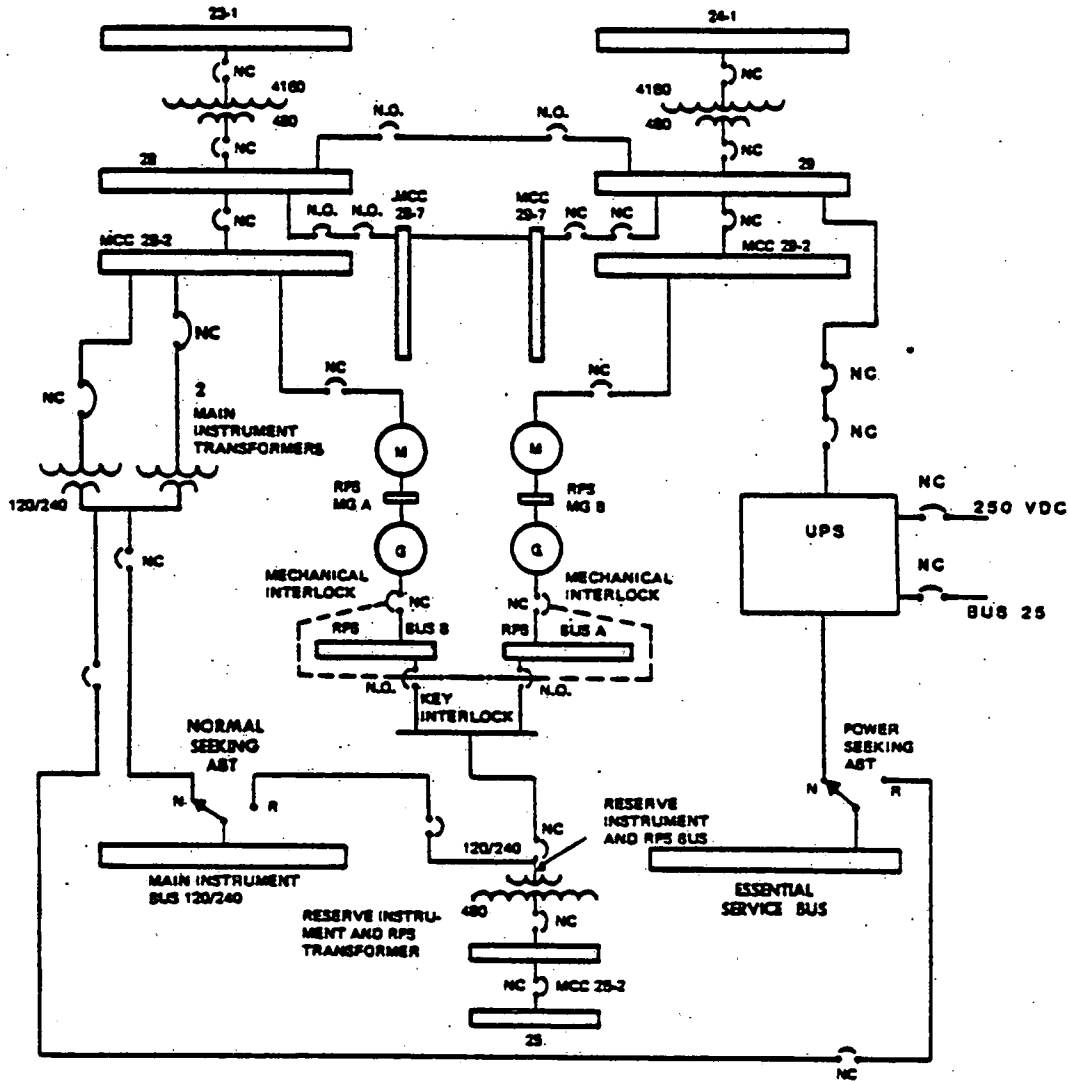
FIGURE 1. REACTOR PROTECTIVE SYSTEM, INSTRUMENT AND ESSENTIAL SERVICE SYSTEM DISTRIBUTION

Investigation found that the trip of the main feed breaker for MCC 28-2 [ED] from Bus 28 [ED] was the earliest intermediate cause of this event. The trip of this breaker was found to have caused the trip of the 2A RPS MG Set [JC], the subsequent reactor scram, the Group II Primary Containment isolation [JM], and the other Control Room indications. The immediate cause of the reactor scram was the loss of the 2B RPS Bus [JC], which is powered by the 2A RPS MG Set [JC]. Loss of power to the B Reactor Vessel Pressure 600 psig interlock Auxiliary Relay resulted in de-energization of the bypass relays associated with the Condenser Low Vacuum [SH] and Main Steam Isolation Valve (MSIV) [SB] scrams for RPS [JC] Channel A, as well as B. Because the unit was shut down for refueling, a Condenser Low Vacuum [SH] condition existed giving a trip of RPS [JC] Channel A. This trip of RPS [JC] Channel, coincident with the loss of the 2B RPS [JC] Bus, initiated the reactor scram. Investigation found that the RPS [JC] system functioned during this event in accordance with the RPS [JC] relay logic design. The loss of MCC 28-2 [ED] was not the result of refueling activities nor the result of the Feedwater Control surveillance being performed at the time of the scram.
