LICENSEE EVENT REPORT (LER)

FACILITY NAME (1) Dresden Nuclear Power Station, Unit 3 DOCKET NUMBER (2) 0 5 0 0 0 2 4 9 1 OF 0 6 PAGE (3)

TITLE (4) Primary Containment Structural Steel Connections Outside Final Safety Analysis Report Design Criteria Due to Apparent Original Construction Oversight

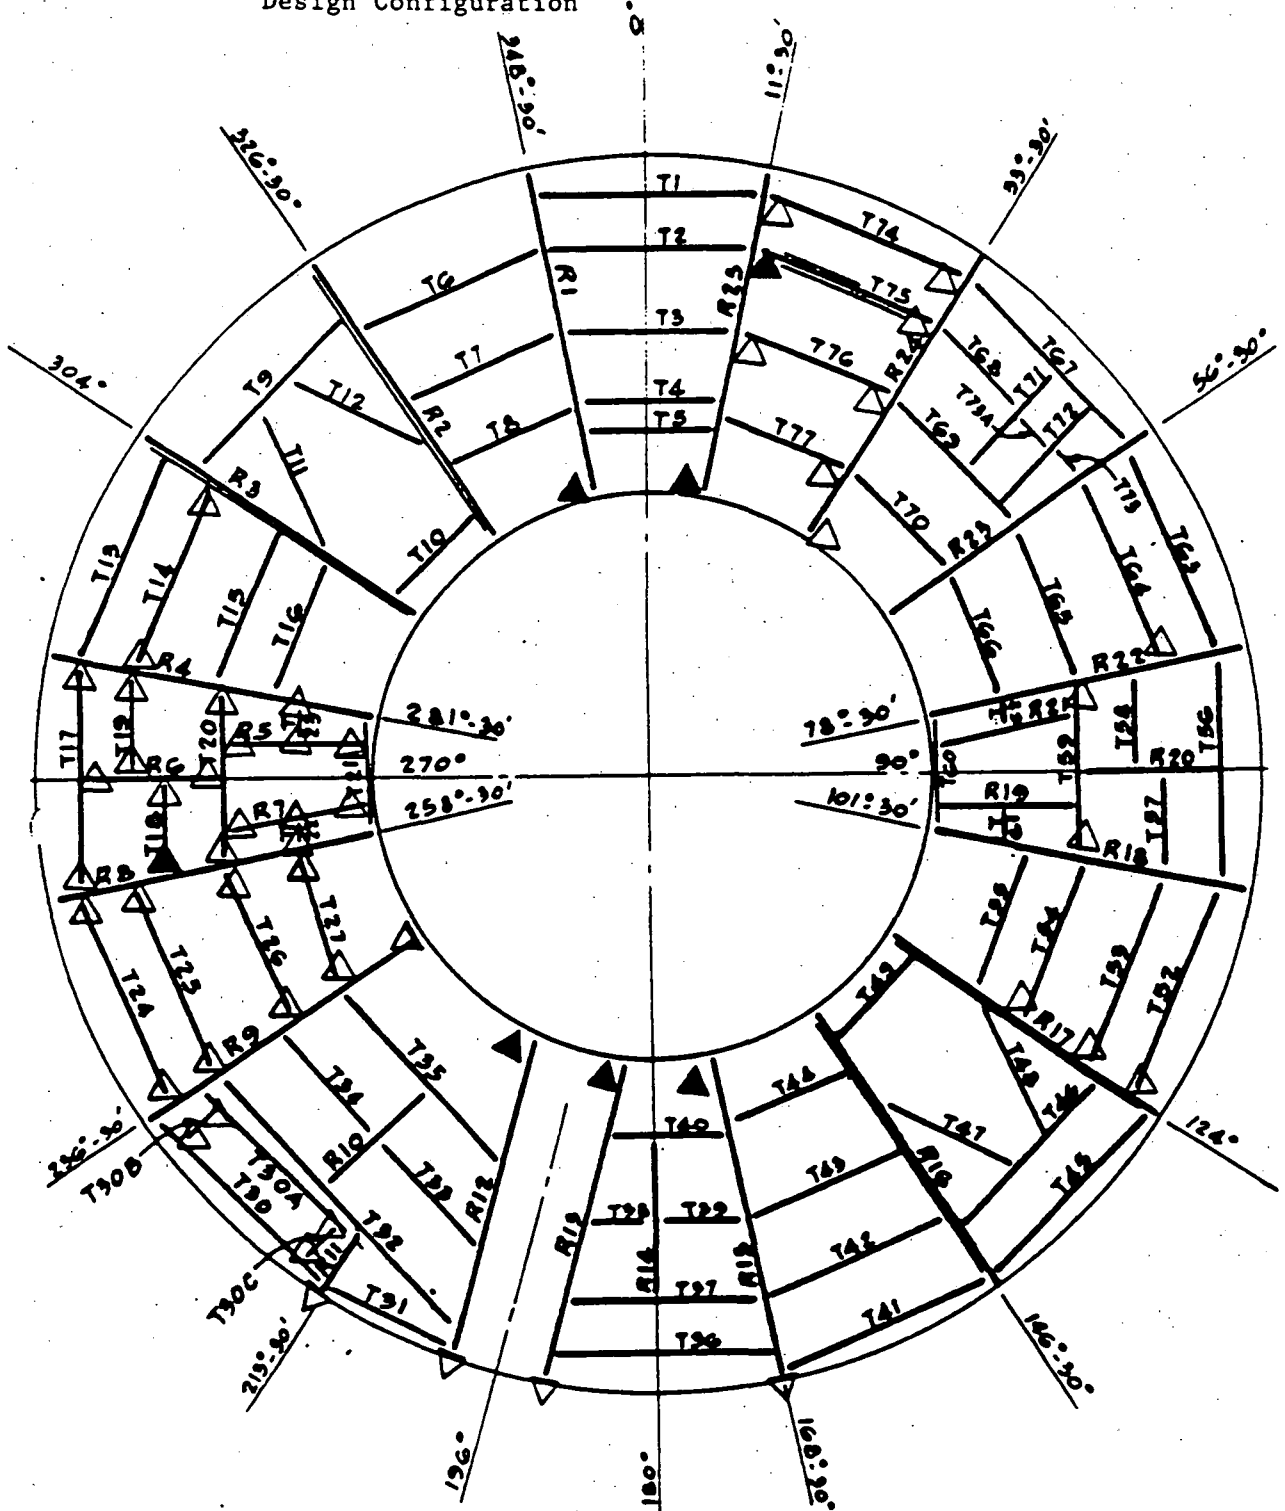
FIGURE 1

A data assessment of the Unit 3 sample inspection completed on March 16, 1987 indicated that the connections for tangential beams T9 (left side only); T33, T34 and T36 (right side only) were in excess of FSAR criteria. Because of the deficiencies in these connections, radial beam R19 at azimuth 22° - 30' and the connection at the biological shield also do not meet the highly conservative FSAR design criteria. However, analysis performed indicates that all these connections meet operability limits for all design basis events. A safety evaluation performed by the Station Nuclear Engineering Department (SNED) in accordance with 10 CFR 50.59 determined that sufficient data had been collected at this time and Unit 3 could return to service to complete its operating cycle. At the next refueling outage, a comprehensive examination of the Unit 3 Drywell Structural Steel [NH] will be performed and a repair program implemented to ensure FSAR compliance. For these reasons, the safety significance of this event is minimal.

▲ = Connection Differs From Design Configuration △ = No Deficiencies

FRAMING PLAN AT EL 515'-4 1/2"
 DRESDEN UNIT 3

A repair program has been developed to assure the drywell Structural Steel [NH] will meet the FSAR design requirements. These repairs will be completed during the next Unit 3 refueling outage. A comprehensive inspection will also be performed at this time.

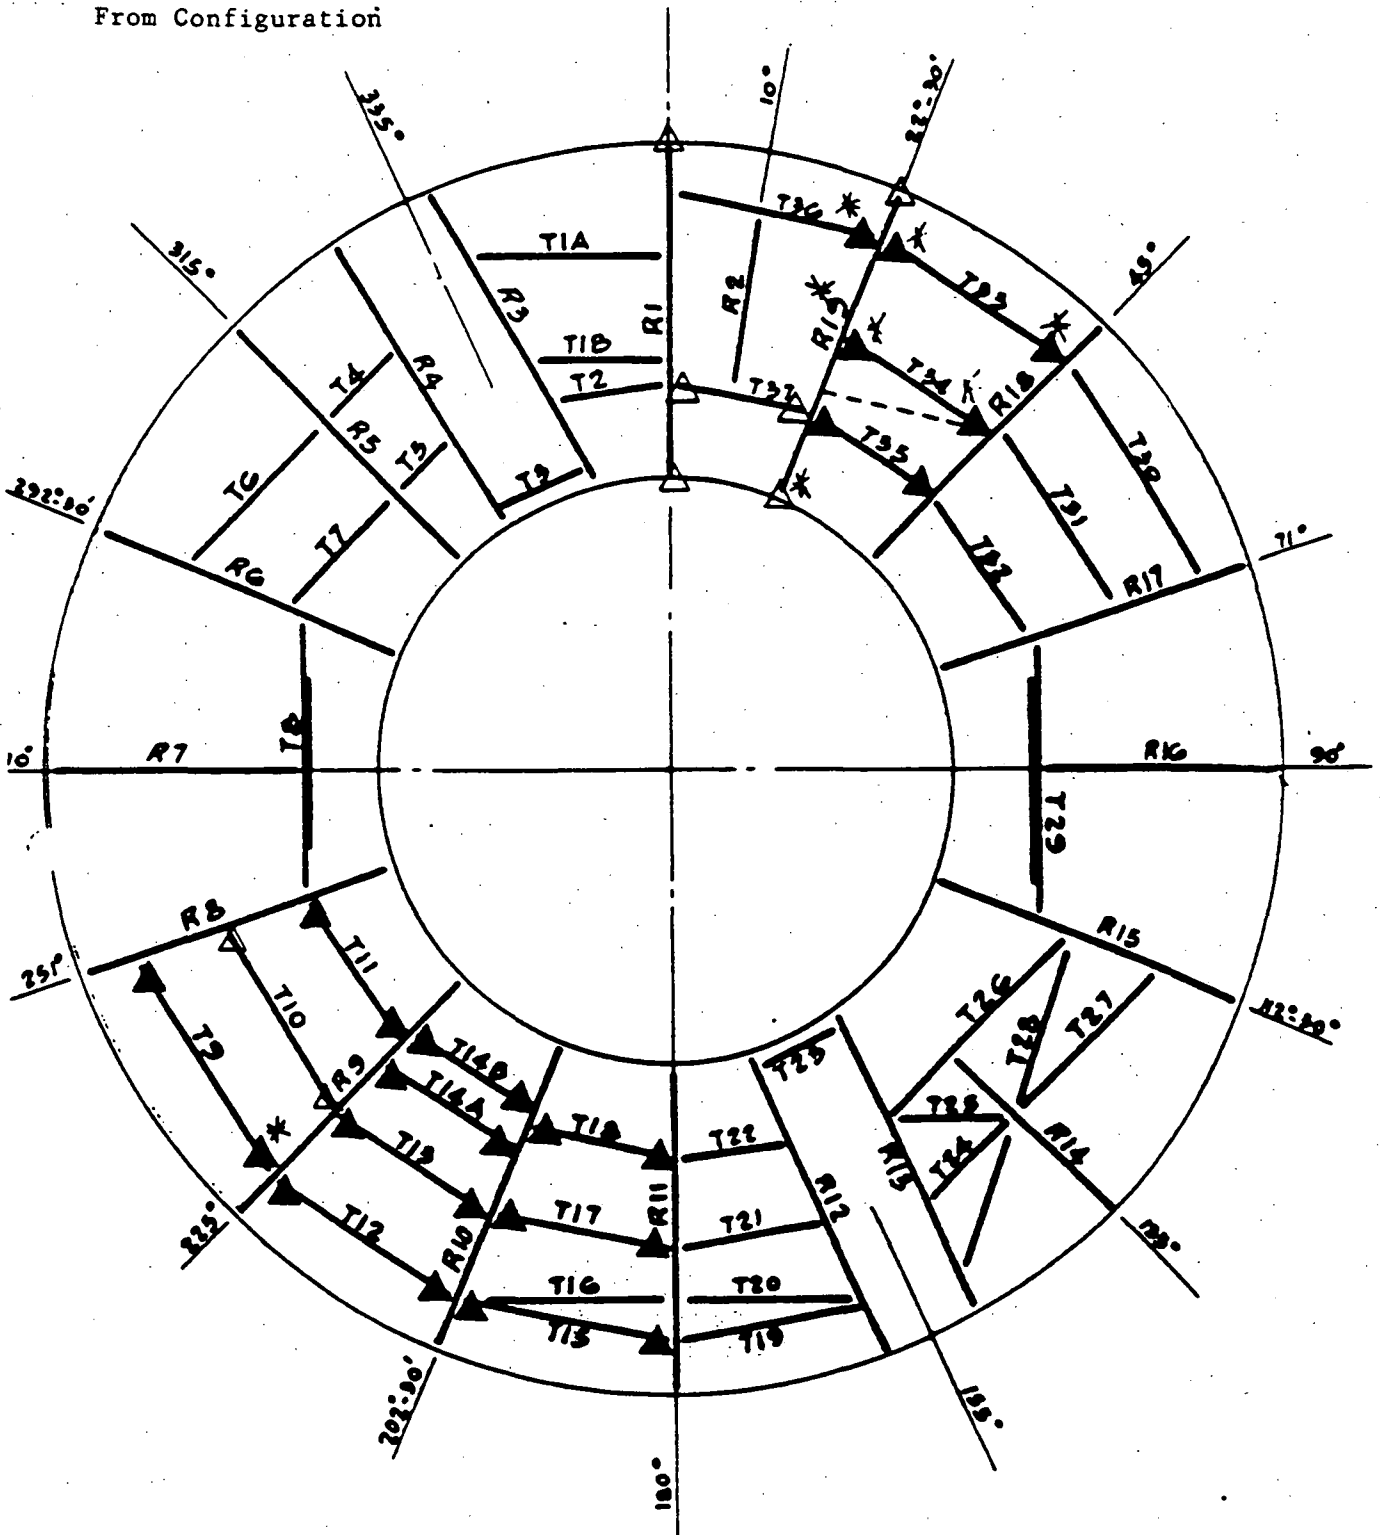
FIGURE 2

▲ = Connection Differs From Configuration

* = Does Not Meet PSAR

FRAMING PLAN AT EL. 597.0'
