LICENSEE EVENT REPORT (LER)

FACILITY NAME (1) Dresden Nuclear Power Station, Unit 2	DOCKET NUMBER (2) 0 5 0 0 0 2 3 7	PAGE (3) 1 OF 0 9
---	---	-----------------------------

TITLE (4)
Reactor Scram During Power Operation Due to Low Reactor Water Level Resulting From Unanticipated Closure of the 2B Feedwater Regulating Valve

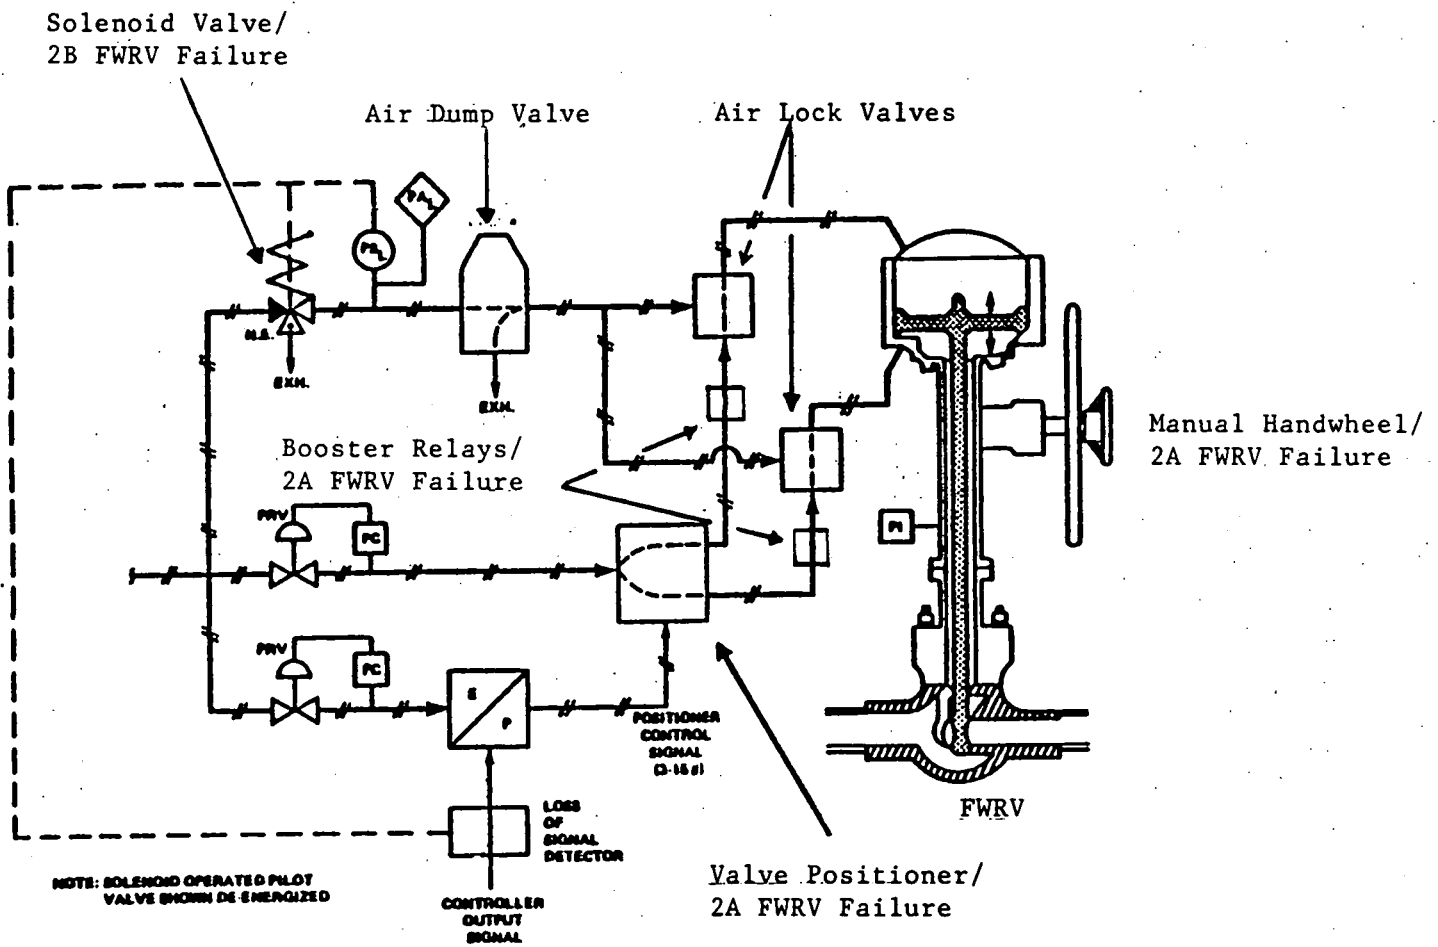
FIGURE 1

FWRV Control System
