LICENSEE EVENT REPORT (LER)

Facility Name (1) Dresden Nuclear Power Station, Unit 3	Docket Number (2) 0 5 0 0 0 2 4 9	Page (3) 1 of 0 5
-------------------------------------------------------------------	-----------------------------------------------------------	-----------------------------------

Title (4) HPCI System Inoperable Due to Failure of Minimum Flow Valve

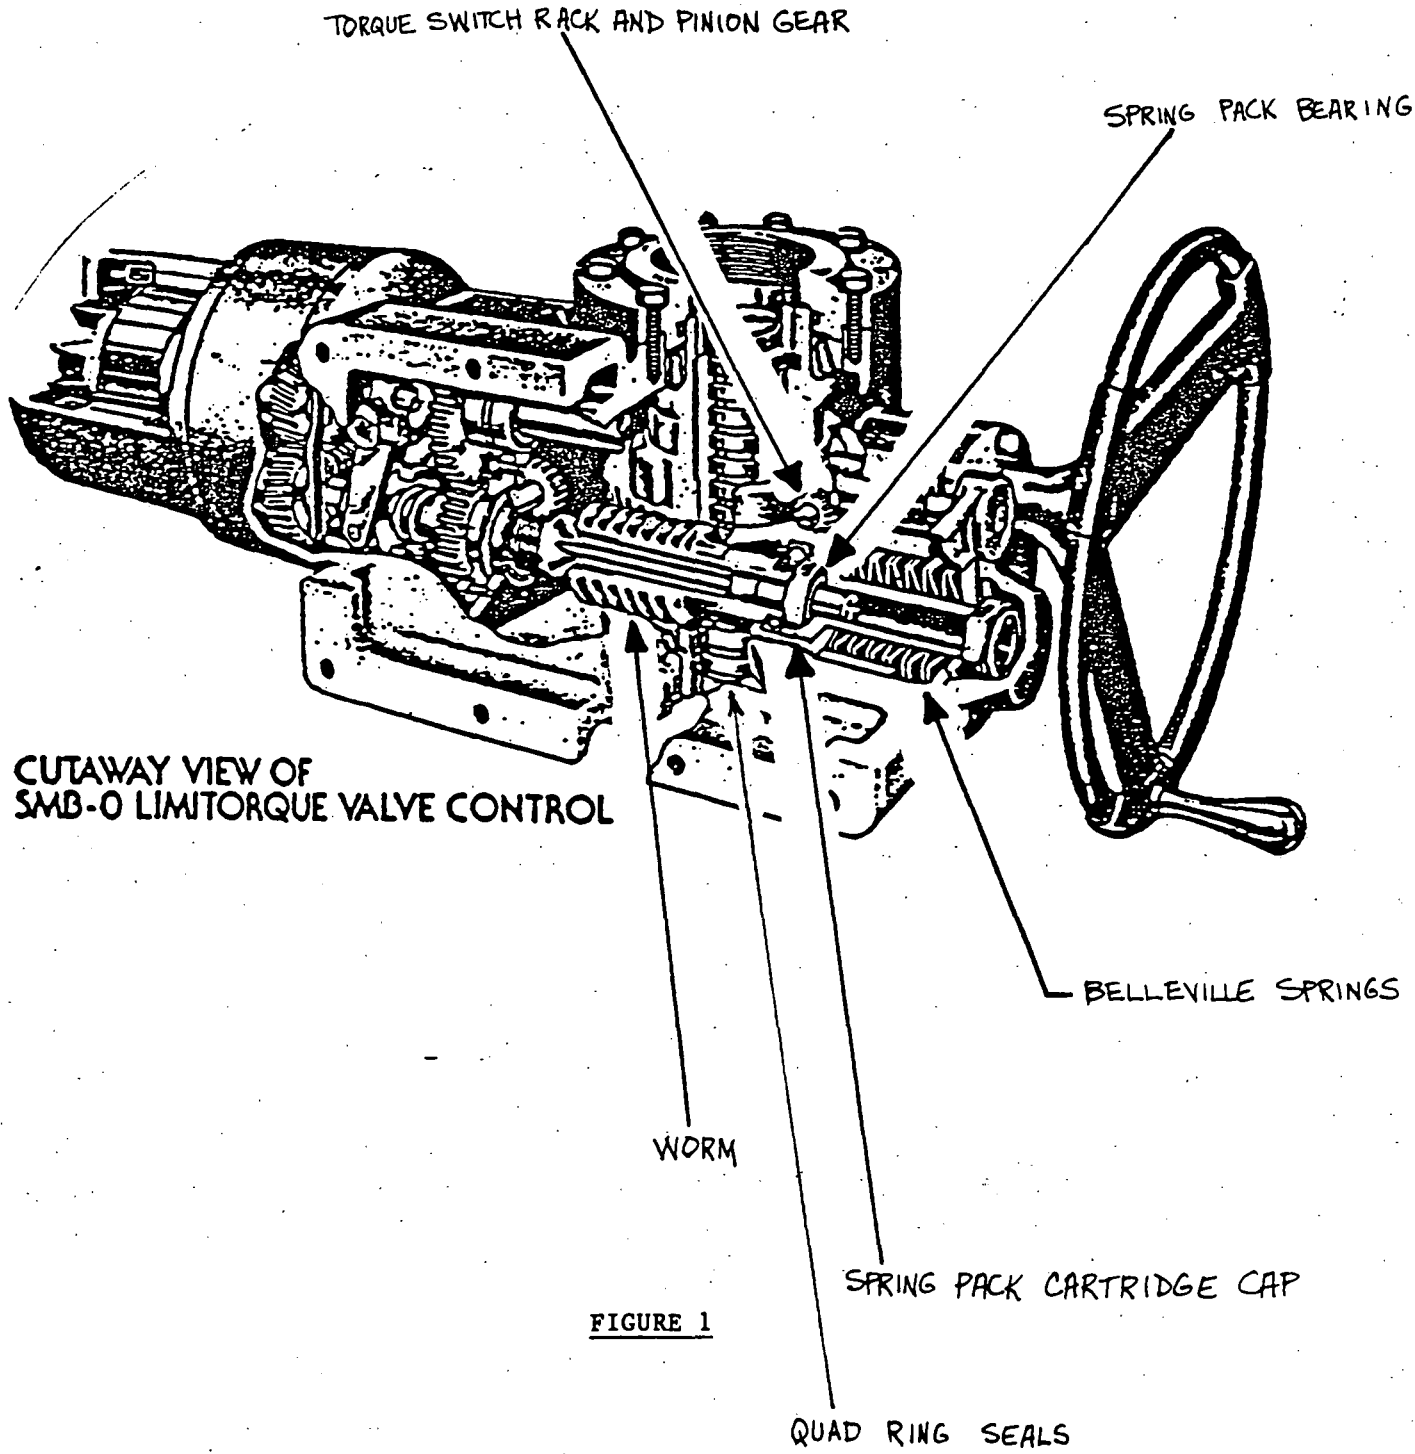
FIGURE 1

The root cause of the M03-2301-14 valve failure was determined to be water penetration into the Limatorque motor operator gearbox. The valve is mounted in the vertical position with the Limatorque motor operator at the lowest point. This orientation allowed water leaking past the valve packing, to travel down the valve stem and into the Limatorque motor operator gear case via the quad ring seals. Once the water entered the gear case, corrosion began to take place. All internal parts of the operator showed signs of corrosion. Additionally, the gear case grease was found in a hardened state.

The root cause of the valve tripping on thermal overloads has been attributed to a corroded spring pack bearing (see Figure 1). This bearing is responsible for aligning the worm with the Belleville spring pack via the bearing cartridge cap. The torque switch pinion gear then rides along a rack type gear located on the bearing cartridge cap. Since the spring pack bearing was no longer intact, worm movement could not be measured by the Belleville spring pack via the bearing cartridge cap, and when the valve reached the closed position, the torque switch could not actuate. With the torque switch no longer available to operate, the Limatorque motor operator continued to thrust the valve disc into the seal until the motor stopped. Once stopped, the motor locked-rotor current caused the thermal overloads to trip.

The Mechanical Maintenance Department was immediately dispatched to repair the M03-2301-14 valve following the directions outlined in Work Request #68947. All worn and corroded parts were replaced and new quad rings were installed. Additionally, a Grease Relief Kit was installed to prevent possible Belleville spring pack hydraulic lock, and the gear case was greased with Mobilux EPO grease. The valve was successfully cycled three times to prove operability. Subsequently, the Electrical Maintenance Department performed a motor current signature per Work Request #68911 and Dresden Maintenance Procedure (DMP) 040-29, Motor Operated Valve Signature, and verified that the open/close limit switches and open torque switch bypass switch were set properly. The HPCI system was tested satisfactorily following these repairs on September 23, 1987.
