LICENSEE EVENT REPORT (LER)

Facility Name (1) Dresden Nuclear Power Station, Unit 3 Docket Number (2) 0 | 5 | 0 | 0 | 0 | 2 | 4 | 9 Page (3) 1 | of | 0 | 7

Title (4) Primary Containment Group I Isolation and Reactor Scram Due to Apparent Personnel Error

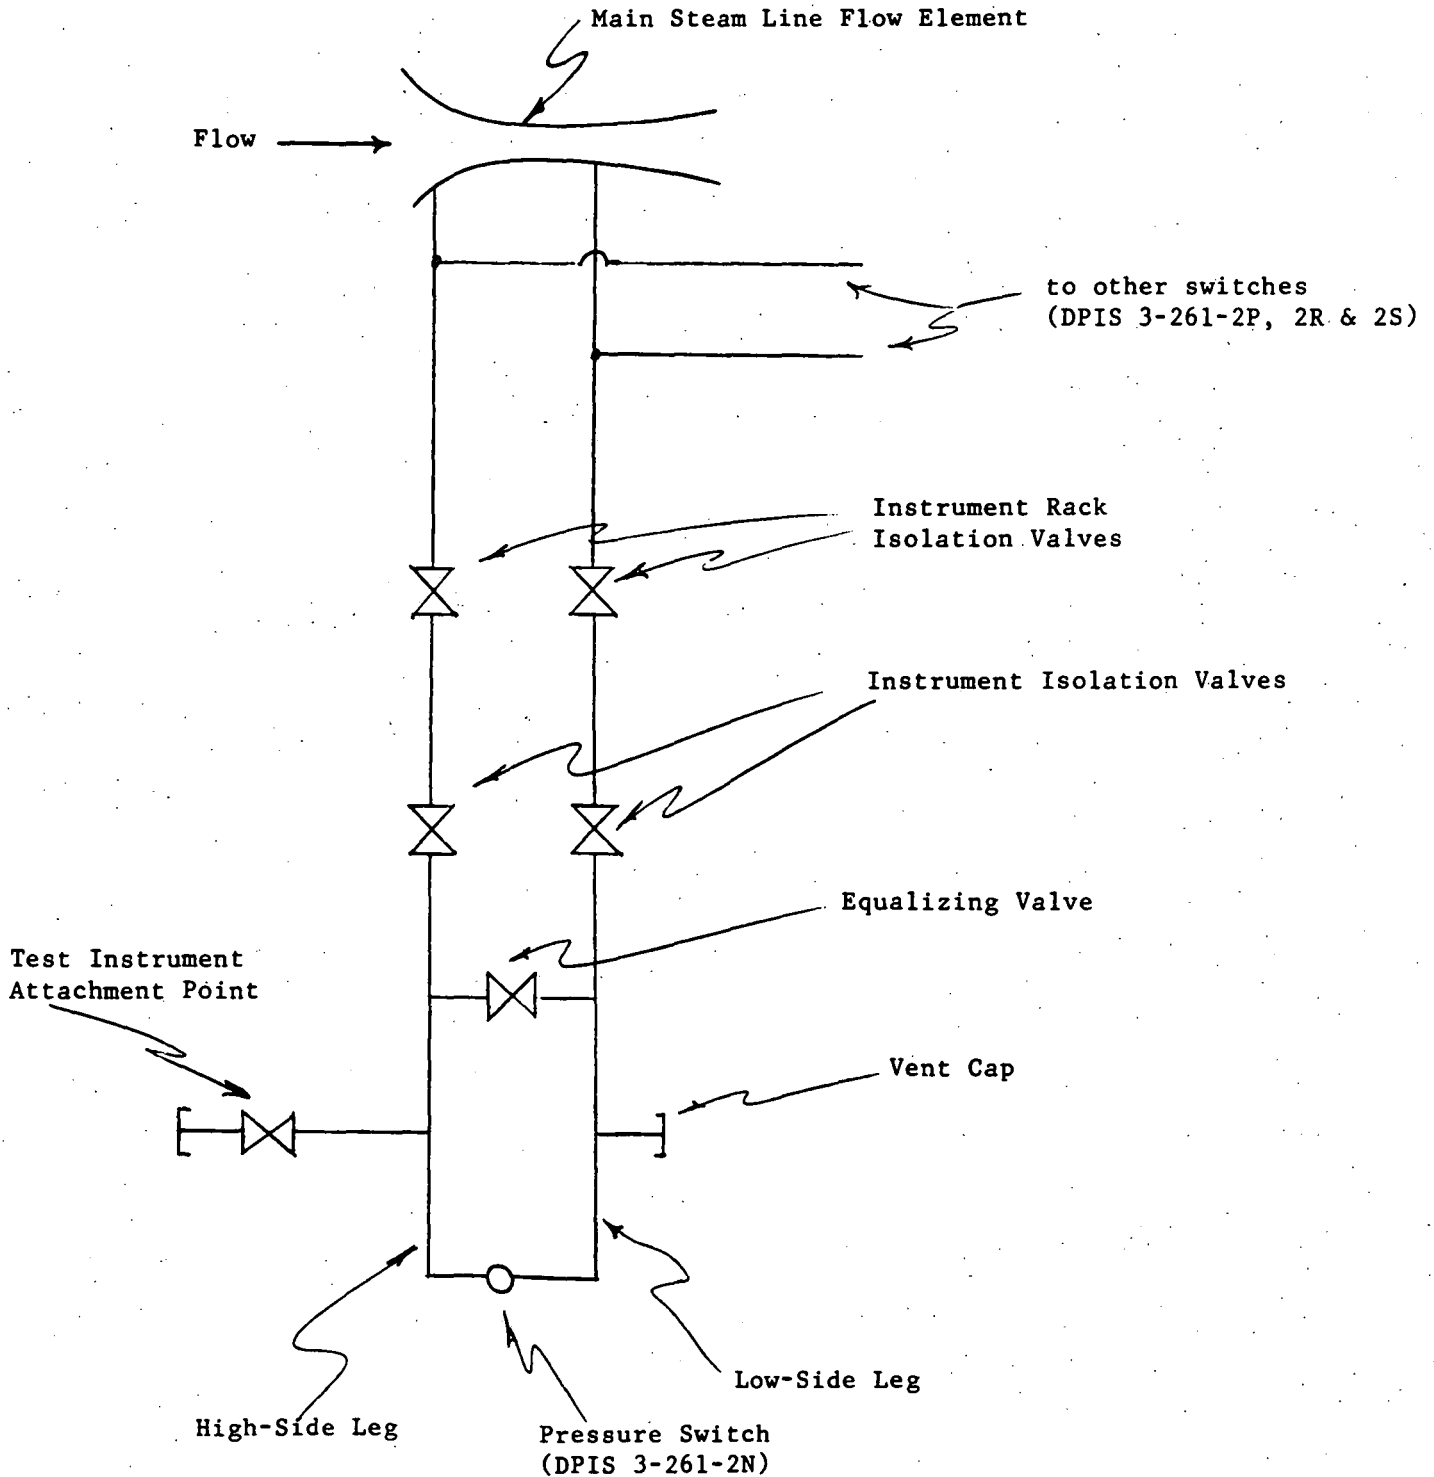
Figure 1

The IM performed the calibration per DIS 250-1 which consists of testing each of the 16 MSL high flow switches, DPIS 3-261-2A through -2S, that are associated with the MSL high flow Group I isolation initiation circuitry. The basic sequence followed by the IM is as follows (refer to Figure 1):

1. The instrument isolation valves are closed.
2. The equalizing valve is opened to equalize the high and low side instrument legs.
3. The vent cap on the low side leg is opened to bleed down the isolated instrument lines.
4. Test equipment is installed on the high side leg for loading of the differential pressure switch. Loading of the pressure switch initiates a half Group I signal and associated Control Room alarm.

While the IM was bleeding down pressure switch DPIS 3-261-2N, which had previously been isolated and equalized, the IM noticed a substantial increase in differential pressure. In an attempt to stop the increase in pressure, the IM immediately closed the equalizing valve. Shortly after closing the equalizing valve, the IM was informed that a Group I isolation and subsequent reactor scram had occurred. The IM then noticed that pressure switches DPIS 3-261-2P, 2R and 2S, which are located on the same instrument rack as pressure switch DPIS 3-261-2N, had pegged high.

During the investigation of this event, it was initially postulated that the IM did not close the low side isolation valve to pressure switch DPIS 3-261-2N. Failure to close this valve would have allowed an increase in differential pressure to occur on all four switches since they are tied to a common header, thereby causing a full Group I isolation and a subsequent reactor scram. However, while interviewing the IM, he stated that the isolation valves were properly closed. Additionally, an Instrument Maintenance Foreman was able to duplicate the event while attempting to repeat the procedure process in order to troubleshoot the system for the cause of the primary containment Group I isolation. The Foreman closed the instrument rack low side isolation valve and left the equalizing valve slightly open. He then loaded pressure switch DPIS 3-261-2N to 1000 psig and began bleeding down the instrument high and low side legs by opening the low side vent. Once the switch was bled down to 300 psig, the Foreman slowly cracked open the high side instrument isolation valve. Immediately following the opening of the high side isolation valve, a second Group I isolation and subsequent reactor scram occurred. This resulted in further investigation into the possibility of leakage through the high side instrument isolation valve.

An inspection of the instrument valve manifold was also conducted on September 29, 1987. This inspection was performed on two separate occasions, once by the Instrument Maintenance Department and once by the Quality Control Department. In addition to the valve manifold inspection, a blue check test was performed to determine if adequate contact existed between the ball on the valve stem and the valve seat. The results of the two independent inspection and test activities revealed that all three valves (high side, low side and equalize valves) exhibited an alignment problem between the ball and the seat. Additionally, the high side valve seat in the manifold block was scratched, the high side ball was nicked in one area, and the high side ball valve randomly would only obtain 95% seat contact. The combination of abnormalities found with the high side valve may have caused a certain amount of through leakage. However, since the seating surfaces were not significantly degraded, it is believed that the root cause of the insufficient isolation was an incognitive personnel error on the part of the IM. This resulted in an increase in differential pressure across the switch during the bleed down period. In an attempt to stop the increase in pressure, the IM immediately closed the equalizing valve. This action is believed to have caused a pressure spike on the high side leg to the other three pressure switches since all four switches are commonly connected together as noted in Figure 1. Because the differential pressure for all four switches increased beyond the setpoint of 110 psid, a Group I isolation occurred and the reactor scrambled on MSIV closure.

The instrument valve manifold was replaced per Work Request #69237 and pressure switch DPIS 3-261-2N was calibrated in accordance with DIS 250-1. The corrective action to the alarm typer failure consisted of modifying the Safety Parameter Display System software. A human factors walkdown of DIS 250-1 was also performed, and improvements suggested will be incorporated into the procedure. As a long term corrective action, installation of an analog MSL high flow trip system not requiring isolation valve manipulation during surveillance will be investigated.

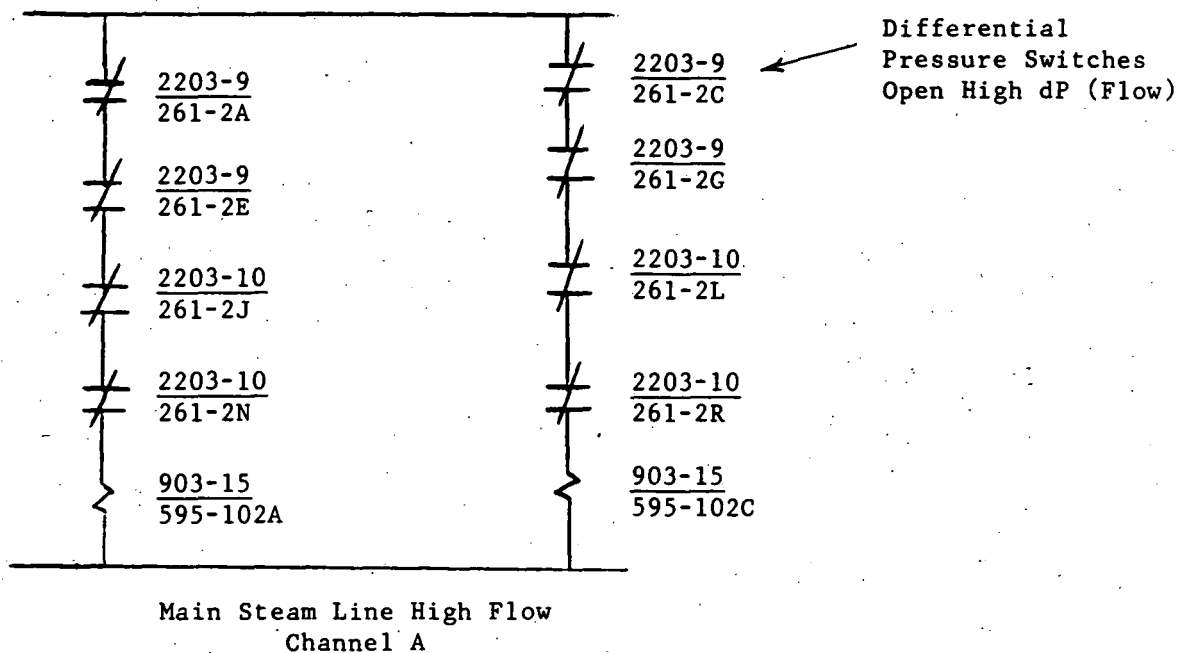
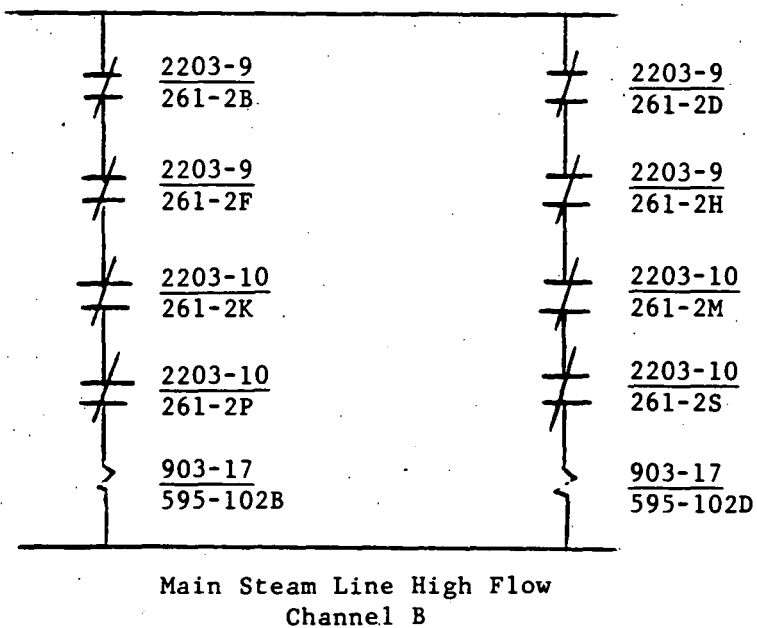
The MSL high flow Group I isolation logic is arranged in a 1 out of 2 twice logic. There are two safety system channels with each one consisting of two subchannels which contain four differential pressure switches. See Figure 2 for logic arrangement. In order to initiate a Group I isolation at least one of the pressure switches must trip in each safety system channel. The pressure switches actuate on high differential pressure. Since pressure switch DPIS 3-261-2N was the only switch being calibrated at the time of the scram, a half Group I isolation should have occurred after loading of the switch. However, because of the through leakage from the high side isolation valve on pressure switch DPIS 3-261-2N, all four switches actuated and caused the Group I isolation. The safety significance of this event was minimal since the instrument high side isolation valve is normally open during normal operation and all four pressure switches operated as designed, thus initiating the primary containment Group I isolation.
