LICENSEE EVENT REPORT (LER)

Facility Name (1) Dresden Nuclear Power Station, Unit 2 Docket Number (2) 0 | 5 | 0 | 0 | 0 | 2 | 3 | 7 | 1 | of | 1 | 3 Page (3)

TITLE (4) Main Steam Isolation Valves Failure to Close Due to High Stem Drag Forces Caused by Valve Packing

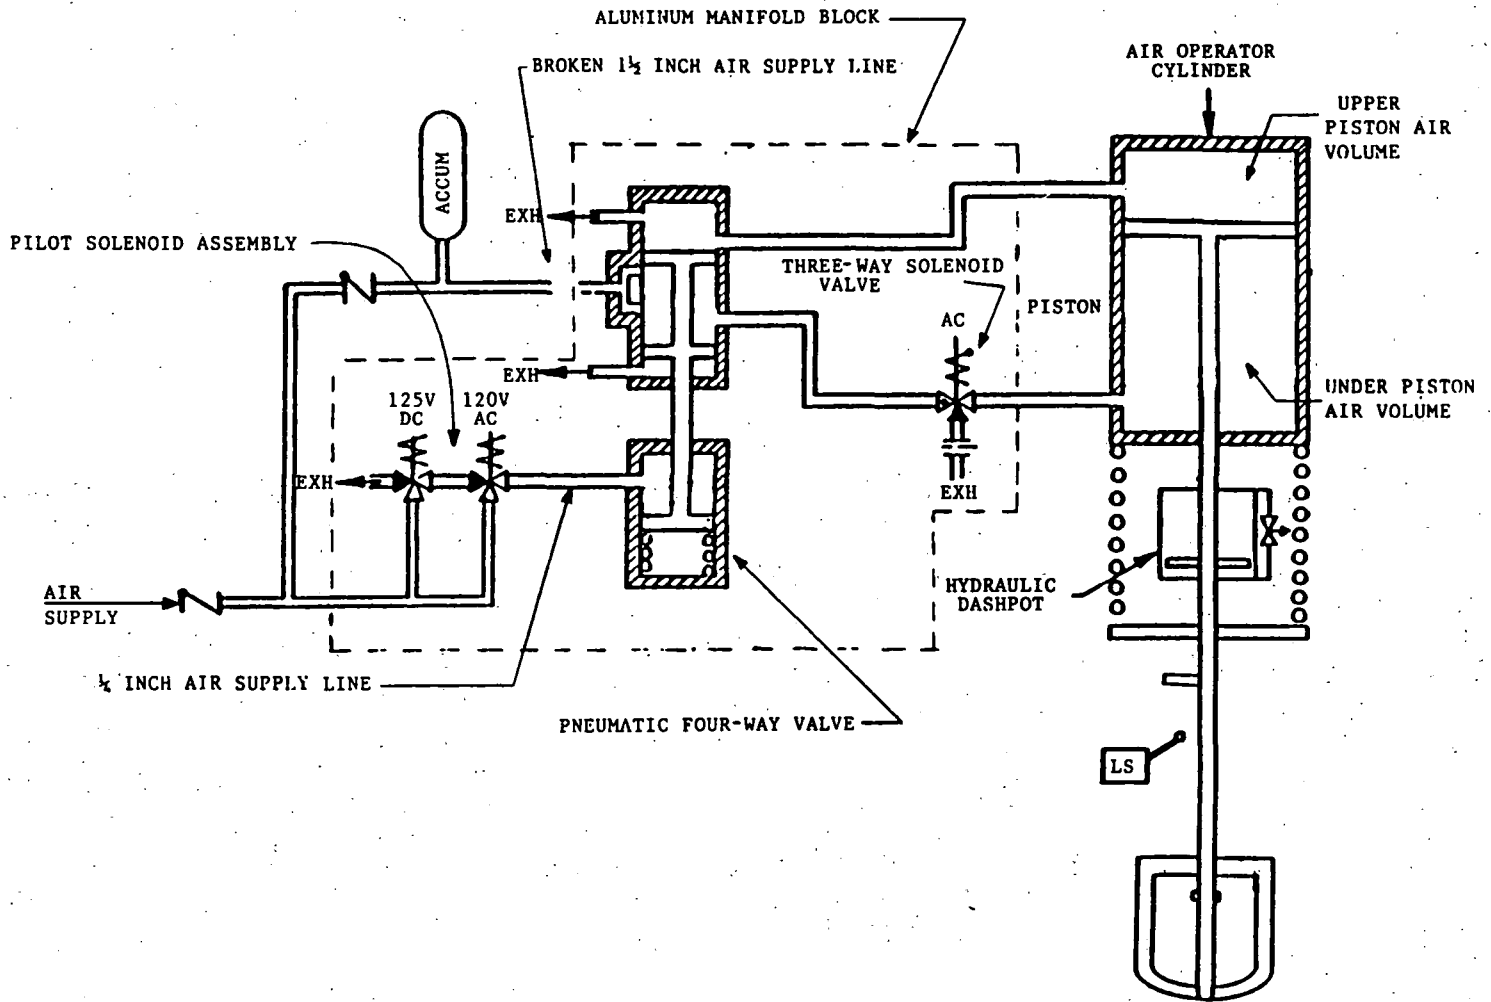
FIGURE 1

MSIV AIR SUPPLY SYSTEM SCHEMATIC
(MSIV SHOWN IN OPEN POSITION)
