Subject: Dresden Station Unit 3
Summary of Augmented IGSCC Inspection
Results for 1988 Refueling Outage
NRC Docket No. 50-249

Dresden Unit 3

Summary of Augmented Inspection Activities

Winter 1988 Outage

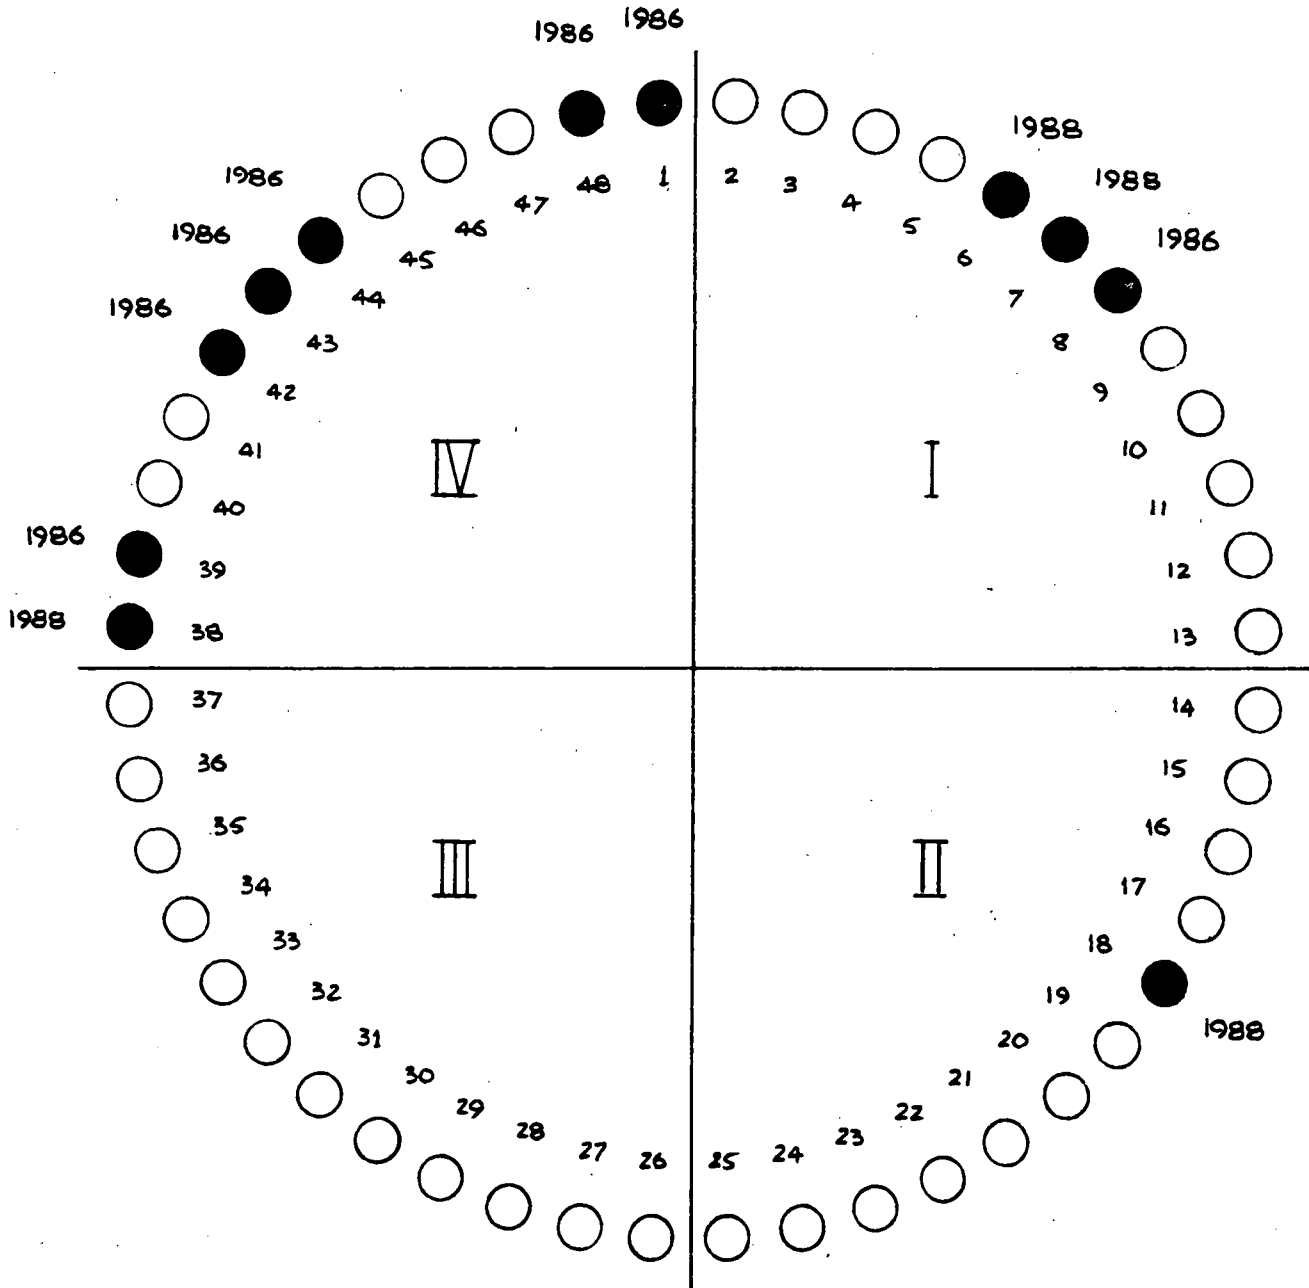
FIGURE 1
 DRESDEN UNIT 3 SHROUD HEAD BOLTS
 WITH INDICATIONS

- a. Shroud Head Bolting - A total of 48 shroud head bolts were ultrasonically re-examined. Evidence of cracking greater than 10% of the bolt area was detected in four (04) additional bolts during this outage. Two (02) of the seven (07) bolts previously identified as cracked (in the 1985/1986 outage) had indications of increased cracking. The remaining five (05) of the seven (07) bolts previously identified as cracked appear to have essentially unchanged indications from the previous inspection. To date a total of eleven (11) bolts with evidence of cracking greater than 10% of the bolt area have been found in Unit 3. No corrective action is necessary since the engineering evaluation by CECo BWR Engineering indicates that Dresden Unit 3 can be safely operated with the present complement of shroud head bolts.

Figure 1 is a map of shroud head bolts with indication. The year in which the cracked bolt was first discovered is marked next to the bolt.
