U.S. NUCLEAR REGULATORY COMMISSION

Report No. 50-249/88010(DRS)

Facility Name: Dresden Station, Unit 3

Inspection Summary

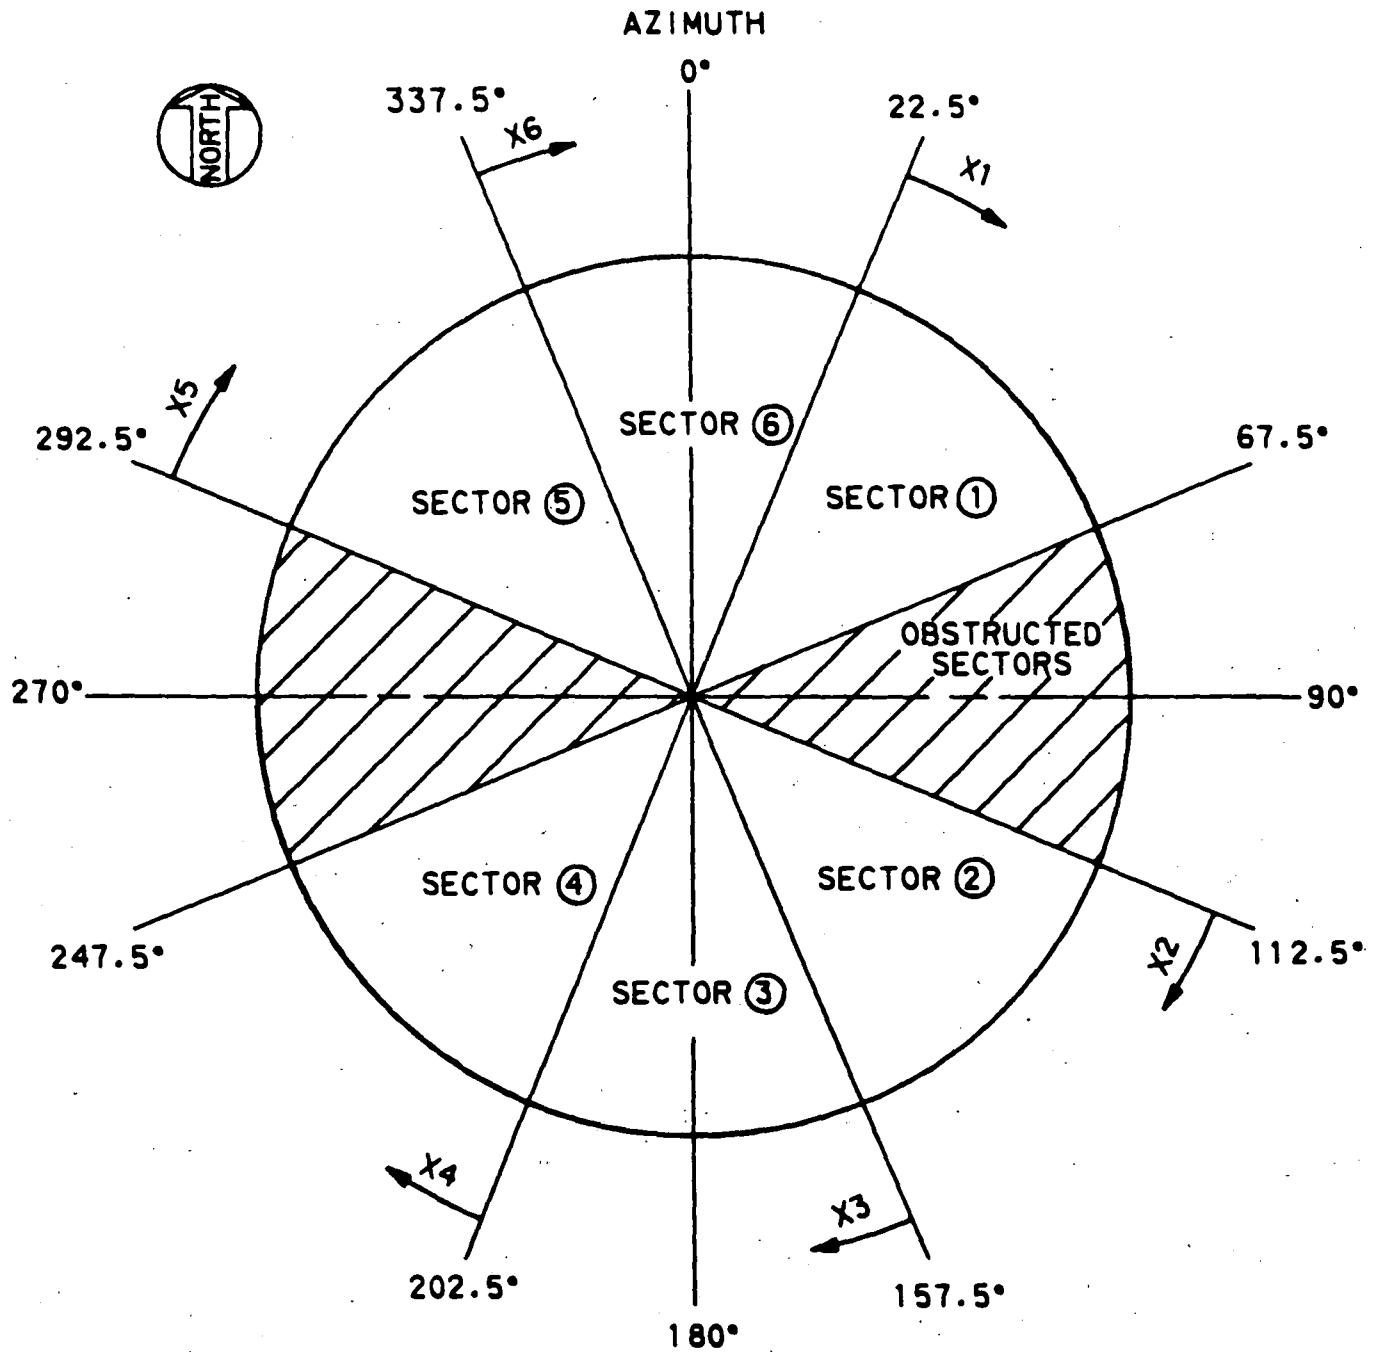
THICKNESS MEASUREMENT

During this outage the licensee initiated an inspection program to measure the thickness of the drywell skin in the sand cushion area. Twenty two core drillings in the concrete surface to the drywell liner was made. The core drillings were made at the top and bottom sections of the sand pocket area (11 at the top and 11 at the bottom). The azimuth sections were selected based on sand pocket location and accessibility. Ultrasonic examinations (UT) of the drywell wall was performed. The as designed nominal wall thickness is 1.0625." The thickness measurements were as follows:

<u>Location (Azimuth)</u>	<u>Identification Point</u>	<u>Report #</u>	<u>Measured Thickness</u>
Sector No. 1: x=5'	22.5.1.1A*	CPD-109	1.10"
Sector No. 1: x=5'	22.5.1.1B**	CPD-110	1.14"
Sector No. 1: x=6'	22.5.1.2A	CPD-110	1.14"
Sector No. 1: x=6'	22.5.1.2B	CPD-112	1.10"
Sector No. 2: x=7'	112.5.1.1A	CPD-107	1.12"
Sector No. 2: x=7'	112.5.1.1B	CPD-119	1.12"
Sector No. 2: x=5.5'	112.5.1.2A	CPD-108	1.10"
Sector No. 2: x=5.5'	112.5.1.2B	CPD-119	1.08"
Sector No. 3: x=11'	157.5.1.1A	CPD-104	1.14"
Sector No. 3: x=11'	157.5.1.1B	CPD-105	1.14"
Sector No. 3: x=9'	157.5.1.2A	CPD-102	1.14"
Sector No. 3: x=9'	157.5.1.2B	CPD-103	1.12"
Sector No. 4: x=13.5'	202.5.1.1A	CPD-100	1.08"
Sector No. 4: x=13.5'	202.5.1.1B	CPD-101	1.08"
Sector No. 5: x=12'	292.5.1.1A	CPD-114	1.18"
Sector No. 5: x=12'	292.5.1.1B	CPD-117	1.12"
Sector No. 5: x=7'	292.5.1.2A	CPD-115	1.12"
Sector No. 5: x=7'	292.5.1.2B	CPD-116	1.26"
Sector No. 6: x=9'	337.5.1.1A	CPD-118	1.20"

Sector No. 6: x=9'	337.5.1.1B	CPD-120	1.08"
Sector No. 11: x=11	337.5.1.2A	CPD-106	1.12"
Sector No. 11: x=11	337.5.1.2B	CPD-113	1.24"

The ultrasonic examinations provides additional assurance that the drywell wall has not degraded due to the trapped water discovered when the plugged drain lines were cleared. During the core drilling of the concrete floor to gain access to the drywell wall in the sand pocket areas, the licensee encountered water in the core holes. The licensee took samples of the core hole water and determined the source was hydrolyzing which was performed prior to the core drilling. To assure all water was removed from this process the licensee drilled a well hole in the center of the containment floor to the Drywell wall interface. However no water was recovered at this point. The licensee's investigation as to the source of the water included inspection of the mastic seal at the concrete - drywell wall interface and the concrete floor within the drywell. The mastic seal appeared to be intact however cracks in the concrete floor of the drywell are a likely source for the water from hydrolyzing.

The licensee sealed the inspection holes and will perform further inspections to assure the drywell wall does not degrade and attempt to find the source of the leakage into the sand pocket area and initiate corrective action.
