LICENSEE EVENT REPORT (LER)

| Facility Name (1) Dresden Nuclear Power Station, Unit 3 | | | | | | | | | | Docket Number (2) 0 5 0 0 0 2 4 9 | | | | Page (3) 1 of 0 6 | |
| TITLE (4) Loss of 3A Reactor Protection System Bus and Subsequent ESF Actuations Due to a Loose Wire Connection | | | | | | | | | | | | | | | |

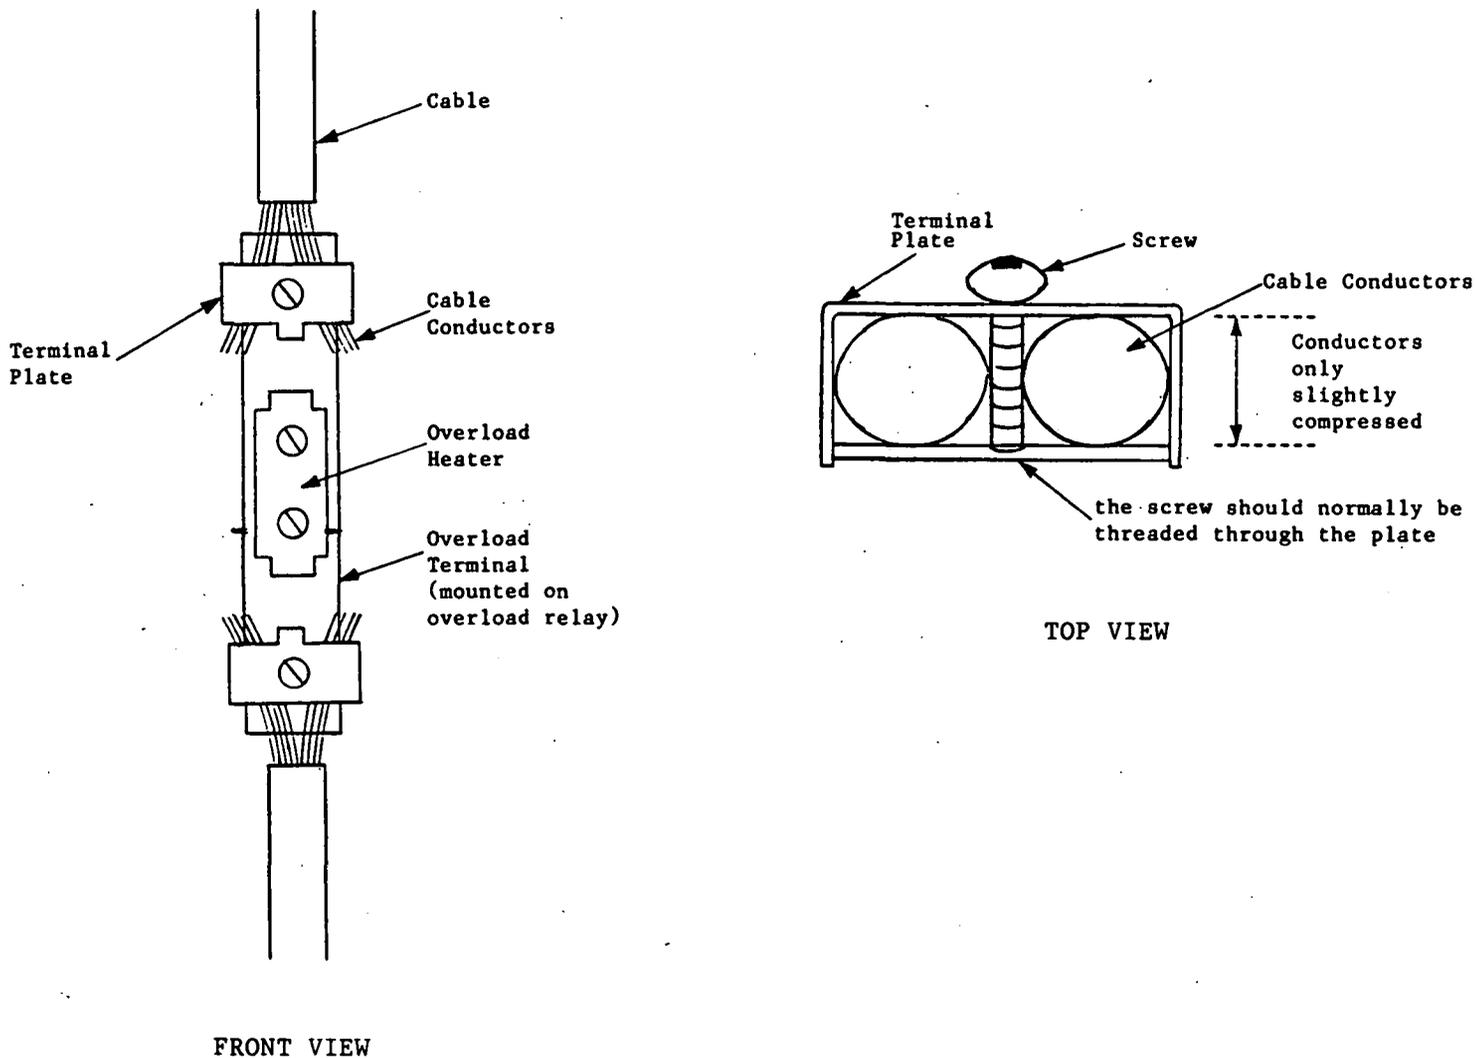
Figure 1

After further inspection of the cable and overload terminal connection, it was concluded that the cable was too large for the terminal connection. With the cable connected to the terminal as shown on Figure 1, the excessive number of conductors between the plate and terminal prevented adequate compression of the conductors and thus created a loose connection. In addition, the terminal screw should normally be threaded through the terminal to ensure a proper connection is made; however, in this event the terminal screw was not threaded through the terminal because of the excessive number of cable conductors, also shown on Figure 1.

The running contactor and its thermal overloads were replaced previously on May 7, 1988 due to a shorted contactor. When the cable was reconnected to the thermal overload, it is believed a secure connection was not made. The loosened connection eventually heated the overload relay to the point at which the overload tripped the 3B RPS MG Set. In conclusion, the original installation cable connection configuration to the overload relay on the running contactor was the root cause of this event.

"AS FOUND" OVERLOAD RELAY TERMINAL CONNECTION

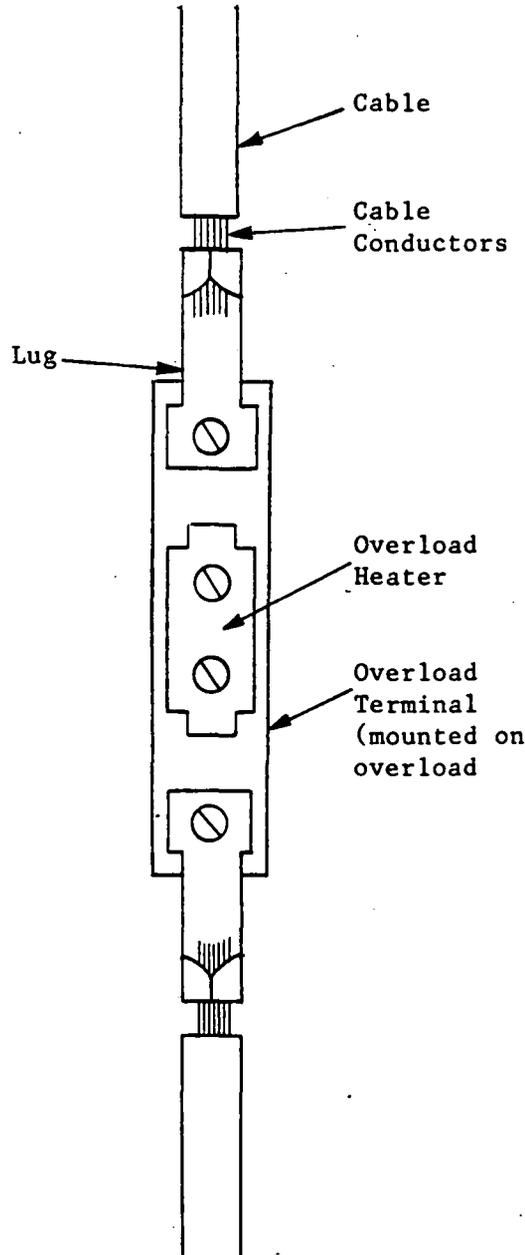
Figure 2

"AS LEFT" OVERLOAD RELAY TERMINAL CONNECTION

Immediate corrective action included lugging the top and bottom cables on both overload relays per Work Request 75683. The new style connection is shown on Figure 2. This repair provided a secure connection from the cable to the overload relay since the conductors in the cables are crimped onto the lug. Following repairs of the main feed breaker and successful testing, the 3B RPS MG Set was returned to service on June 8, 1988 at 1330 hours. To prevent future occurrences of this type, the following Dresden Maintenance Procedures (DMP) will be revised by the EMD to ensure that all wiring connected to overload relays have secure connections following maintenance on breakers (249-200-88-05901).
