LICENSEE EVENT REPORT (LER)

Facility Name (1) Dresden Nuclear Power Station, Unit 3										Docket Number (2) 0 5 0 0 0 2 4 9				Page (3) 1 of 0 6	
TITLE (4) Loss of 3A Reactor Protection System Bus and Subsequent ESF Actuations Due to a Loose Wire Connection															
Event Date (5) Month Day Year			LER Number (6) Year Sequential Number Revision Number				Report Date (7) Month Day Year			Other Facilities Involved (8) Facility Names Docket Number(s)					
0 6 0 7 8 8 8 8			— 0 1 3 — 0 0				0 6 3 0 8 8			N/A					
OPERATING MODE (9) POWER LEVEL (10)			THIS REPORT IS SUBMITTED PURSUANT TO THE REQUIREMENTS OF 10CFR (Check one or more of the following) (11)												
N			20.402(b)		20.405(c)		<input checked="" type="checkbox"/> 50.73(a)(2)(iv)		73.71(b)						
0 0 0			20.405(a)(1)(i)		50.36(c)(1)		50.73(a)(2)(v)		73.71(c)

Loss of the 3A Reactor Protection System (RPS) Bus and Subsequent Engineered Safety Feature (ESF) Actuations due to a Loose Wire Connection.

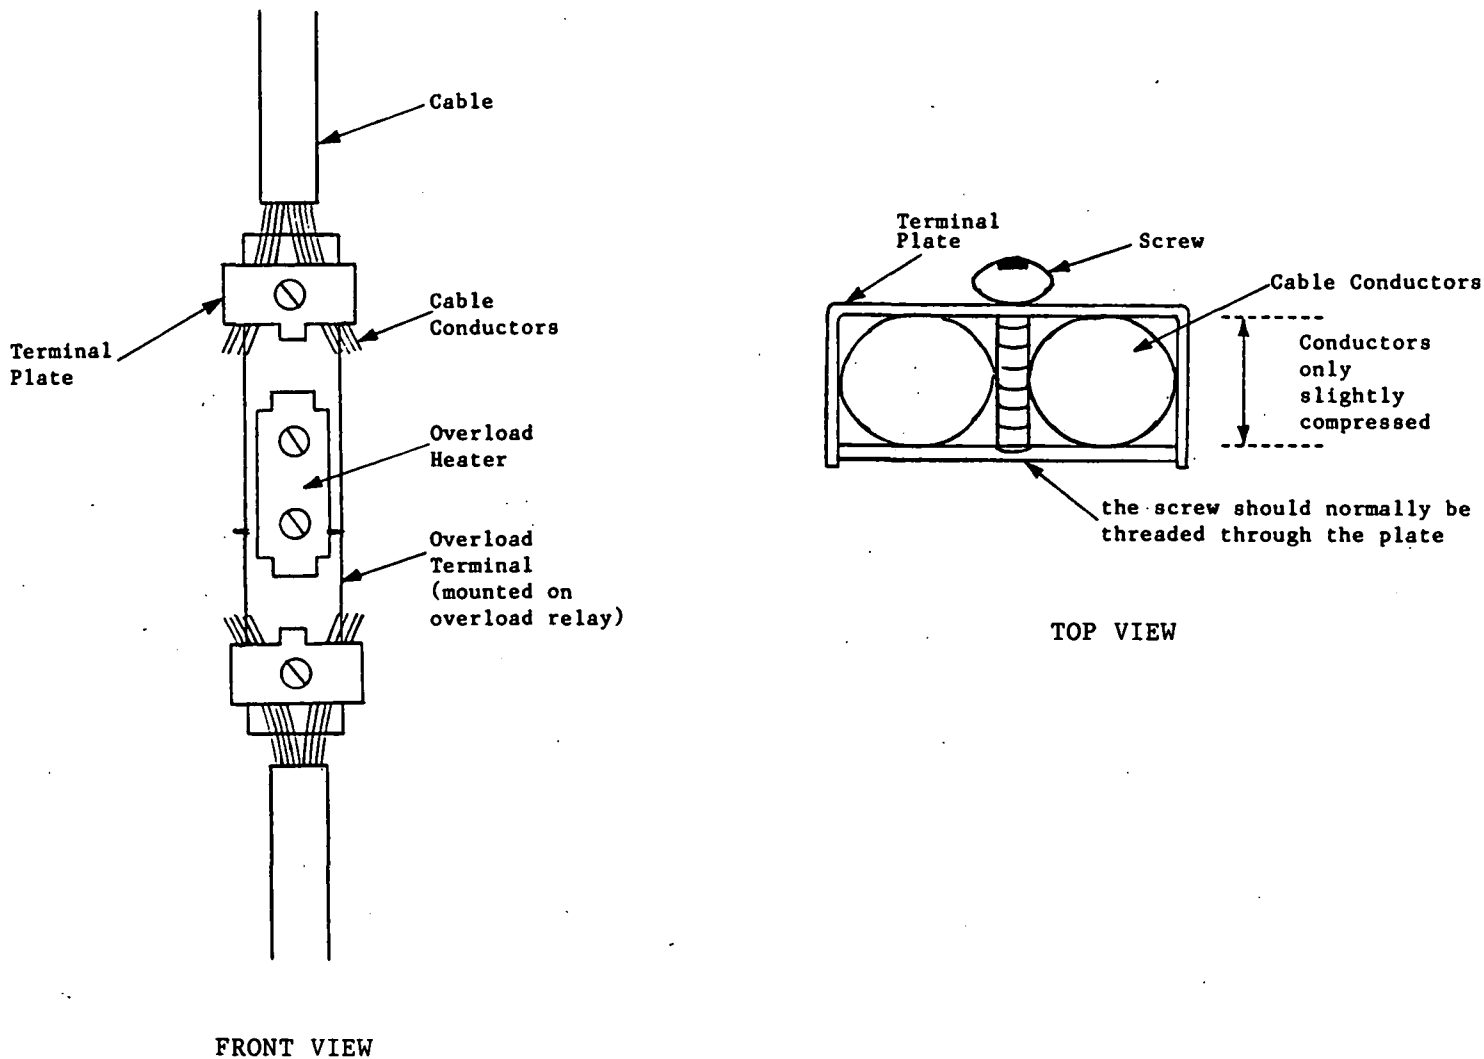
Figure 1

After further inspection of the cable and overload terminal connection, it was concluded that the cable was too large for the terminal connection. With the cable connected to the terminal as shown on Figure 1, the excessive number of conductors between the plate and terminal prevented adequate compression of the conductors and thus created a loose connection. In addition, the terminal screw should normally be threaded through the terminal to ensure a proper connection is made; however, in this event the terminal screw was not threaded through the terminal because of the excessive number of cable conductors, also shown on Figure 1.

The running contactor and its thermal overloads were replaced previously on May 7, 1988 due to a shorted contactor. When the cable was reconnected to the thermal overload, it is believed a secure connection was not made. The loosened connection eventually heated the overload relay to the point at which the overload tripped the 3B RPS MG Set. In conclusion, the original installation cable connection configuration to the overload relay on the running contactor was the root cause of this event.

"AS FOUND" OVERLOAD RELAY TERMINAL CONNECTION

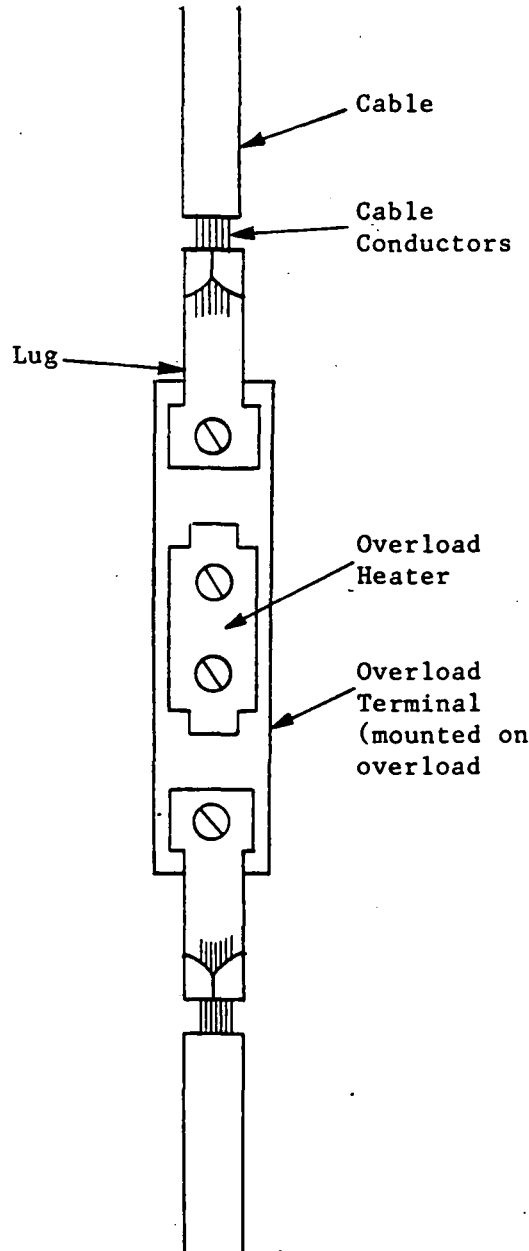
Figure 2

"AS LEFT" OVERLOAD RELAY TERMINAL CONNECTION

Immediate corrective action included lugging the top and bottom cables on both overload relays per Work Request 75683. The new style connection is shown on Figure 2. This repair provided a secure connection from the cable to the overload relay since the conductors in the cables are crimped onto the lug. Following repairs of the main feed breaker and successful testing, the 3B RPS MG Set was returned to service on June 8, 1988 at 1330 hours. To prevent future occurrences of this type, the following Dresden Maintenance Procedures (DMP) will be revised by the EMD to ensure that all wiring connected to overload relays have secure connections following maintenance on breakers (249-200-88-05901).
