LICENSEE EVENT REPORT (LER)

Facility Name (1) Dresden Nuclear Power Station, Unit 3 Docket Number (2) 0 5 0 0 0 2 4 9 Page (3) 1 of 0 4

TITLE (4) Anticipated Transient Without Scram System Actuation Due to Inadequate Operator Training

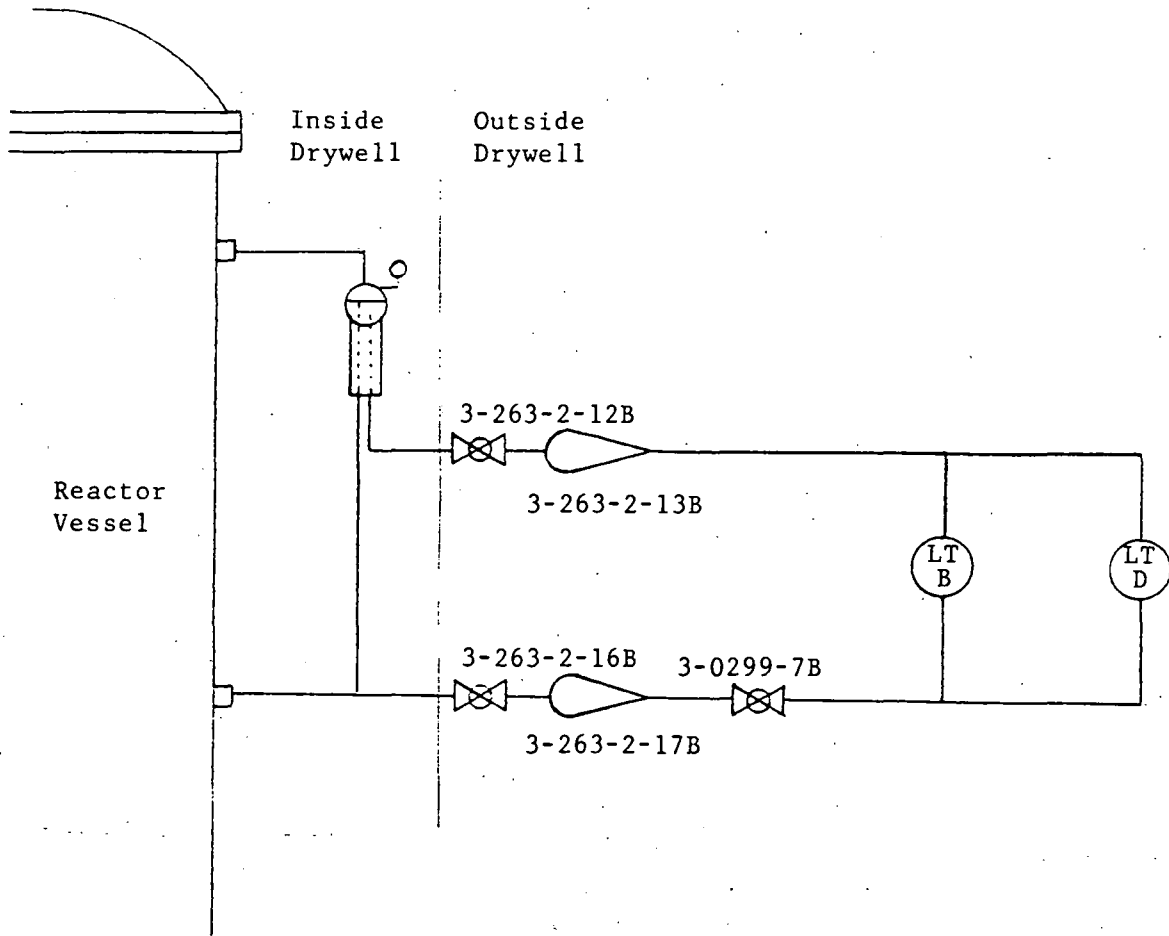
Figure 1

This report is being submitted to comply with 10CFR50.73(a)(2)(iv) which requires the reporting of any unplanned Engineered Safety Feature (ESF) actuation. On June 13 at 0500 hours instrument flow check valve 3-263-2-17B was taken out-of-service for the Mechanical Maintenance Department (MMD) to repair a leak. The valve was isolated by closing root valve 3-263-2-16B (see Figure 1). The leaking flow check valve, 3-263-2-17B, allowed the water in the variable leg of the B and D ATWS low water level transmitters to slowly bleed off until the trip setpoint was reached. Actual reactor vessel level remained steady during the event. The root cause of the event has been determined to be inadequate training. The Operating Department had routinely taken instrument flow check valves out-of-service by closing only the root valve. In this instance the equalizing valves for the level transmitters should have been opened, which would have failed the transmitters high, thus preventing a low water level actuation. Had the Operating Department been instructed on the proper method to isolate various instruments based on their trip function, this event would have been avoided,

Channel B ATWS Level Piping Diagram

Immediate corrective actions consisted of bypassing the Scram Discharge Volume high level circuitry which prevented a reactor scram due to high level in the scram discharge Volume. The high water level in the Scram Discharge Volume is caused by the water flow through the control rod drive scram outlet valve which is opened when air is bled off the scram outlet valve by the ARI valves. Subsequently the variable instrument leg was backfilled, the out-of-service cleared and the ATWS trip was reset. Training will be conducted during Operator continuing training to instruct operating personnel on the correct manner to isolate various types of instruments based on their trip function (249-200-88-06301). No further corrective actions are deemed necessary at this time.
