LICENSEE EVENT REPORT (LER)

Facility Name (1) Dresden Nuclear Power Station
 Docket Number (2) 0 | 5 | 0 | 0 | 0 | 2 | 4 | 9
 Page (3) 1 | of | 0 | 6
 Title (4) Primary Containment Structural Steel Connections Outside Final Safety Analysis Report Design
 Criteria Due to Apparent Original Construction Oversight

Primary Containment Structural Steel Connections Outside Final Safety Analysis Report (FSAR) Design Criteria Due to Apparent Original Construction Oversight.

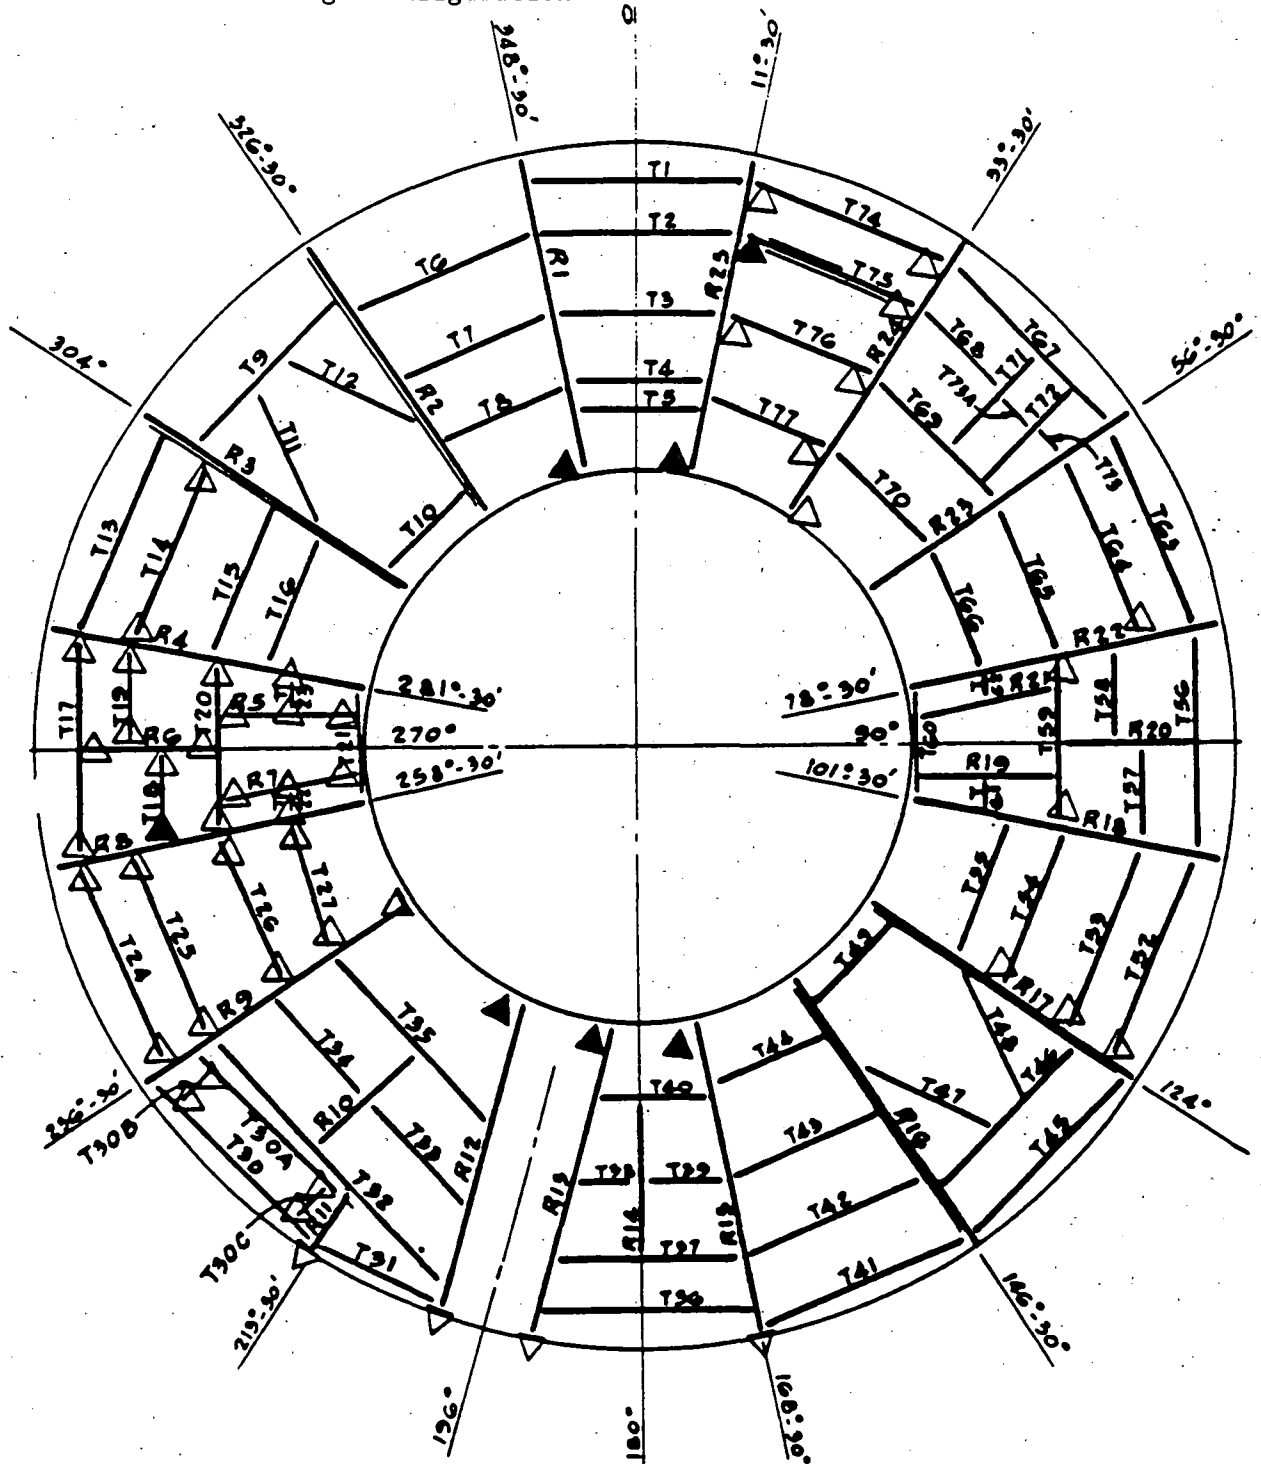
FIGURE 1

Elevation	Beam	Connections	
		Left	Right
515'	T19	X	X
	T10	X	
		Inside	Outside
515'	R23		X
	R24		X

In April, 1988 the inspection of all drywell structural steel connections was completed. Analysis completed on April 25, 1988 indicated only one additional connection in excess of FSAR design criteria. This was a bolted radial beam connection of beam R2 on elevation 515' that was found with loose nuts.

A data assessment of the Unit 3 sample inspection completed on March 16, 1987 indicated that the connections for tangential beams T9 (left side only), T33, T34, and T36 (right side only) were in excess of FSAR criteria. Because of the deficiencies in these connections, radial beam R19 connection at azimuth 22° - 30' and the connection at the biological shield also did not meet the highly conservative FSAR design criteria. However, analysis performed indicates that all these connections meet operability limits for all design basis events. A safety evaluation performed by the Station Nuclear Engineering Department (SNED) in accordance with 10 CFR 50.59 determined that sufficient data had been collected at this time and Unit 3 could return to service to complete its operating cycle.

FRAMING PLAN AT EL 515'-4 1/2'
DRESDEN UNIT 3

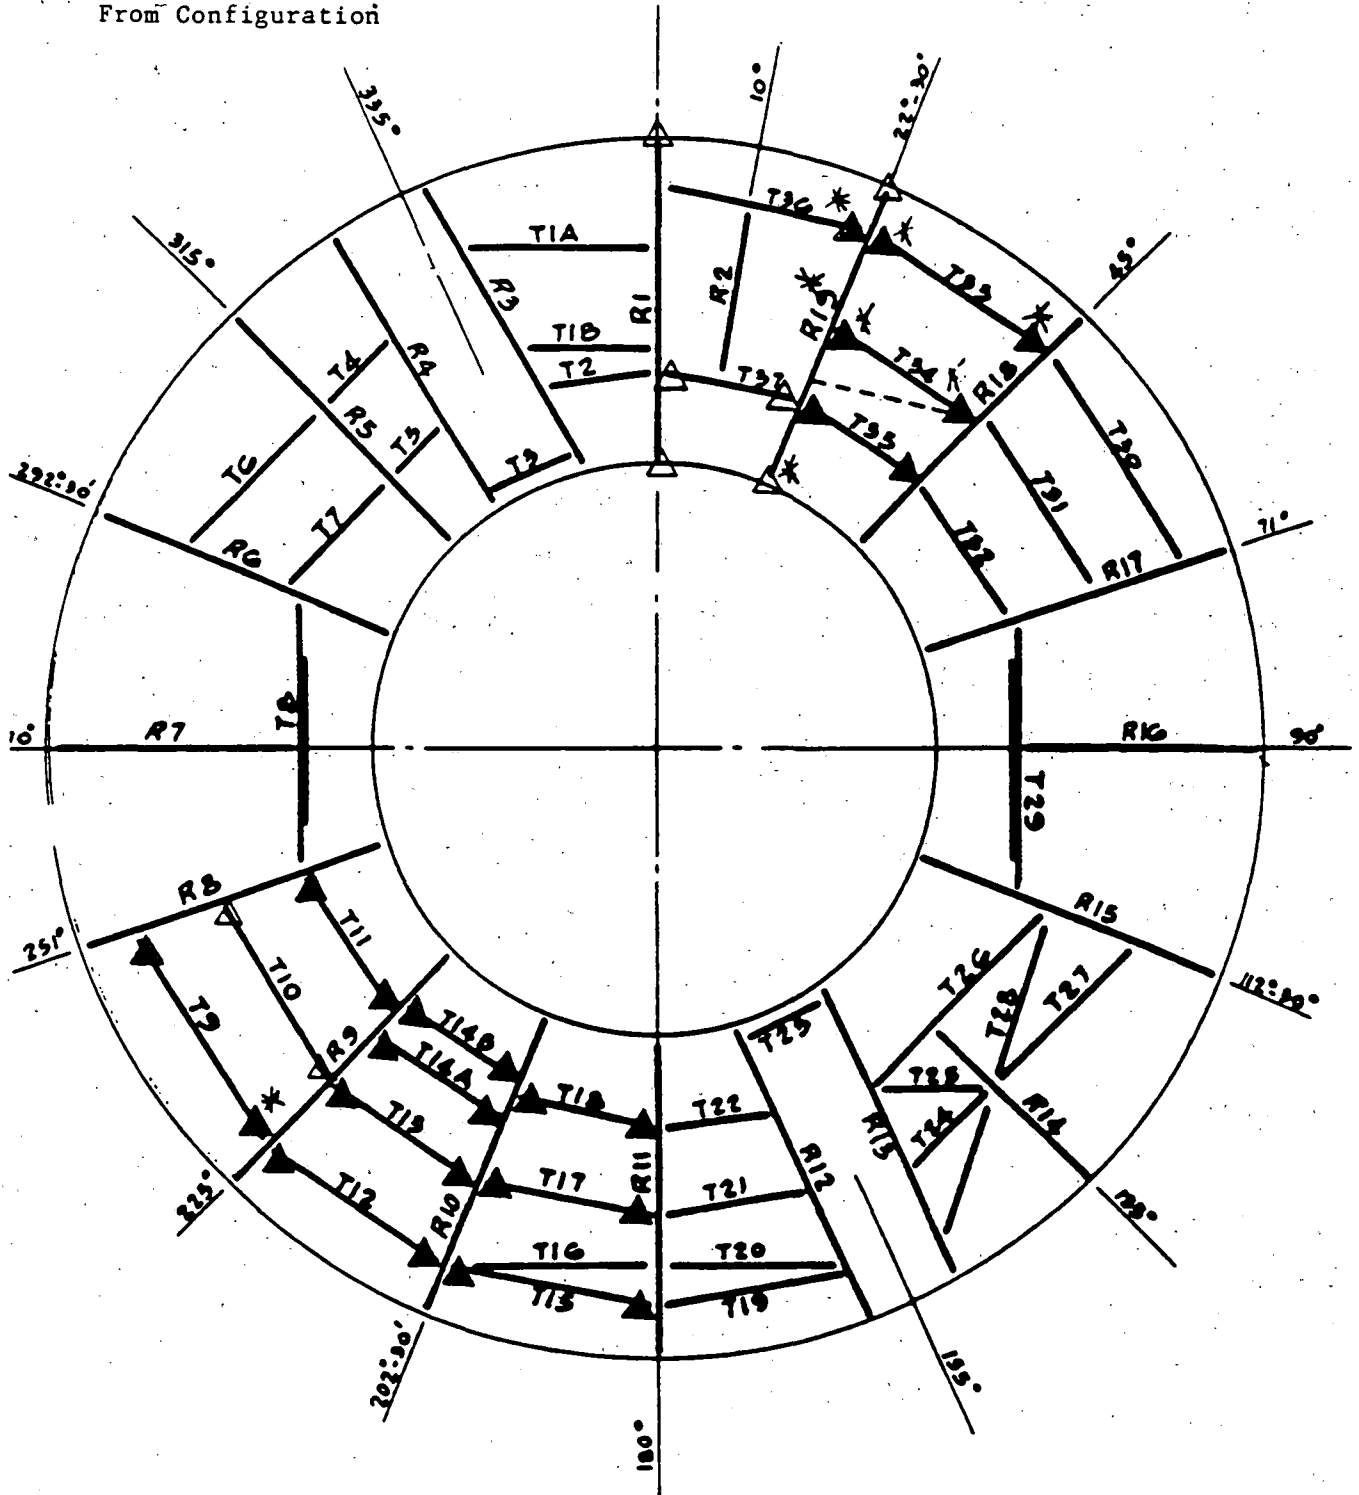
FIGURE 2

FRAMING PLAN AT EL. 597.0'
