**Commonwealth Edison**  
One First National Plaza, Chicago, Illinois  
Address Reply to: Post Office Box 767  
Chicago, Illinois 60690 - 0767

Subject: Dresden Station Units 2 and 3  
Quad Cities Station Units 1 and 2  
Zion Station Units 1 and 2  
LaSalle Station Units 1 and 2  
Byron Station Units 1 and 2  
Braidwood Station Units 1 and 2  
Response to NRC Bulletin 88-08 &  
88-08: Supplement 1 & 2  
NRC Docket Nos: 50-237/249, 50-254/265, 50-295/304,  
50-373/374, 50-454/455 and 50-456/457

DRESDEN, QUAD CITIES and LASALLE  
COUNTY STATION RESPONSE TO  
NRC BULLETIN 88-08 and 88-08:  
SUPPLEMENT 1&2

ZION STATION RESPONSE TO  
NRC BULLETIN 88-08 and 88-08:  
SUPPLEMENT 1&2

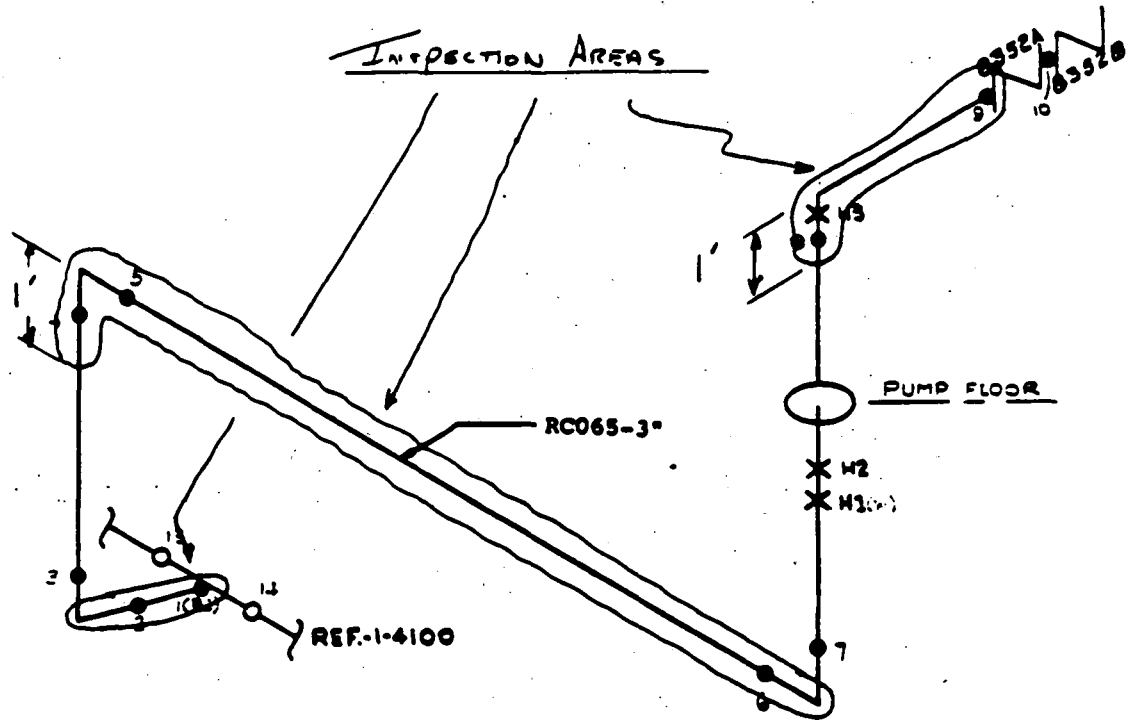
FIGURE Z-1  
(Zion Units 1 & 2)

- a. One (01) Alternate charging line, RC065 (3 inches nominal pipe size);
- b. One (01) Auxiliary Spray Line, RC145 (2 inches nominal pipe size);
- c. Four (04) Charging Pump to Cold Leg Injection lines; RC005, RC038, RC071, RC079 (1.5 inches nominal pipe size);

- a. Alternate charging line (RC065), perform NDE on all horizontal sections and the first vertical section, base metal and welds, from the RCS connection back to the first check valve on line RC065. Examination areas are indicated on figure Z-1.
- b. On the Auxiliary Spray line (RC145), perform NDE on the first horizontal section, base metal and welds back from the main spray line connection. Examination areas are indicated on figure Z-2.
- c. On the SI Cold Leg Injection lines (RC005, RC038, RC071, RC079), perform NDE on the sections, base metal and welds, from the RCS connections back to the first check valves. Examination areas are indicated on figures Z-3, 4, 5 and 6.

- a. Temperature monitoring devices will be installed on the Alternate Charging line and on the Auxiliary Spray line in order to identify the temperature profiles downstream of the potentially leaking isolation valves. The temperature profiles will determine the existence and severity of the problem. These temperature profiles will be taken immediately upon each unit startup and immediately after manipulation of one of the subject valves. Completion dates are: Unit 1 - end of 1989 refueling outage, Unit 2 - end of 1988 refueling outage.

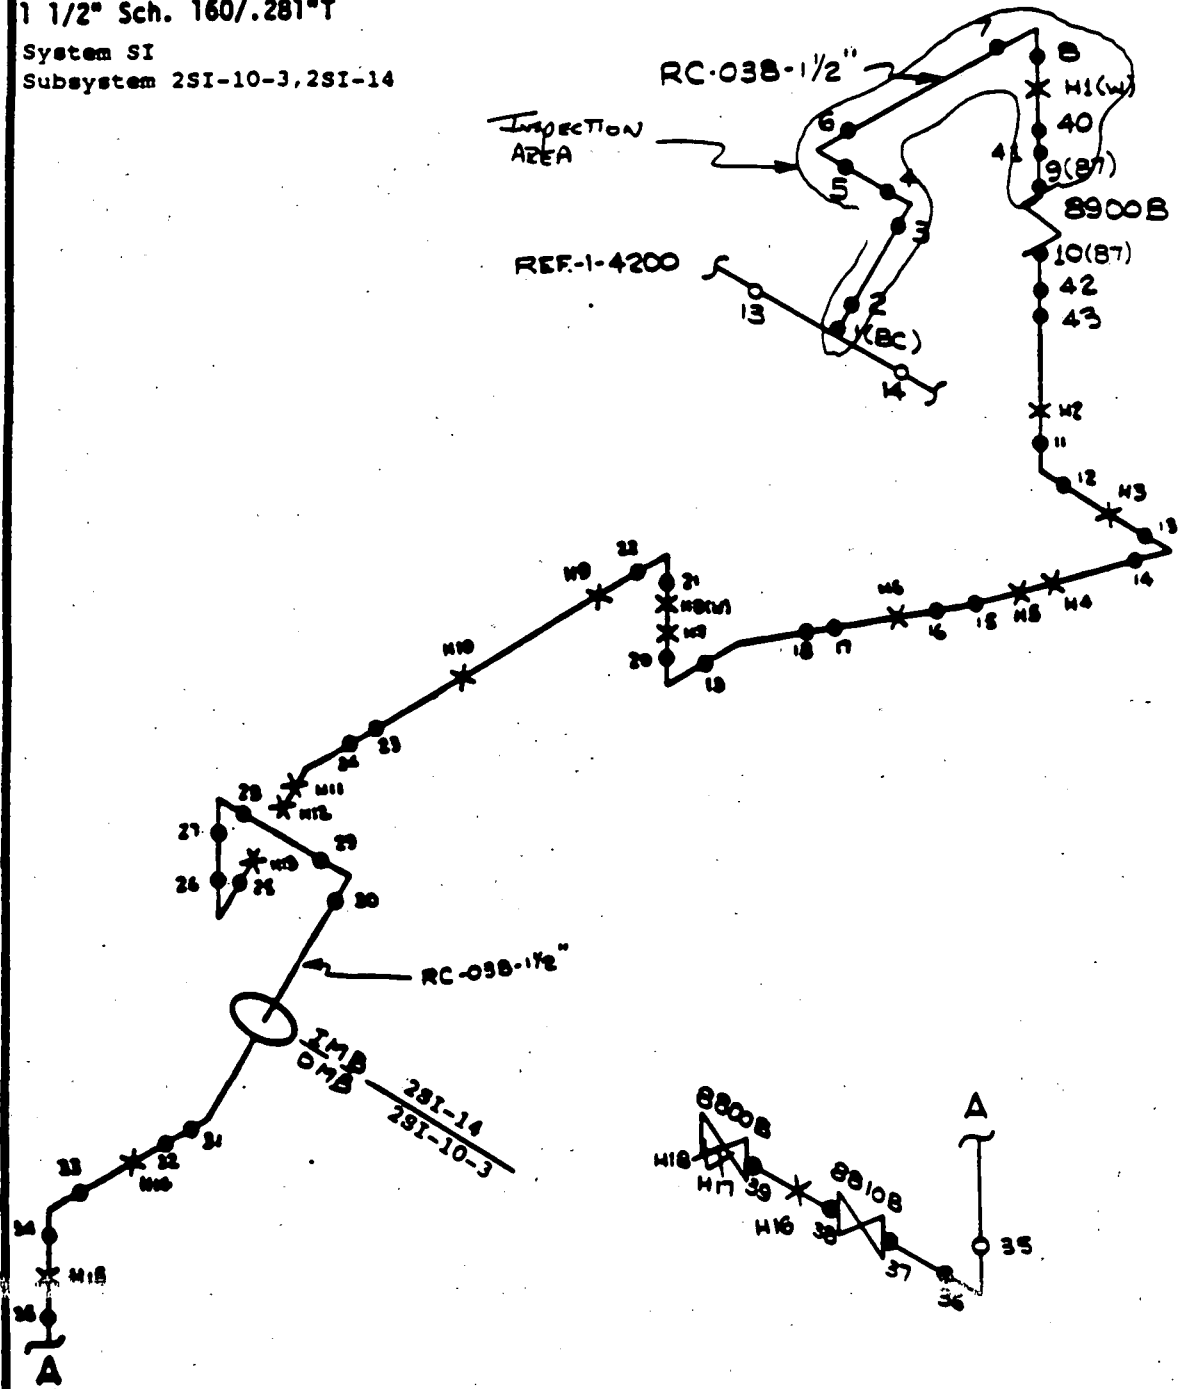
FIGURE Z-4  
(Zion Units 1 & 2)

Modification 1987-Valve 8900B Replaced and Welds 40 thru 43 Added

- b. For the SI Cold Leg Injection Lines (RC005, RC038, RC071, RC079) the following actions will be taken.
  1. Develop and implement a procedure to test valve SI8925 "BIT Bypass" for seat leakage. If the valve is determined to have leakage through, a repair should be made at the earliest opportunity. This test should be performed each time the valve is manipulated and upon each unit start up. This is considered an interim measure as the BIT removal modification will remove the bypass line and valve from service. (Test Completion by September 20, 1988)

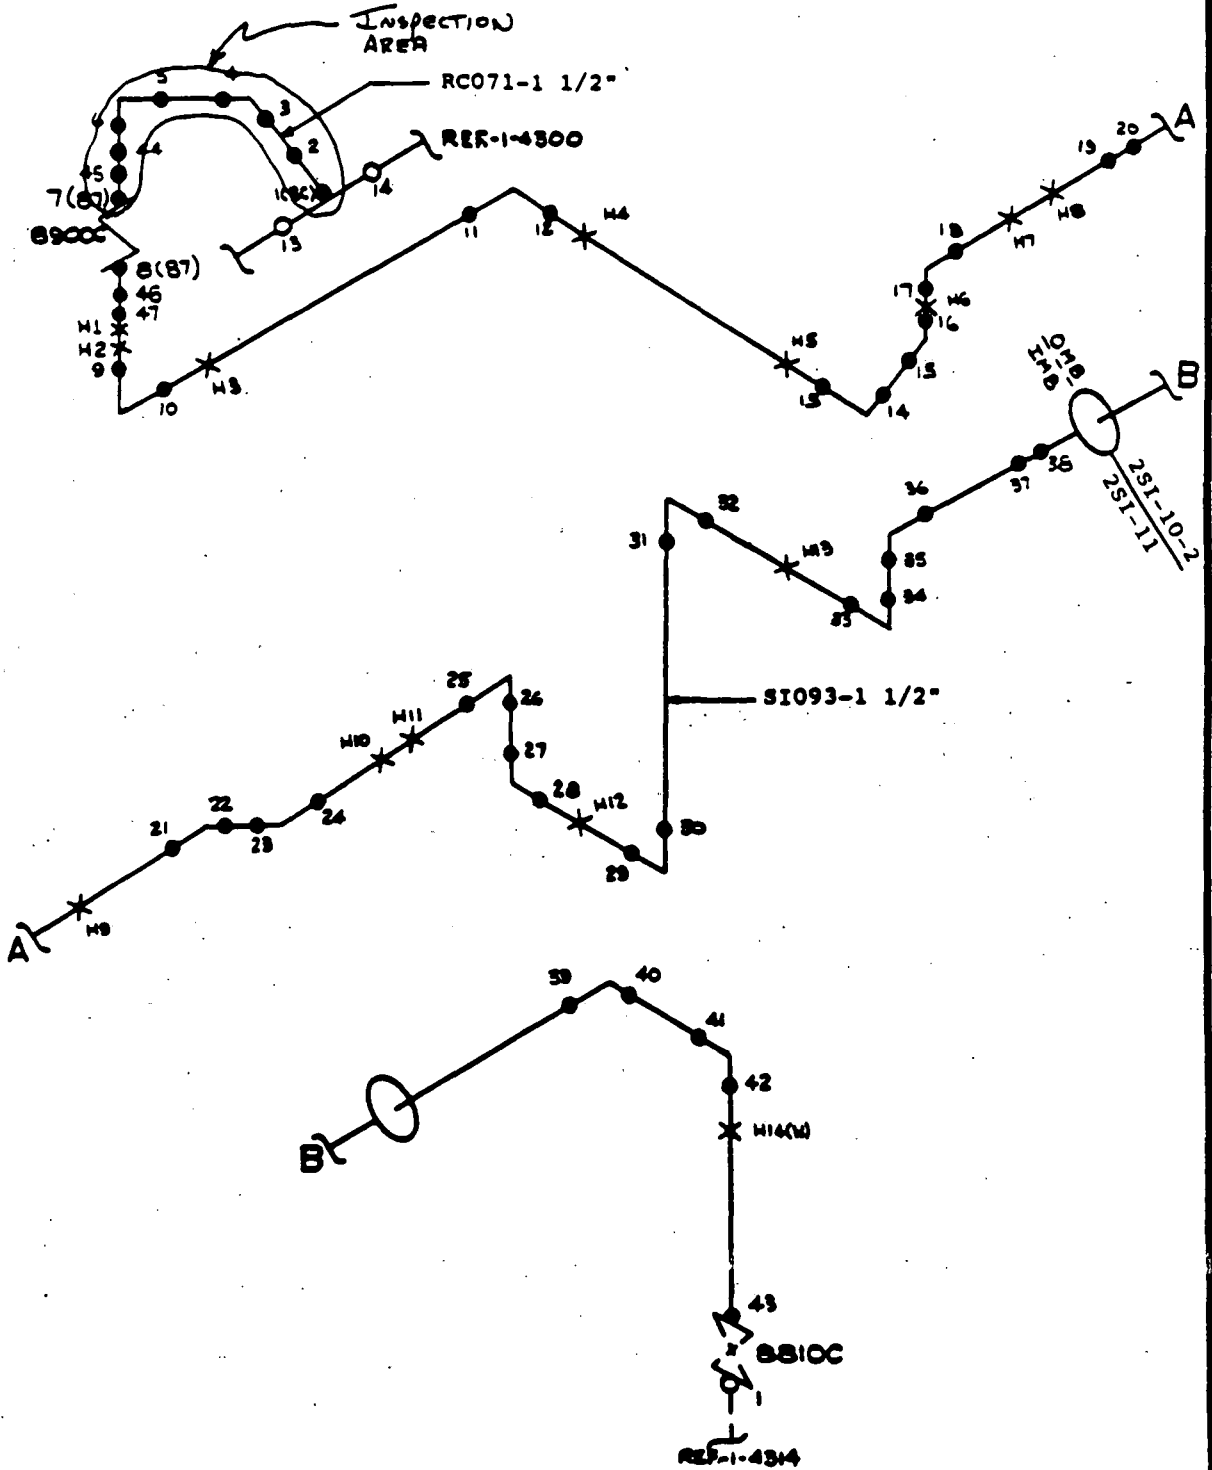
FIGURE Z-5  
(Zion Units 1 & 2)

Modification 1987-Valve 8900C Replaced and Welds 44 thru 47 Added

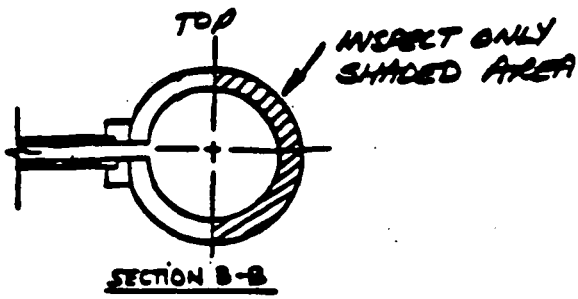
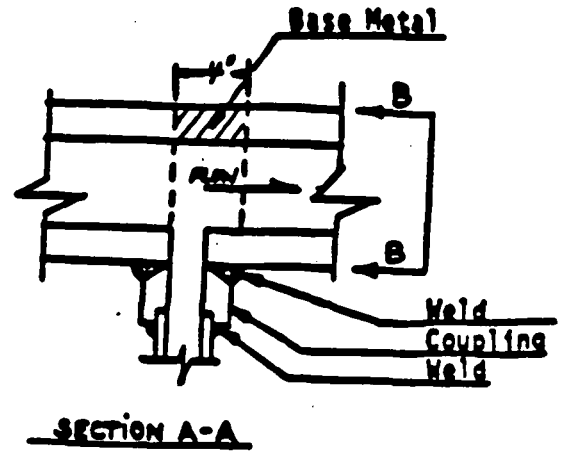
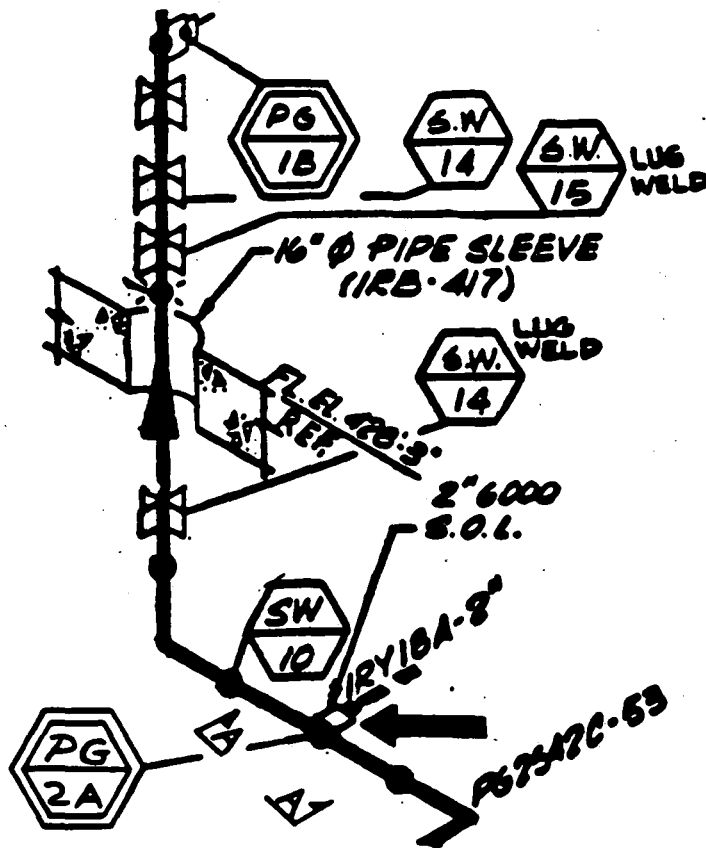
FIGURE B-1: Auxiliary Spray Line  
(Braidwood/Byron Units 1 & 2)

- a. One (01) Auxiliary Spray Line (2 inches nominal pipe size).
- b. Four (04) Charging Pump to Cold Leg Injection lines (1.5 inches nominal pipe size).

- a. During the current Byron Unit 1 refueling outage (began September 2, 1988) the high stress areas on the Auxiliary Spray line will be non-destructively examined. The 2-inch socket weld at the RCS piping connection will receive a surface examination and a portion of the 6-inch main spray piping will be ultrasonically examined. Because a proven Commonwealth Edison (CECo) ultrasonic examination procedure for small diameter piping (3-inch nominal diameter or less) does not exist at this time, an additional ultrasonic examination will not be performed at this time for the horizontal section of piping upstream of the 2-inch socket weld. Also, a stress analysis of the Auxiliary Spray line will be performed. If the stress analysis indicates that the Auxiliary Spray line is susceptible to fatigue failure and a proven ultrasonic examination procedure for small diameter piping is available, then the horizontal section of the Auxiliary Spray line immediately upstream of the 2-inch socket weld will be ultrasonically examined during the NEXT Unit 1 refueling outage (in 1990).

The necessity of performing NDE on the high stress areas on the Auxiliary Spray line at Byron Unit 2 will be determined by a stress analysis of the pipe. If the stress analysis indicates that the pipe is susceptible to fatigue failure, the 2-inch socket weld at the RCS connection will receive a surface examination and a portion of the 6-inch main spray piping will be ultrasonically examined. Additionally, if a proven CECo ultrasonic examination procedure for small diameter piping is available in time, the horizontal section of piping upstream of the 2-inch socket weld will be examined ultrasonically. In the event that NDE of the Byron Unit 2's Auxiliary Spray line is required, the examinations will be performed during the next Unit 2 refueling outage scheduled to begin in January, 1989. See figure B-1 for the applicable NDE areas.

- a. In order to assure that the Auxiliary Spray Line on Byron Unit 1 will not be subjected to cyclic thermal stresses that could cause fatigue failure, appropriate sections of the piping will be instrumented with external temperature monitoring devices. The outputs of these devices will be evaluated to determine if leakage past the single isolation valve from the charging system is occurring. The temperature monitoring devices will be installed on Unit 1 prior to the end of the second refueling outage (scheduled to begin September 2, 1988). If a pending stress analysis of the line concludes that the Auxiliary Spray line is not susceptible to fatigue failure, then the temperature monitoring devices may be removed. The necessity to

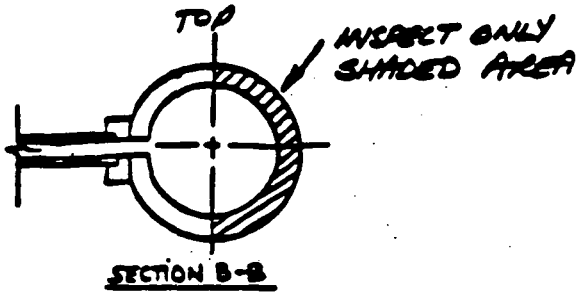
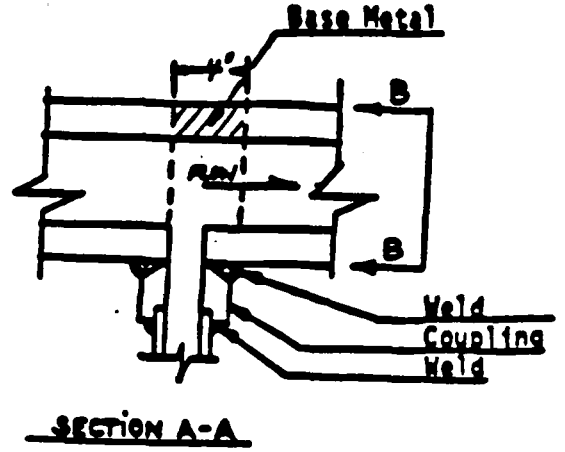
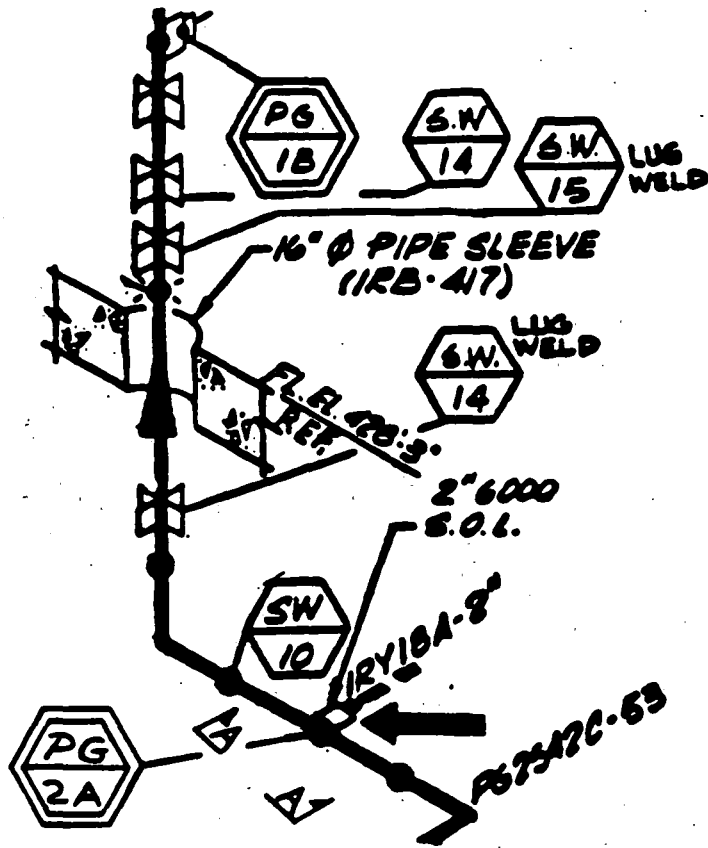
FIGURE B-1: Auxiliary Spray Line  
(Braidwood/Byron Units 1 & 2)

- a. One (01) Auxiliary Spray Line (2 inches nominal pipe size);
- b. Four (04) Charging Pump to Cold Leg Injection lines (1.5 inches nominal pipe size).

- a. The necessity of performing NDE on the high stress areas on the Auxiliary Spray line will be determined by a stress analysis of the pipe. If the stress analysis indicates that the pipe is susceptible to fatigue failure, the 2 inch sockolet at the RCS piping connection will receive a surface examination and a portion of the 6 inch main spray piping will be ultrasonically examined. Additionally, if a proven Commonwealth Edison (CECo) ultrasonic examination procedure for small diameter piping (3-inch nominal diameter or less) is available in time, the horizontal section of piping upstream of the 2-inch sockolet weld will be examined ultrasonically. In the event that NDE of the Auxiliary Spray line is required, the examinations will be performed during the Unit 1 first refueling outage scheduled to begin in September 1989, and during the Unit 2 first refueling outage scheduled to begin in March, 1990. See figure B-1 for the applicable NDE areas.

- a. If the stress analysis indicates that the Auxiliary Spray line at Braidwood Units 1 and 2 is susceptible to fatigue failure, appropriate sections of the piping will be instrumented with external temperature monitoring devices. In the event that temperature monitoring devices are required, they will be installed during the Unit 1 first refueling outage scheduled to begin in September, 1989, and during the Unit 2 first refueling outage scheduled to begin in March, 1990.
