LICENSEE EVENT REPORT (LER)

Facility Name (1) Dresden Nuclear Power Station, Unit 2										Docket Number (2) 0   5   0   0   0   2   3   7				Page (3) 1   of   1   0			
Title (4) Reactor Scram During Power Operation Due to Low Reactor Water Level Resulting From an Unanticipated Closure of the 2B Feedwater Regulating Valve																	
Event Date (5)			LER Number (6)				Report Date (7)			Other Facilities Involved (8)							
Month	Day	Year	Year	Sequential Number	Revision Number	Month	Day	Year	Facility Names		Docket Number(s)						
0   7	1   7	8   7	8   7	0   2   3	0   1	1   0	2   5	8   8	N/A		0   5   0   0   0						
OPERATING MODE (9) POWER LEVEL (10) 0   8   4			THIS REPORT IS SUBMITTED PURSUANT TO THE REQUIREMENTS OF 10CFR (Check one or more of the following) (11) N <input type="checkbox"/> 20.402(b) <input type="checkbox"/> 20.405(c) <input checked="" type="checkbox"/> 50.73(a)(2)(iv) <input type="checkbox"/> 73.71(b) <input type="checkbox"/> 20.405(a)(1)(i) <input type="checkbox"/> 50.36(c)(1) <input type="checkbox"/> 50.73(a)(2)(v) <input type="checkbox"/> 73.71(c) <input type="checkbox"/> 20.405(a)(1)(ii) <input type="checkbox"/> 50.36(c)(2) <input type="checkbox"/> 50.7

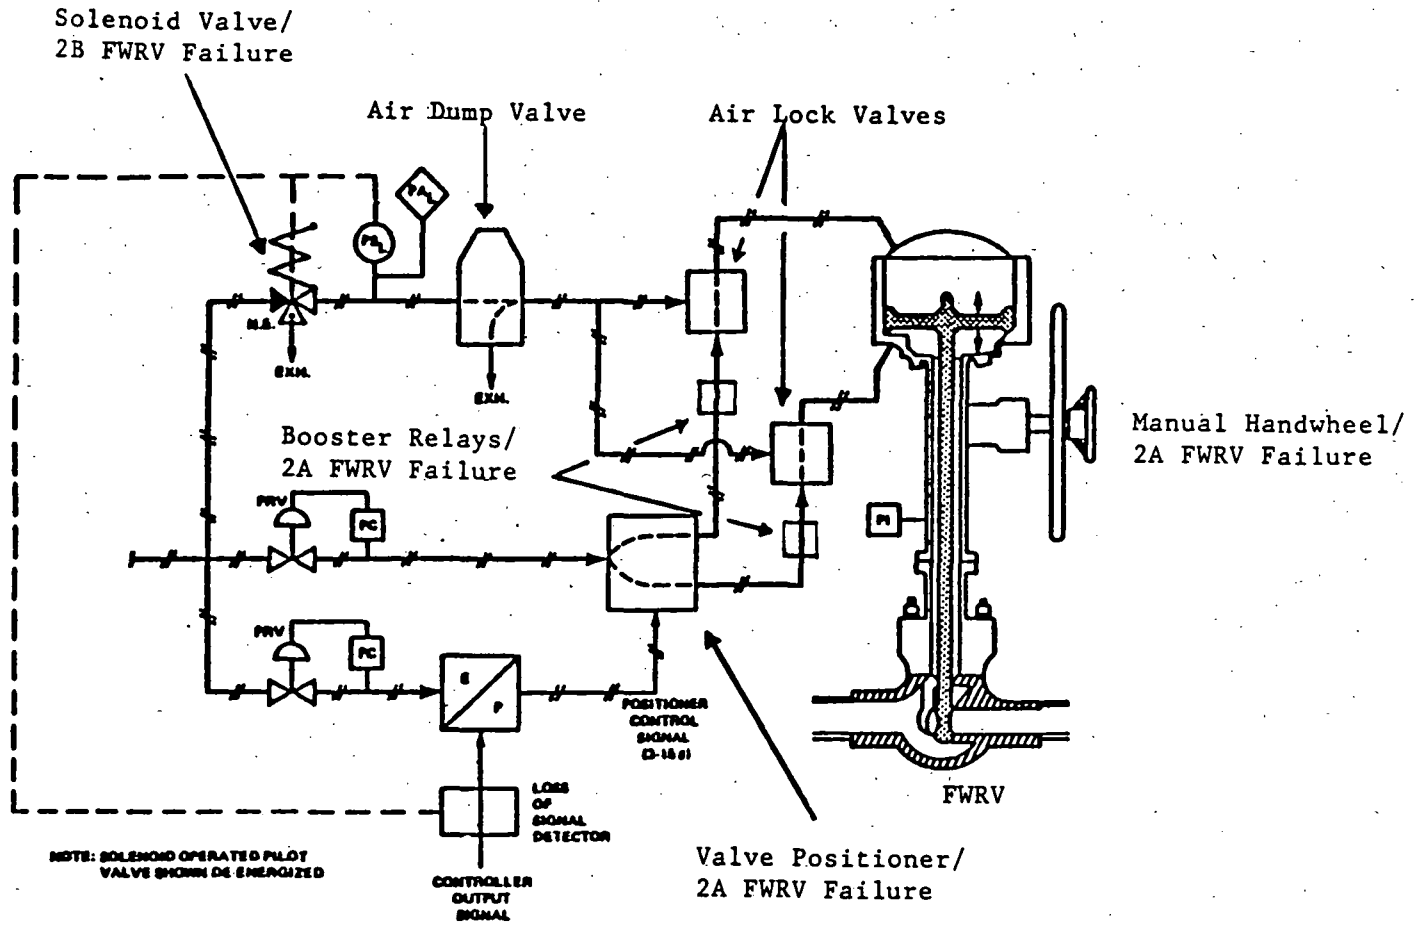
FIGURE 1

Either of these conditions causes a solenoid operated valve to deenergize, thus interrupting and bleeding off the air to a dump valve. See Figure 1. The air dump valve is spring loaded and when spring tension overcomes air pressure (65 psig), the air dump valve exhausts air from the air lock valves. The air lock valves then reposition closed to interrupt any air signal from the positioner and locks-out the air in the valve operator preventing any position change. The Instrument Maintenance Department inspected the feedwater level control circuitry; however, no problems were discovered. Subsequently, the 2B FWRV and the low flow FWRV were placed in the automatic mode of operation.
