LICENSEE EVENT REPORT (LER)

Facility Name (1) Dresden Nuclear Power Station, Unit 2	Docket Number (2) 0 5 10 10 10 12 13 17	Page (3) 1 of 0 7
--	--	----------------------

Title (4) Leak Rate Limits Exceeded in Drywell Head Seal and MSIV 2-203-1D Tests  
Due to Misalignment and Seat Wear

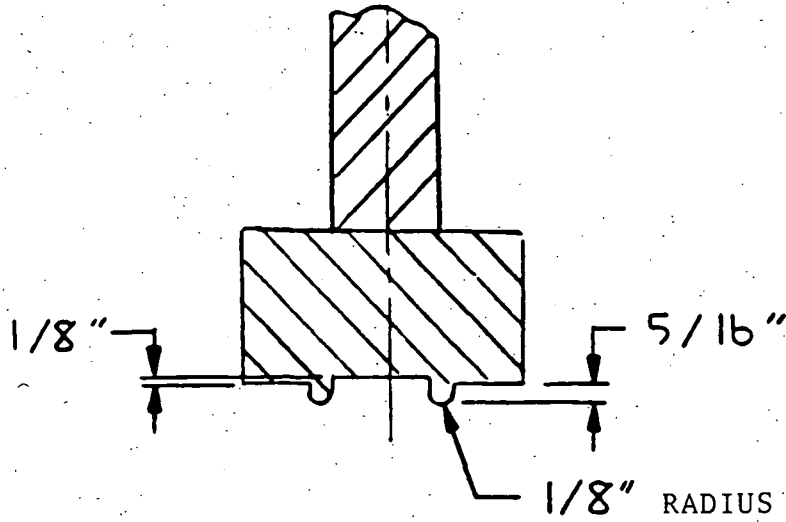
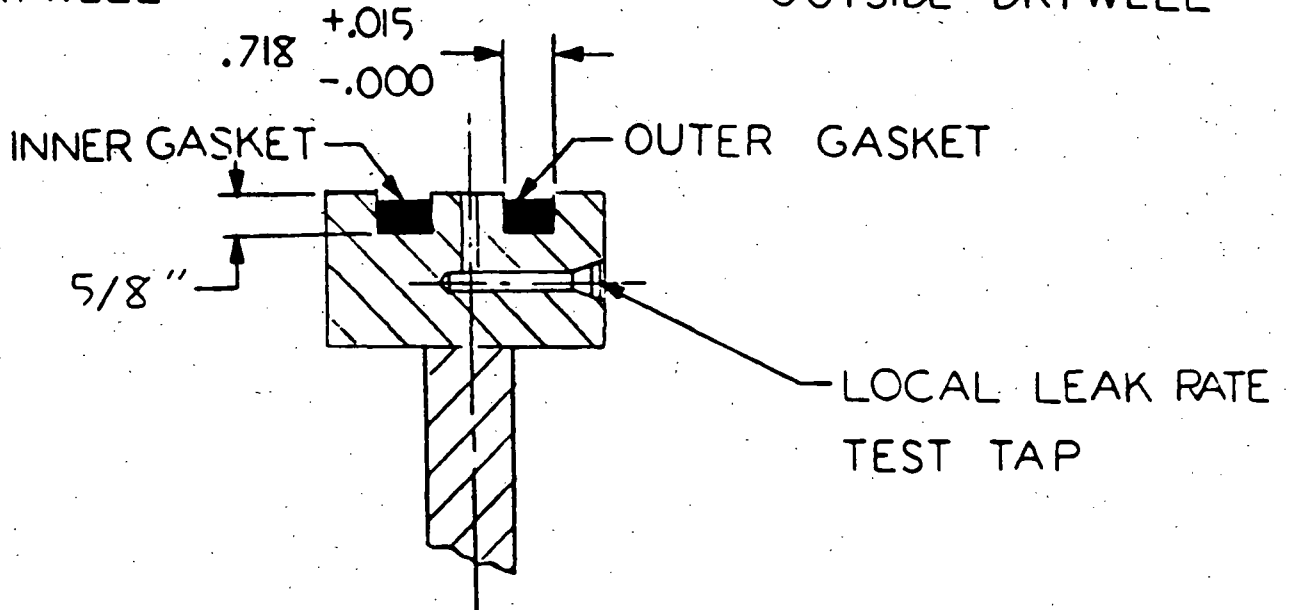
Figure 1

The arrangement of the drywell head, gaskets, and drywell head flange are shown in Figure 1. Rounded "knife edges" on the drywell head are designed to seat on the inner and outer gaskets on the drywell head flange. The endless gaskets used are 3/4" wide by 1/2" thick.

Improper seating of the outer gasket is believed to have resulted from the intermediate cause of that section of the outer gasket not being fully inserted in the drywell head flange groove prior to installation of the drywell head. As shown in Figure 1, the knife edges are rounded with a 1/8" radius. Therefore any section of the gasket extending more than approximately 1/8" above the drywell head flange would have been caught by the knife edge when the southeast section of the drywell head was jacked inward to allow the knife edges to seat into the grooves. This conclusion is further supported by the fact that the improperly seated length of outer gasket was located in the southeast section of the drywell head flange.

DOUBLE - GASKETED  
DRYWELL HEAD SEAL

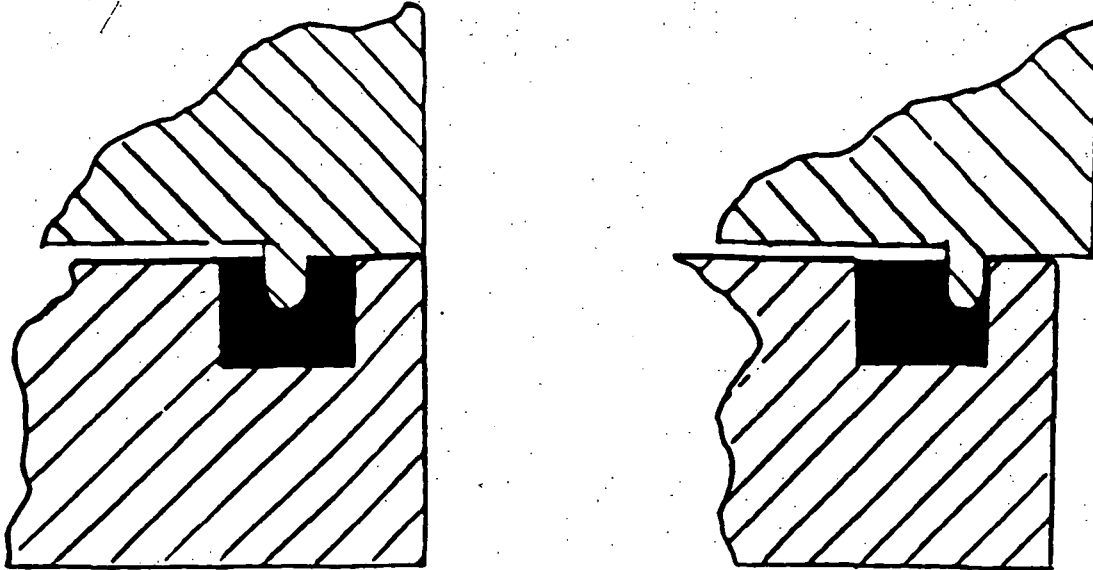
Figure 2

Following removal of the drywell head on October 31, 1988, a continuous impression from the inner knife edge was seen on the inner gasket for the full circumference of the drywell head flange. Examples of normal gasket seating are illustrated in Figure 2. No damage to either knife edge was observed and the gasket material was found to be pliable.

NORMAL GASKET SEATING EXAMPLES

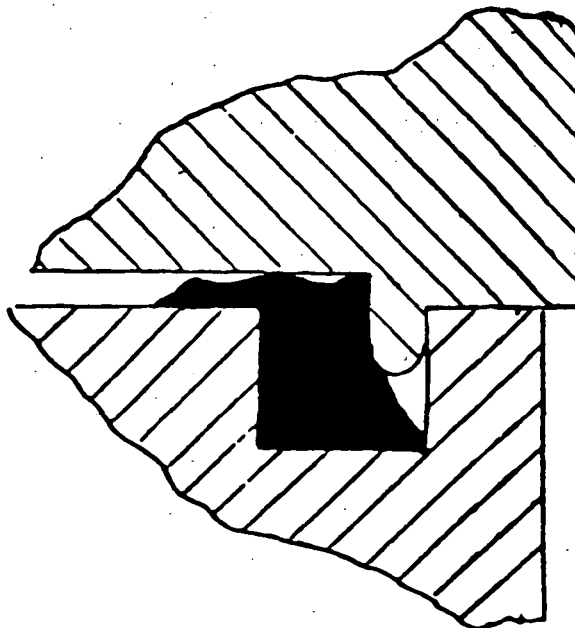
Figure 3

However, for approximately six inches of the outer gasket, the knife edge was beside rather than atop the outer gasket, and a portion of the gasket material appeared to have been forced into the normally empty volume between the two knife edges. This improper gasket seating is illustrated in Figure 3. It was concluded that the leakage path was caused by this improperly seated outer gasket.

The low leakage rate observed following installation is evidence that the inner gasket provided a tight seal and that the outer gasket initially made sufficient contact with the knife edge to provide a tight seal. The six inch section of the outer gasket apparently pulled away from the side of the knife edge due to the thermal cycling of the drywell head flange during operation and subsequent cooldown, thus providing the leakage path.

DMP 1600-5 was reviewed and found to contain inadequate instructions for ensuring that the gaskets were properly inserted into the grooves prior to installation of the drywell head. The root cause of the drywell head seal leakage was therefore attributed to procedure deficiency.

IMPROPER GASKET SEATING EXAMPLE

Prior to unit startup, DMP 1600-5 will be revised to require a Quality Control inspection to ensure that the gaskets are properly inserted into the grooves in the drywell head flange prior to installing the drywell head (237-200-88-13101). DTS 1600-15 will also be revised to include troubleshooting guidance should a double-gasketed seal show significant leakage during an LLRT (237-200-88-13102). Gaskets currently in stock for the drywell head flange will be verified to be of the proper material prior to use (237-200-88-13103). A supplement to this report will then be submitted to provide the retest results and the final Type B and C leak rate test results; included with the supplement will be a tabulation of all the testable penetration maximum and minimum pathway leakages (237-200-88-13104).
