LICENSEE EVENT REPORT (LER)

Facility Name (1) Dresden Nuclear Power Station, Unit 2 Docket Number (2) 0 5 10 10 10 12 13 17 Page (3) 1 of 2 7

Title (4) Heat Damage to Upper Elevation Drywell Components Due to Closed Ventilation Hatches

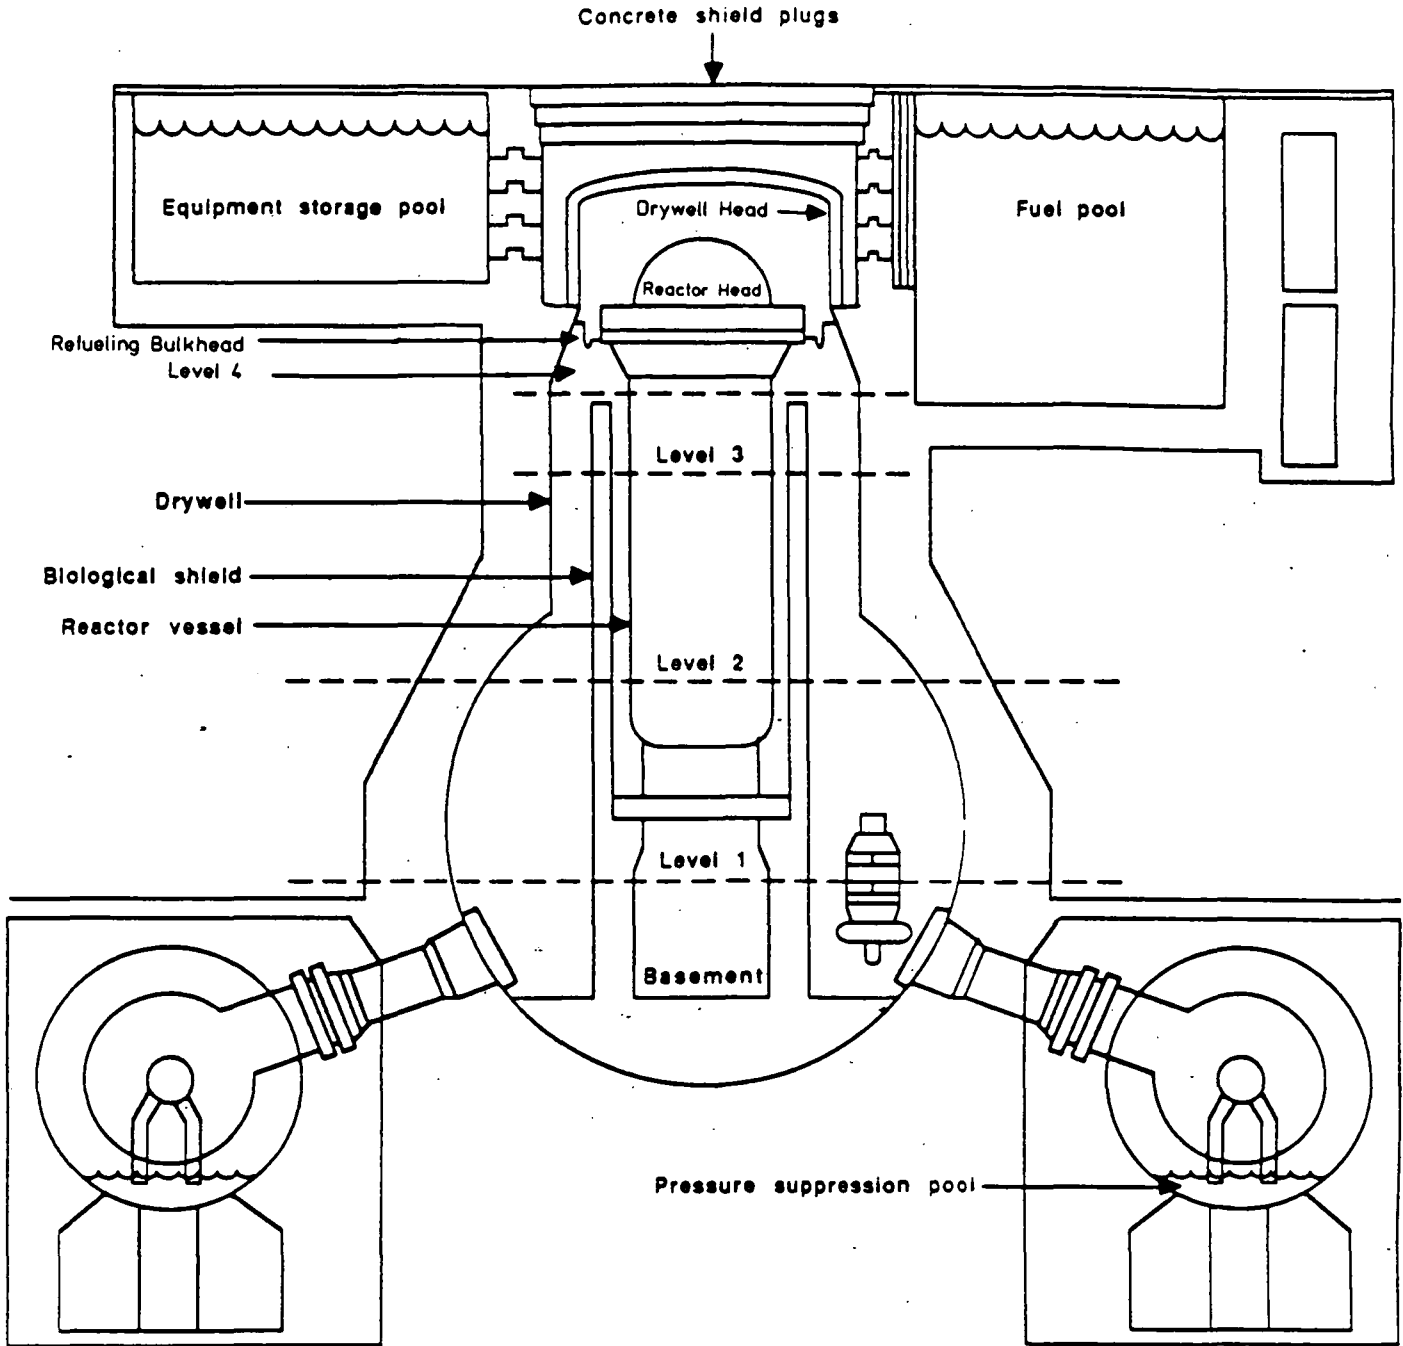
DRESDEN UNIT 2 DRYWELL
FIGURE 1

Dresden Unit 2 was shutdown on October 29, 1988, for a scheduled refueling outage. The first indication of heat damage was peeling and discolored paint observed by Mechanical Maintenance Department personnel on October 30, 1988, while removing shield plugs from the top of the reactor well. See Figure 1.

The initial indication of the apparent cause of the heat damage to the paint was seen on October 31, 1988, when the drywell head [NH] was removed and the four ventilation hatches in the refueling bulkhead were found closed. It should be noted that the two manway hatches in the refueling bulkhead were found open. Figure 2 shows the location of six hatches in the refueling bulkhead (the ceiling of the fourth elevation). Normal ventilation to the reactor head area is through the two supply hatches and then downward through the two return hatches and two manway hatches. All six hatches should have been open. Figure 3 shows drywell cooling system temperature data from various thermocouples located in the drywell. Figures 4 and 5 show details of air flow to the fourth drywell elevation and to the fifth drywell elevation (reactor head area).

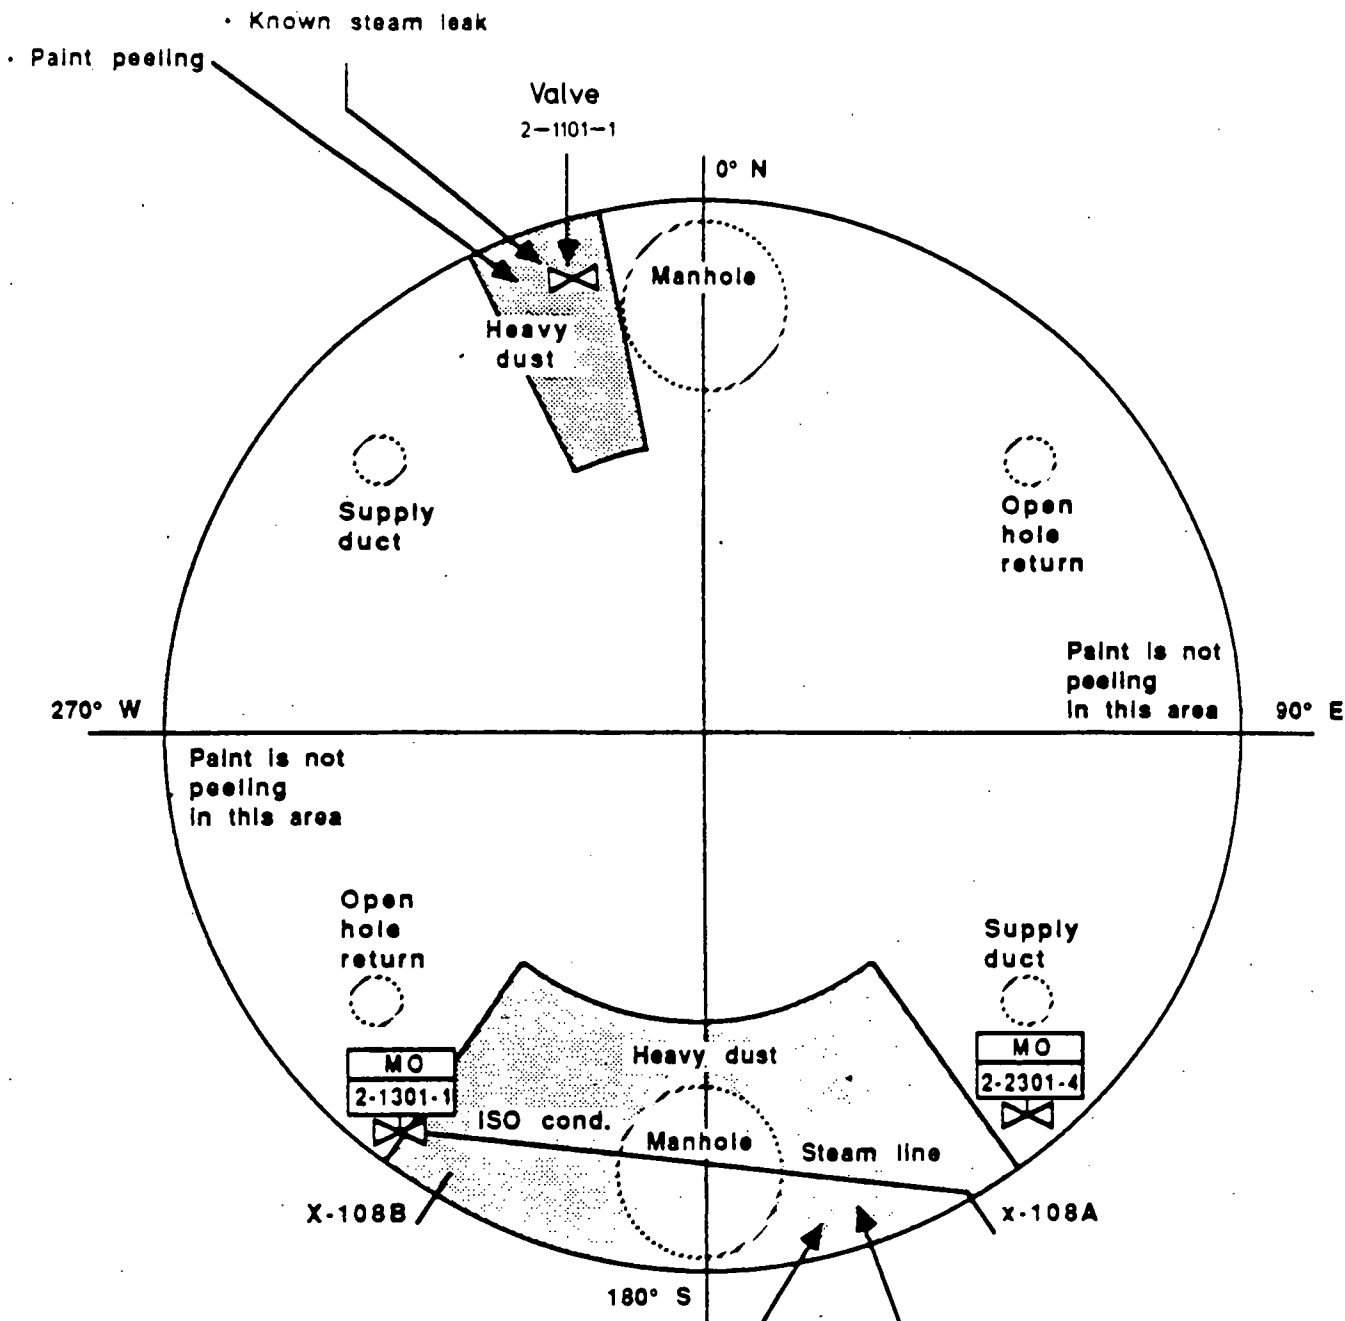
During a radiation survey of the fourth drywell elevation on August 26, 1987, red dust was noted in the vicinity of Standby Liquid Control [BR] inboard isolation valve 2-1101-1 but not in other areas. Figure 2 shows the floor plan of the fourth drywell elevation and includes major steam lines. Dresden Unit 2 was shutdown for a scheduled dual unit maintenance outage from May 14, 1988 to May 29, 1988. During the dual unit outage, a radiation survey of the fourth drywell elevation on May 18, 1988, noted red dust between valves M02-1301-1 and M02-2301-4. As discussed in Section C, Apparent Cause of Event, the major source of the red dust was apparently the excessive temperatures in the upper drywell elevations.

Dust also appeared in radiation survey 5-18-88 (Dual unit outage)

- Heavy dust in this area
- Paint is peeling, concentrated around the manhole
- Top rungs of ladder showed no evidence of dust
- Piles of dust where bulkhead beam connects into drywell liner

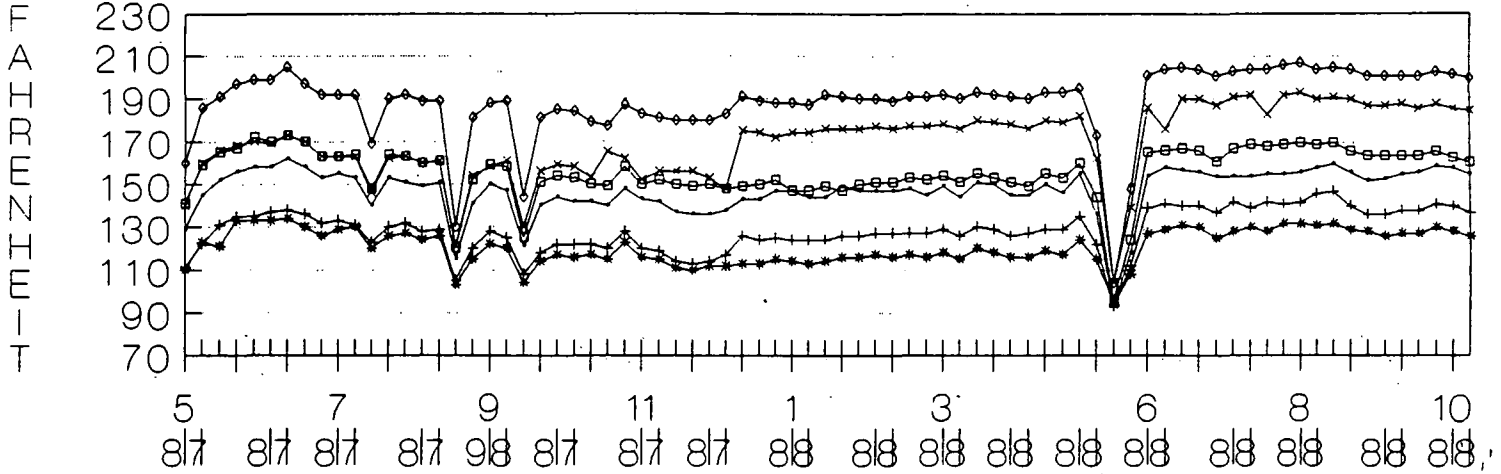
RECORDER 2-260-20B

In general, peak temperatures for 1988 were approximately equal to those for 1987. One exception was the temperature reading in the south section of the second elevation (point T9). This reading showed a step increase of approximately 22 degrees F for the week of December 17, 1987, and remained high throughout 1988. The cause of this step increase was attributed to 2A drywell cooler [VB] (one of seven) being taken out of service due to failure of blower motor 2-5788-A on December 15, 1987. The failure of the blower motor was caused by water leaking from a pipe union on the bottom head drain line.
