LICENSEE EVENT REPORT (LER)

Facility Name (1) Dresden Nuclear Power Station, Unit 2 Docket Number (2) 0 5 10 10 10 2 3 7 1 of 0 6 Page (3)

Title (4) ESF Actuation Due to the Loss of Both RPS Busses Caused by Diesel Generator Fuel Filter Fouling

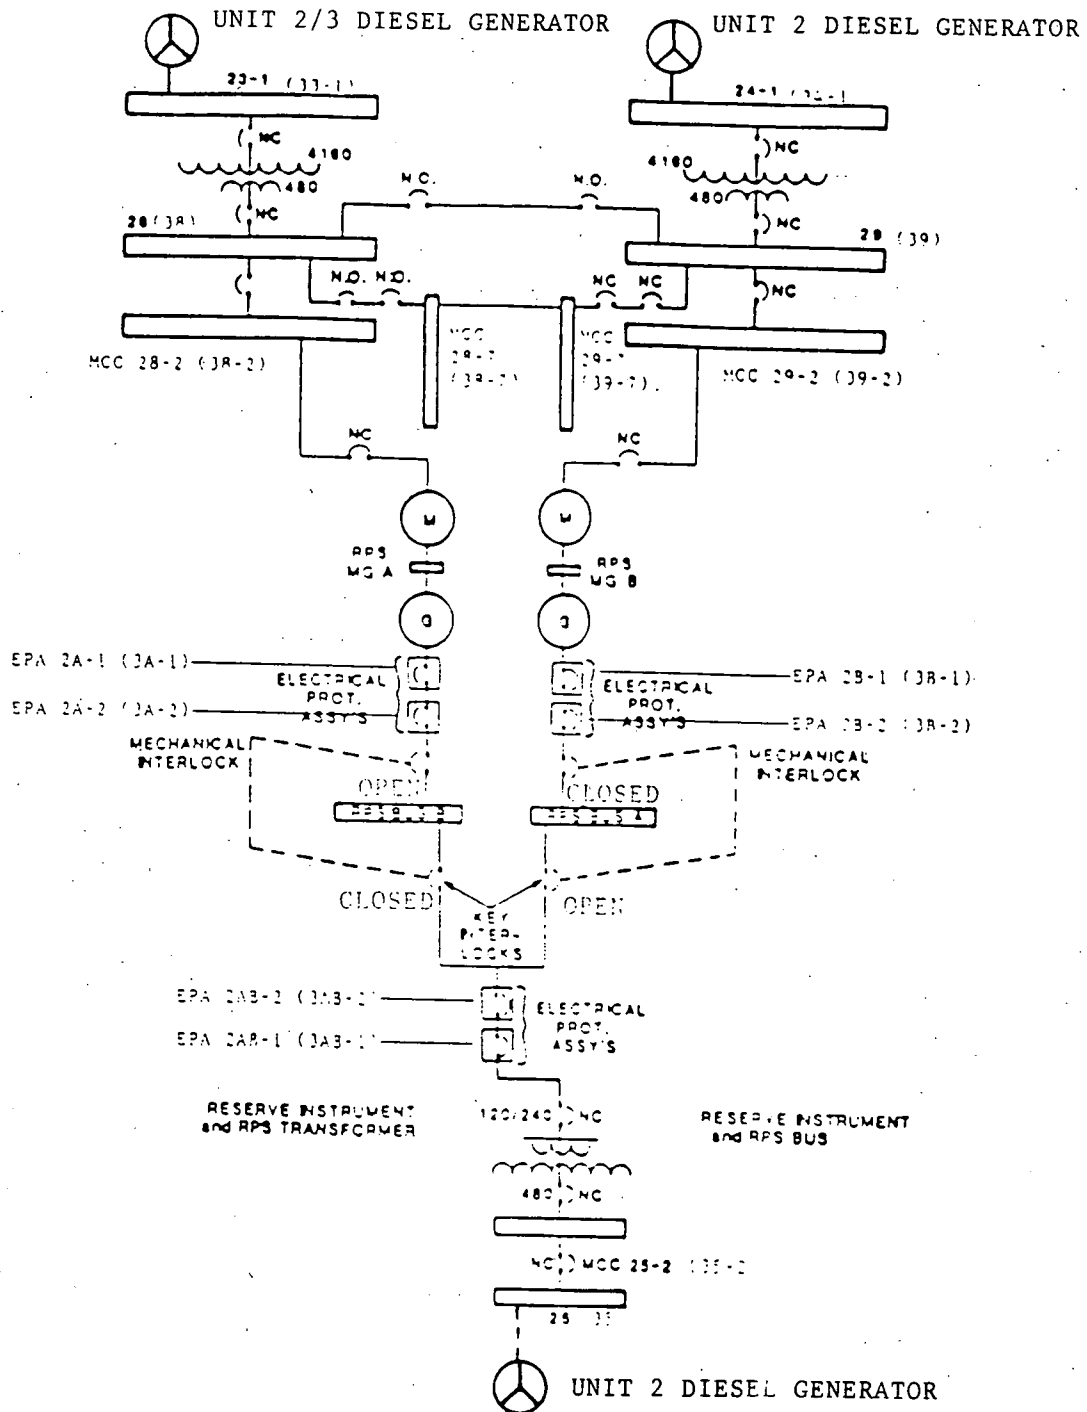
Figure 1

This report is being submitted to comply with 10CFR50.73(a)(2)(iv) which requires the reporting of any unplanned Engineered Safety Feature (ESF) actuation. The intermediate cause of the event has been determined to be the frequency oscillations of the Unit 2 Diesel Generator. The EPA underfrequency relays are set to trip at 56 hz, consequently when the relays actuated the RPS busses were deenergized resulting in a scram signal on both RPS channels. The Control Rod Drive (CRD) [AA] System was not in operation and the CRD accumulators were drained, therefore no CRD movement occurred. The SBTG initiations and Reactor Building System Ventilation isolation also resulted from the deenergization of the RPS busses. The Reactor Building and refuel floor radiation monitors [IL] are fed from RPS. When the monitors are deenergized, the logic circuitry seals in a high radiation signal resulting in the SBTG initiation and Reactor Building Ventilation isolation.

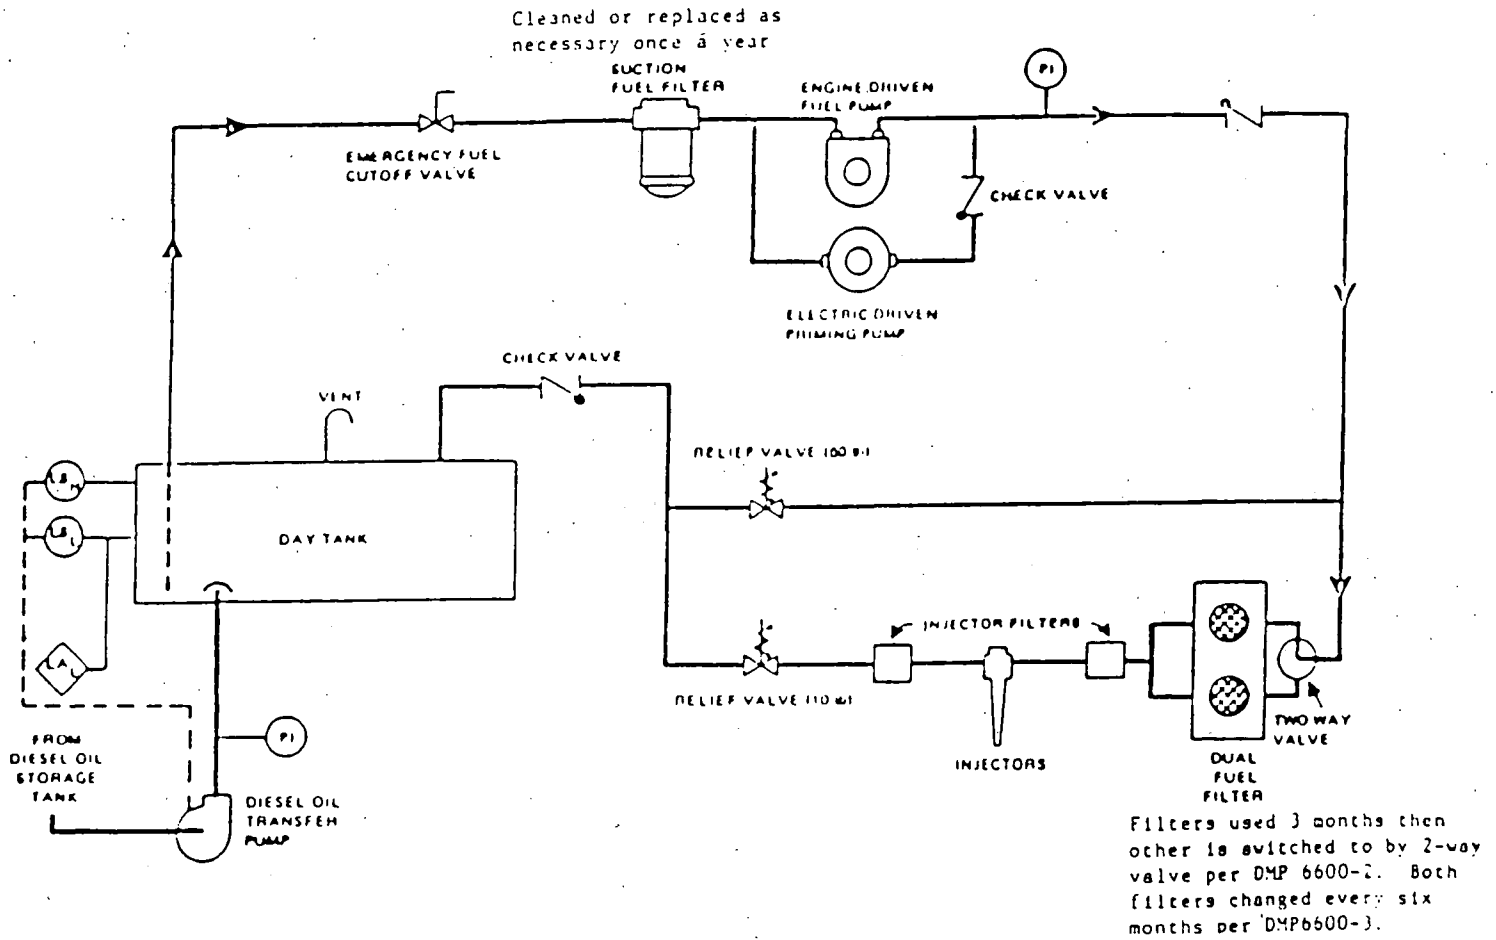
Figure 2

The Control Room frequency meter has a scale from 58 to 62 hz while the local meter has a scale from 56 to 62 hz. Both meters were observed oscillating through their entire range. The frequency oscillations were the result of a fouled fuel filter [DC], which has been determined to be the root cause of this event. The Unit 2 Diesel Generator had been operating for approximately 100 hours when the failure occurred. Conversation with the diesel generator vendor has indicated that the fouling of a fuel filter is not uncommon with a run of this duration. Diesel fuel is inherently dirty and coupled with the agitation of contaminants in the main storage tank by fuel deliveries resulted in the filter becoming fouled.

The diesel engines utilize two fuel filters, a dual filter assembly and a suction fuel filter as shown in Figure 2. The various filters are checked and/or replaced periodically. The dual fuel filter is cycled every three months in accordance with Dresden Maintenance Procedure (DMP) 6600-2, Diesel Generator Three Month Inspection/Mechanical Maintenance Department, and the filter elements are replaced every six months in accordance with DMP 6600-3, Diesel Generator Six Month Inspection/Mechanical Maintenance Department. The suction fuel filter is cleaned or replaced yearly as required in accordance with DMP 6600-4, Diesel Generator Annual and Biennial Mechanical Inspection.

Immediate corrective actions consisted of switching to the other diesel generator fuel filter, flashing the RPS MG set, resetting the EPA relays, energizing the RPS busses and resetting the scram signal. The Reactor Building Ventilation System was placed in operation and SBTG secured. The fuel oil filters were subsequently replaced under Work Request 80921 when TR22 was returned to service. Dresden Operating Surveillance (DOS) 6600-1, Diesel Generator Surveillance Test, was performed to verify the operability of the Unit 2 Diesel Generator. Additional corrective action will consist of replacing the Unit 2/3 Diesel Generator fuel filters during the upcoming maintenance outage (237-200-88-15001). Additionally the High Voltage Operator's (HVO) Round Book will be revised to include a section for critical diesel generator parameters when the engine is running. This section will include fuel pressure and will direct the HVO to switch filters if fuel pressure exceeds 70 psig (237-200-88-15002) in addition to initiating a work request to replace the filter. The filters can be replaced while the engine is running if necessary.
