LICENSEE EVENT REPORT (LER)

Facility Name (1) Dresden Nuclear Power Station, Unit 2 Docket Number (2) 0 15 10 10 10 12 13 17 Page (3) 1 OF 0 4

Title (4) Group II Primary Containment Isolation and Standby Gas Treatment System Initiation Due to Personnel Error

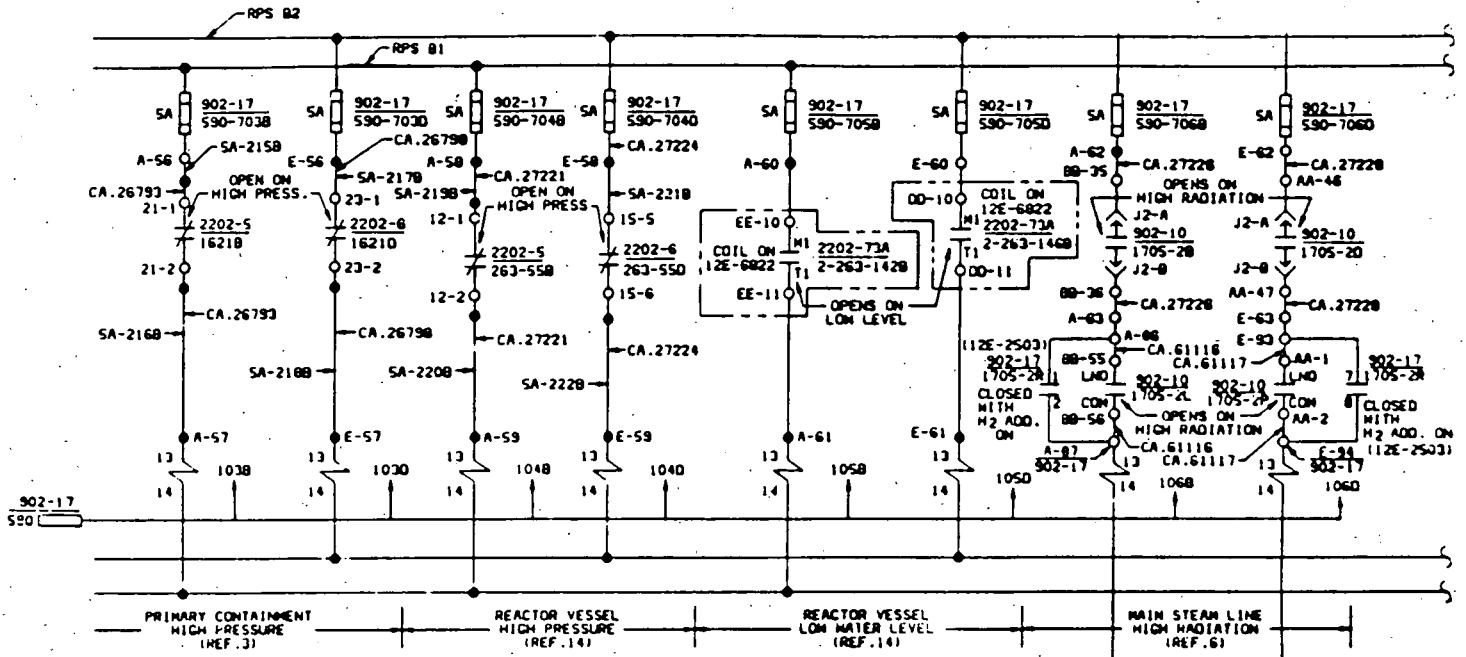
Figure 1

The cause of the Group II Primary Containment Isolation was the loss of power to relay 590-105D when fuse 590-705D was removed. See Figure 1. The root cause of this event is believed to be the fact that the Shift Foreman did not have the Equipment Outage Checklist independently verified by a second Senior Reactor Operator after the changes to the fuse numbers were made. Therefore, this event has been attributed to personnel error. A contributing factor to this event is that the labeling of the fuse block in Panel 902-17 does not adequately identify that there are two different fuse series numbers contained in the same fuse block.

The immediate corrective action was to replace the fuses, secure SGBT and return the RBVS to its normal system lineup. As a long term corrective action, the Operating Department shall instruct all Operating personnel that when changes are made to Equipment Outage Checklists, these changes are to be independently verified prior to processing the outage request (237-200-88-15401). In addition Panels 902(3)-15 and 902(3)-17 will be relabeled to more clearly differentiate the 590 and 595 series fuses (237-200-88-15402). To accomplish this each fuse series shall have a different background color. In addition this event will be reviewed during an upcoming Station tailgate meeting (237-200-88-15403).
