LICENSEE EVENT REPORT (LER)

Facility Name (1) Dresden Nuclear Power Station, Unit 2 Docket Number (2) 0 15 10 10 10 12 13 17 Page (3) 1 of 2 6

Title (4) Heat Damage to Upper Elevation Drywell Components Due to Closed Ventilation Hatches

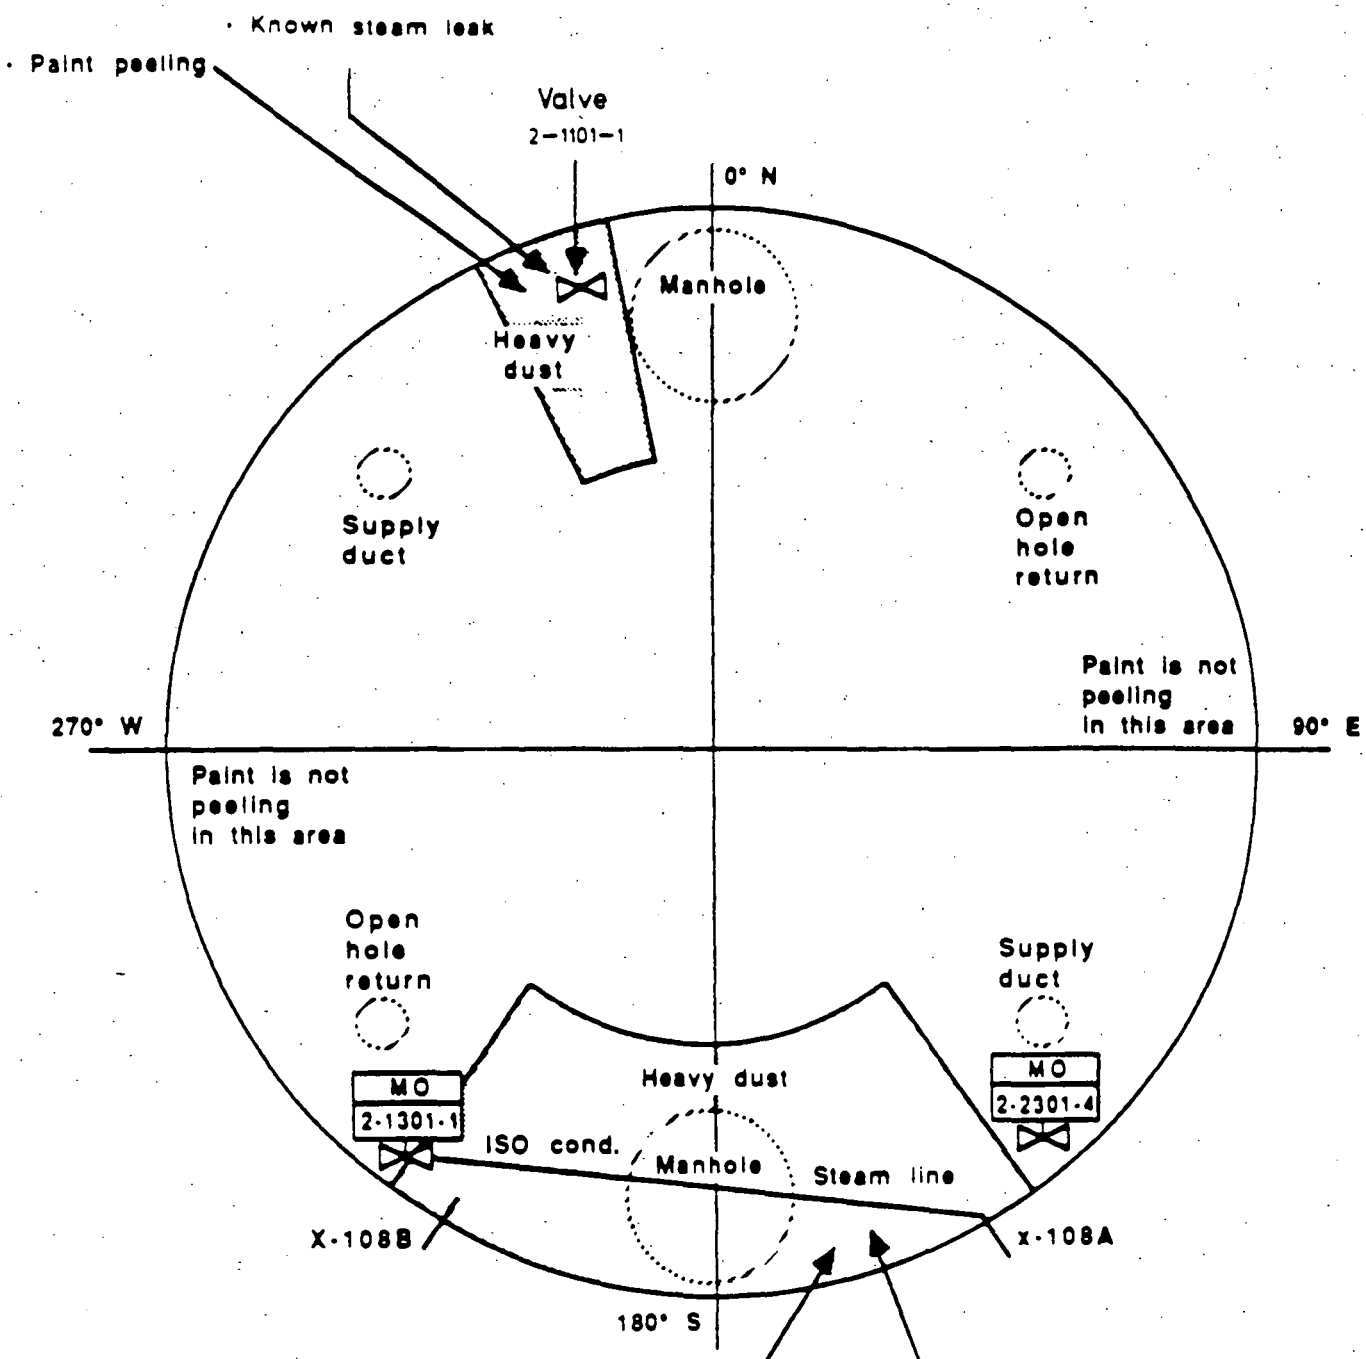
During a radiation survey of the fourth drywell elevation on August 26, 1987, red dust was noted in the vicinity of Standby Liquid Control [BR] inboard isolation valve 2-1101-1 but not in other areas. Figure 2 shows the floor plan of the fourth drywell elevation and includes major steam lines. Dresden Unit 2 was shutdown for a scheduled dual unit maintenance outage from May 14, 1988 to May 29, 1988. During the dual unit outage, a radiation survey of the fourth drywell elevation on May 18, 1988, noted red dust between valves M02-1301-1 and M02-2301-4. As discussed in Section C, Apparent Cause of Event, the major source of the red dust was apparently the excessive temperatures in the upper drywell elevations.

Dust also appeared in radiation survey 5-18-88 (Dual unit outage)

- Heavy dust in this area
- Paint is peeling, concentrated around the manhole
- Top rungs of ladder showed no evidence of dust
- Piles of dust where bulkhead beam connects into drywell liner

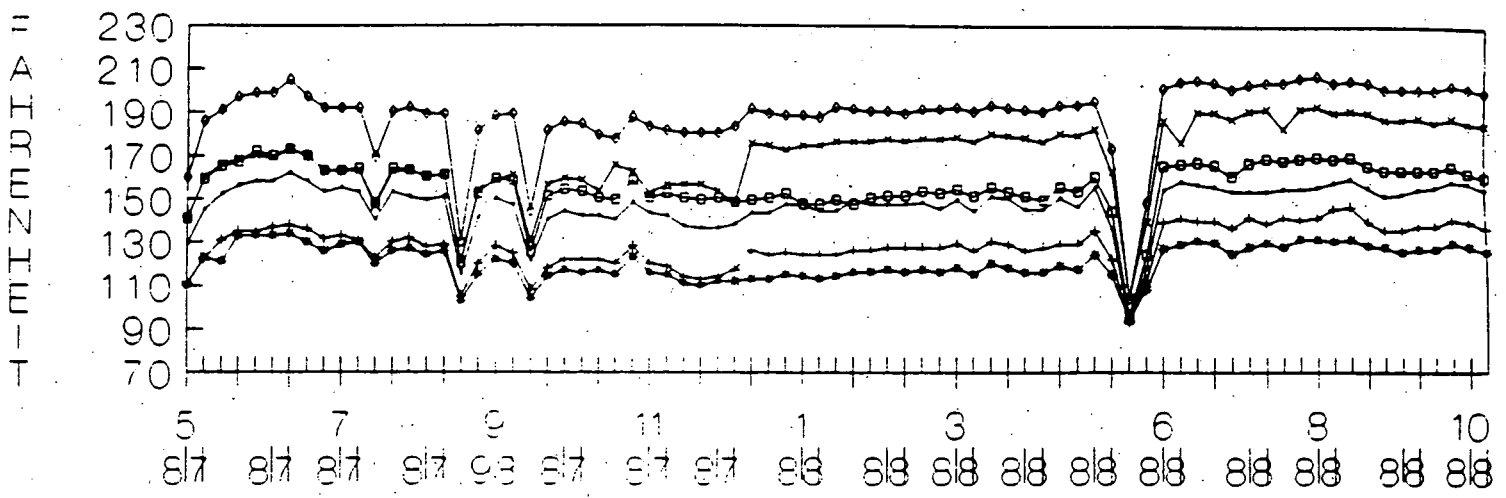
RECORDER 2-261-20B

In general, peak temperatures for 1988 were approximately equal to those for 1987. One exception was the temperature reading in the south section of the second elevation (point T9). This reading showed a step increase of approximately 22 degrees F for the week of December 17, 1987, and remained high throughout 1988. The cause of this step increase was attributed to 2A drywell cooler [VB] (one of seven) being taken out of service due to failure of blower motor 2-5788-A on December 15, 1987. The failure of the blower motor was caused by water leaking from a pipe union on the bottom head drain line.

- T5 RECIR PMP-A
- T6 RECIR PMP-B
- T7 COOLER-D
- T8 COOLER-A
- T9 LEVEL 2 SOUTH
- T10 LEVEL 2 NORTH
