LICENSEE EVENT REPORT (LER)

Facility Name (1) Dresden Nuclear Power Station, Unit 2 Docket Number (2) 0 5 10 10 10 12 13 17 Page (3) 1 of 0 4

Title (4) Inadvertent Engineered Safety Feature (ESF) Actuation Due to Procedural Deficiency

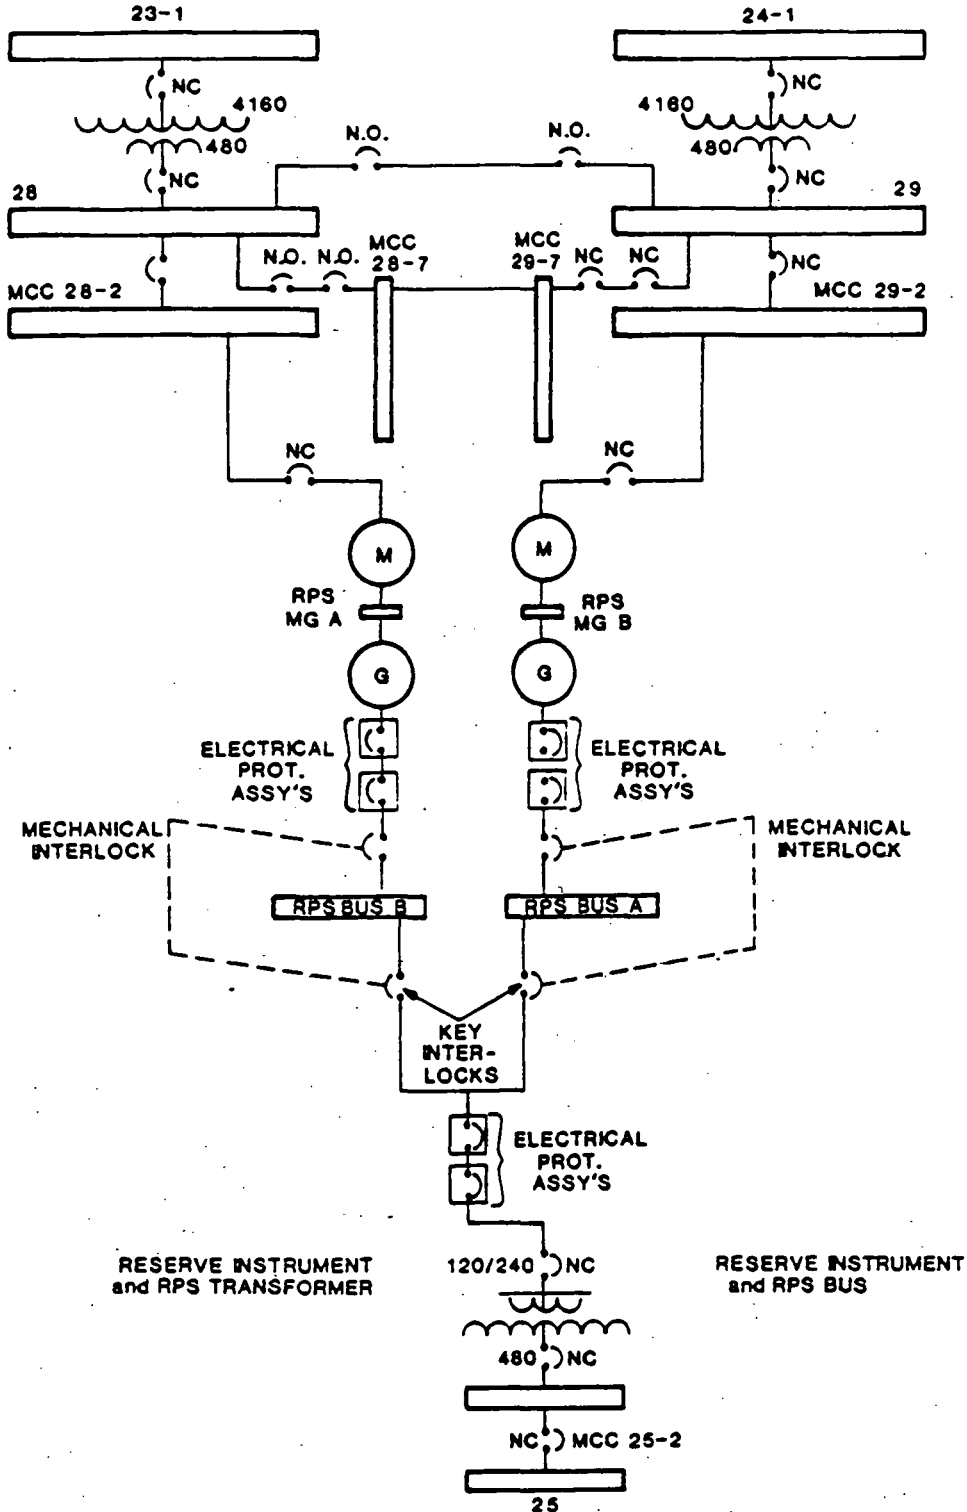
Figure 1

REACTOR PROTECTIVE SYSTEM DISTRIBUTION
