LICENSEE EVENT REPORT (LER)

Facility Name (1) Dresden Nuclear Power Station, Unit 3 Docket Number (2) 0 5 0 0 0 2 4 9 Page (3) 1 of 0 6

TITLE (4) HPCI Area Temperature Switches Exceeded Technical Specification Limit Due to Instrument Setpoint Drift

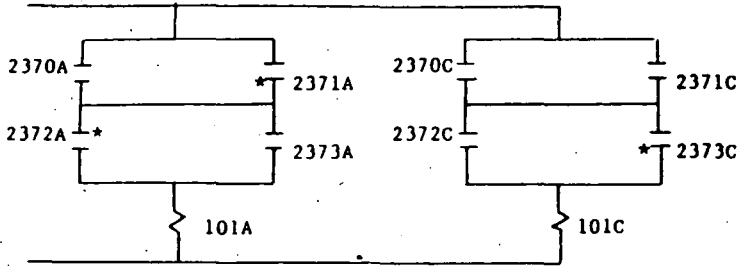
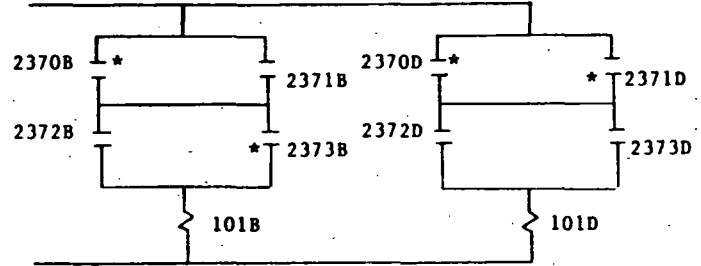
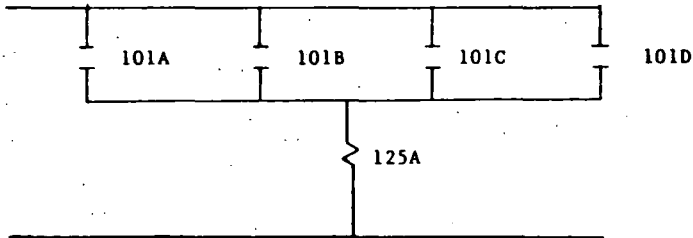
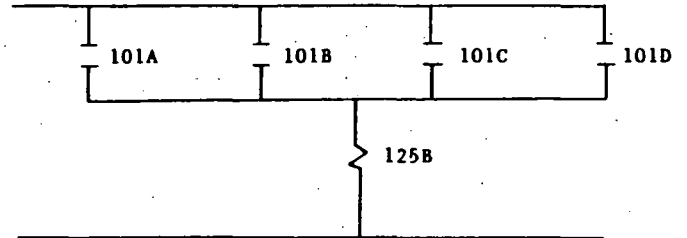
Figure 1

The purpose of the HPCI area temperature switches are to detect significant steam leaks in the HPCI pump room and initiate an isolation of the steam supply to the HPCI turbine. There are a total of 16 temperature switches connected in four one-out-of-two-twice logic channels (see Figure 1). These 16 temperature switches are located in four different areas of the HPCI pump room with four switches in each area. Upon detection of a HPCI area steam leak, the temperature switches actuate and energize relays 101A through 101D respectively, which in turn energize relays 125A and 125B. Energizing either the 125A or 125B relay will initiate a HPCI isolation (Group IV) closing the HPCI steam supply isolation valves, 3-2301-4 and 3-2301-5. Consequently, there are two trip systems for the HPCI auto-isolation system using this type of logic scheme. In the event of a HPCI steam line break, only 2 out of 4 temperature switches from any one group are capable of initiating a HPCI isolation (See Figure 1).

Technical Specification Table 3.2.1 states that four instrument channels shall be operable per trip system. This requirement was not met since the 101D relay was inoperable due to the failure of temperature switches 3-2370D and 3-2371D. However, the remaining three instrument channels (relays 101A, 101B and 101C) were capable of isolating the HPCI system upon detection of a steam leak. Therefore, the safety significance of this event was minimal.

* Exceeded Technical Specification Limit

SIMPLIFIED HPCI HIGH TEMPERATURE ISOLATION LOGIC
