LICENSEE EVENT REPORT (LER)

Facility Name (1) Dresden Nuclear Power Station, Unit 2 Docket Number (2) 0 5 0 0 0 2 13 17 Page (3) 1 of 0 4

Title (4) Anticipated Transient Without Scram (ATWS) Actuation Due to Procedural Deficiency

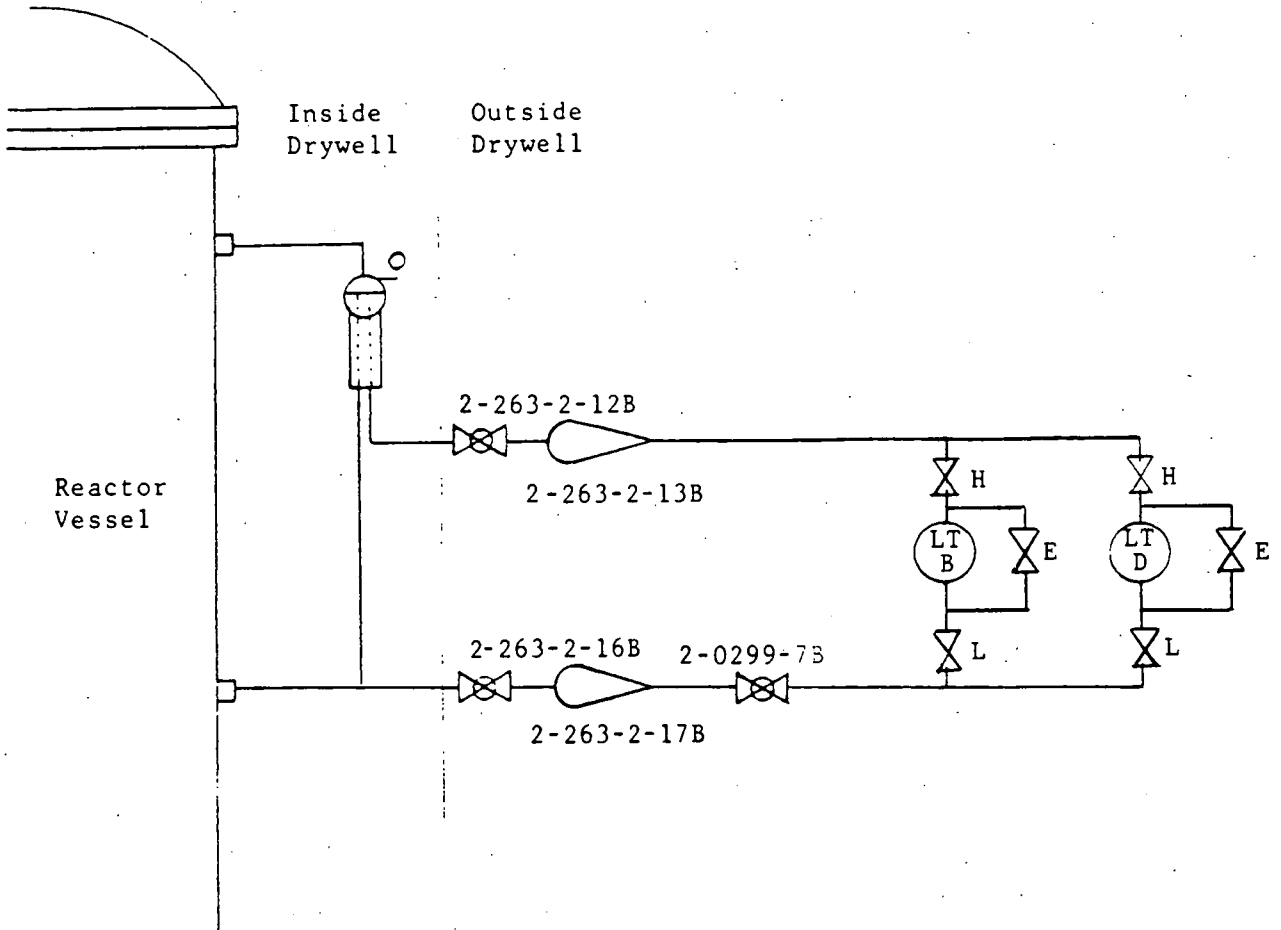
Figure 1

The root cause has been identified as an improper valve-out sequence for isolating the reactor level ATWS transmitters. This was due to procedural deficiency in that no procedure existed to give proper guidance on the proper method to take the ATWS transmitters out of service.

The equipment outage checklist contained an out-of-service card specifying closing the 2-263-2-16B isolation valve. Caution cards were used on the level transmitters high and low side valves which stated to close the high and low side valves "as needed" and to open the equalizing valve "as needed". Subsequently, the high, low, and equalizing valves were left in their as-found positions: high and low side valves open and equalizing valve closed. The equipment outage checklist did not give adequate direction in regards to isolating the ATWS transmitter, which was also a contributing factor to this event. Due to a similar event on Unit 3 in June 1988, training had been given to Operations Department personnel on how to properly valve out a differential pressure (dP) instrument. The training stated that the proper valve-out sequence for reactor level ATWS transmitters was to close both the high and low valves and to open the equalizing valve. The Equipment Operator and Shift Supervisor failed to follow the sequence described in the training session and no procedure existed to take the reactor level ATWS transmitters out of service. If Operations Department personnel had specific procedural guidance on how to properly isolate the reactor level ATWS transmitters, this event would have been avoided.

Channel B ATWS Level Piping Diagram

Immediate corrective action consisted of opening the equalizing valves of reactor level ATWS transmitters 2-263-23B and 2-263-23D. This caused the level signal to go upscale permitting the ATWS ARI signal to automatically reset.

To prevent this event from recurring, the Operations Department will prepare a new procedure specifying the proper valving sequence required to take various level transmitters out-of-service (237-200-89-01901). This event will be included in the continuing Licensed Operator training program (237-200-89-01902).
