Facility Name (1) Dresden Nuclear Power Station, Unit 2 Docket Number (2) 0 5 10 10 10 12 13 17 Page (3) 1 of 1 1

Title (4) Inoperative CRD Hydraulic Control Unit Charging Header Ball Check Valves Due to Procedural Deficiency

Control Rod Drive (CRD) [AA] Hydraulic Control Unit (HCU) Charging Water Header Check Valve Ball Missing on Hydraulic Control Units (HCUs) E-11 and J-10 Due to a Procedural Deficiency.

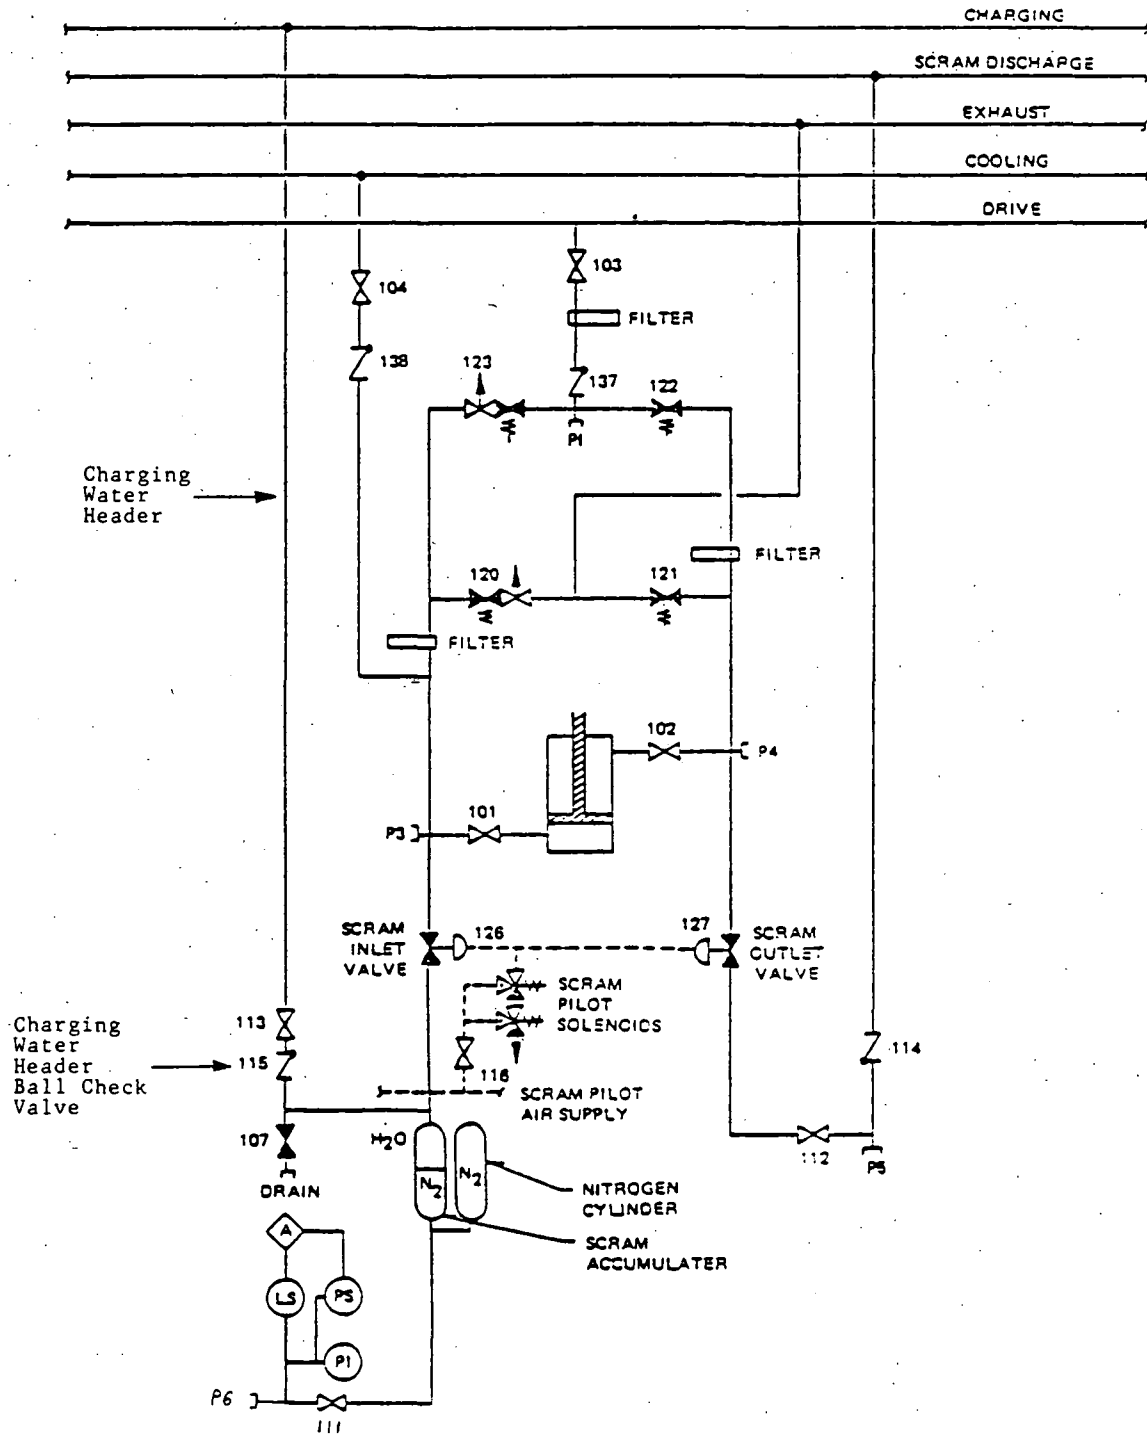
Figure 1

Annunciation of the accumulator low pressure alarm (1000 psig setpoint) within five minutes is a possible indication of excessive leakage of the charging water header ball check valve, 2-2305-115. See Figure 1.

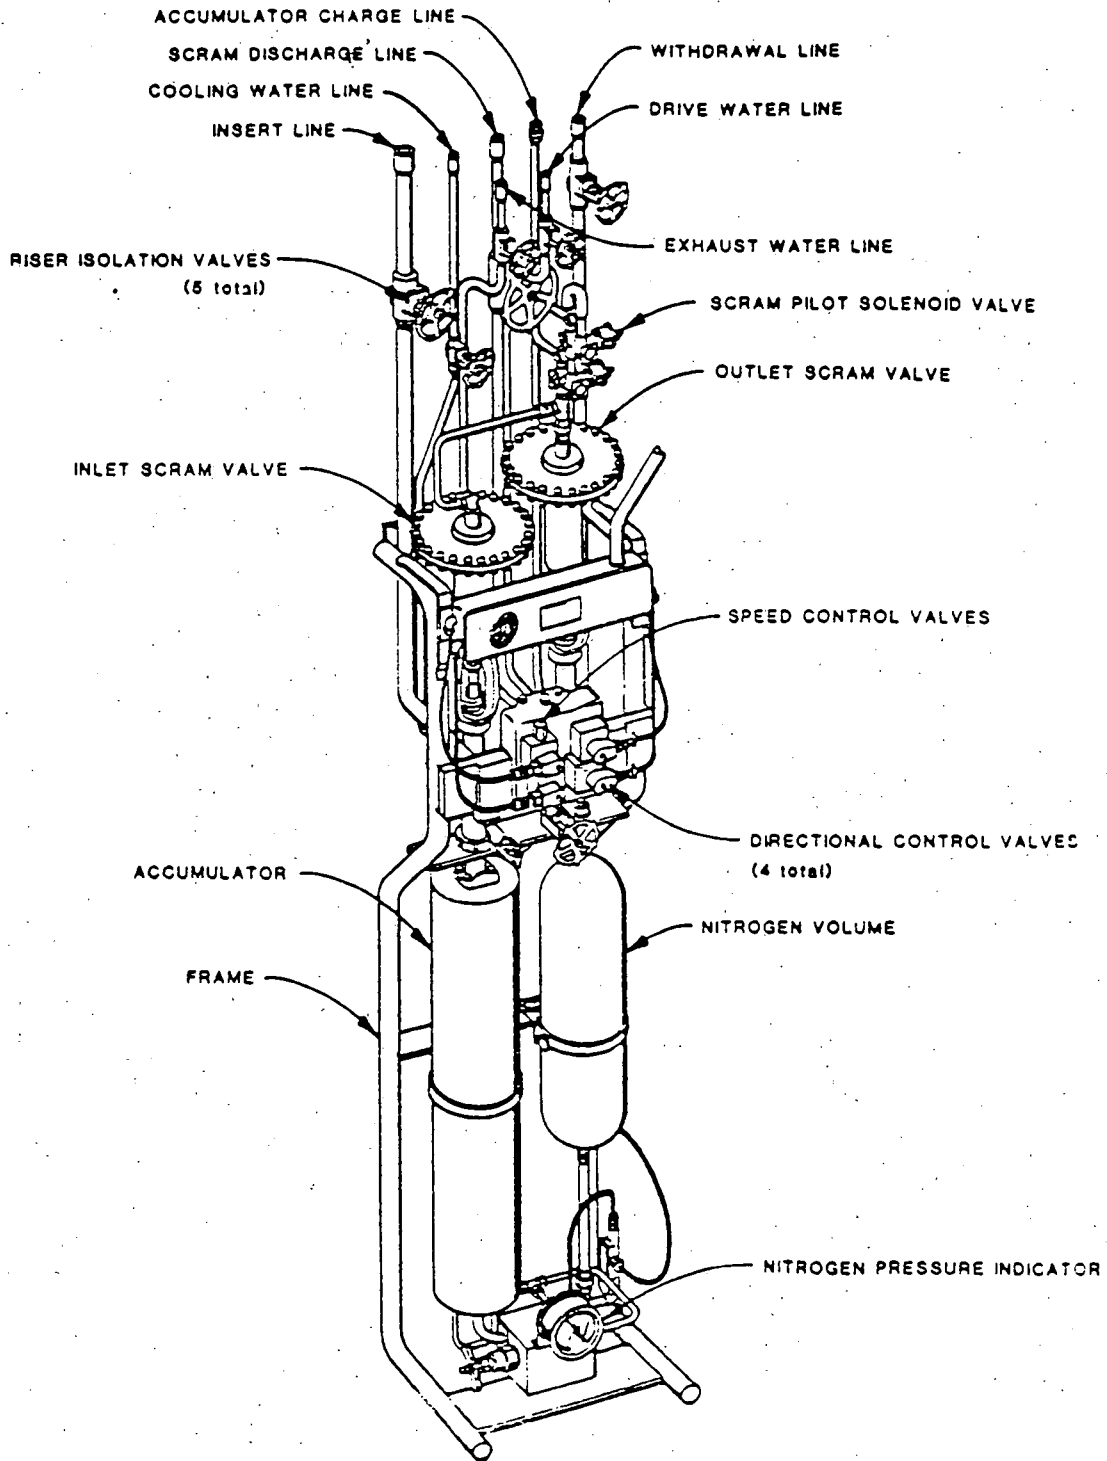
Figure 2

Initial CRD System pre-operational testing did not include testing of the HCU charging water header ball check valves. However, the HCUs were factory built and tested by General Electric prior to shipment. See Figure 2. General Electric has a Quality Control (QC) hold point which specifies a water leakage of < 5 cc/min at 1750 pounds pressure for the charging water header ball check valve. It is therefore unlikely that the HCUs were received without a ball in its charging water ball check valve.

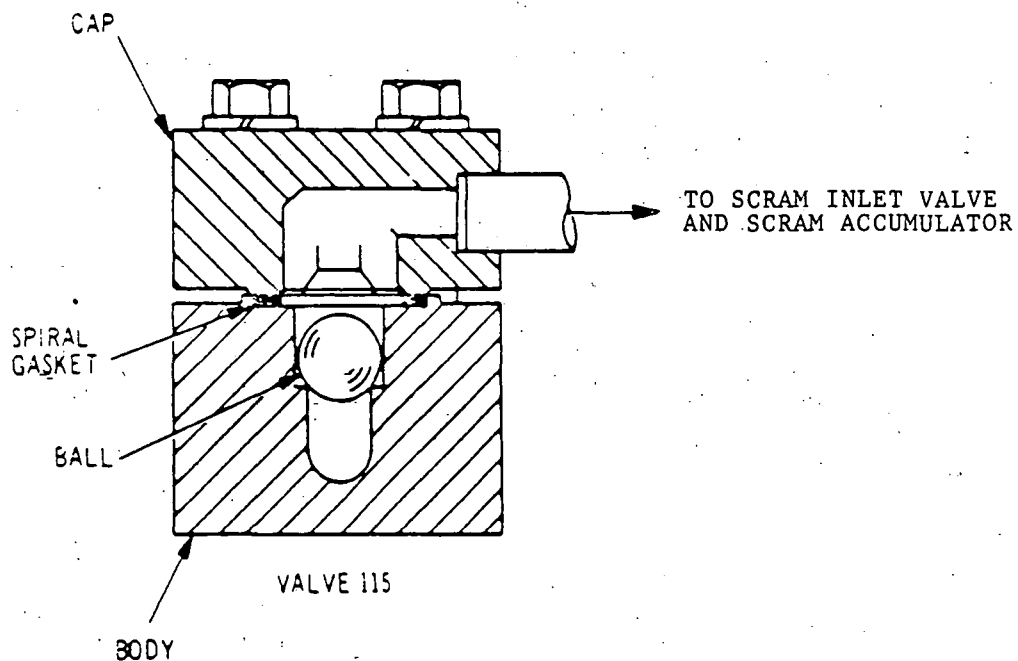
Figure 3

On January 30, 1989, at 1500 hours with Unit 2 in the Shutdown mode at 0% thermal power, HCUs E-11, J-10 and N-13 had their charging water header ball check valves disassembled. At that time, it was discovered that HCU E-11 and J-10 had no ball in the charging water header ball check valve. HCU N-13 had some scratches on the check valve ball. The three valves were cleaned and a new ball was placed in each of the charging water header ball check valves.

The root cause of the missing charging water header check valve ball for HCUs E-11 and J-10 is a result of inadequate procedural controls. Dresden Maintenance Procedure (DMP) 300-18, Control Rod Drive Inlet and Outlet Scram Valve Maintenance, did not address placement or verification of the ball in the charging water header ball check valve.

DMP 300-18 has been revised to include a sign-off step verifying the charging water header check valve ball is in place prior to aligning the valve body and cap for reassembly. The same sign-off step was added for the scram discharge check valve (2-0305-114) which is disassembled when the seat of the scram outlet valve (2-0305-127) is replaced.

HCU's E-11, J-10 and N-13 had their charging water header ball check valves disassembled, cleaned and had a new check valve ball installed in each valve. The remaining charging water header ball check valves that failed DOS 300-3 were flushed with clean demineralized water and successfully passed a leak test. The scram inlet valve for HCU's K-3 and P-8 had their valve stems extended and satisfactorily passed a leak test. Additionally, the accumulator charging water header isolation valves for HCU's F-4, K-3, N-13 and P-8 previously identified as leaking were overhauled and inspected.
