LICENSEE EVENT REPORT (LER)

Facility Name (1) Dresden Nuclear Power Station, Unit 2  
 Docket Number (2) 0 5 10 10 10 12 13 17  
 Page (3) 1 of 0 5

Title (4) Unsatisfactory Main Steam Relief Valve Pressure Setpoints Due to Instrument Drift and Limit Switch Failure

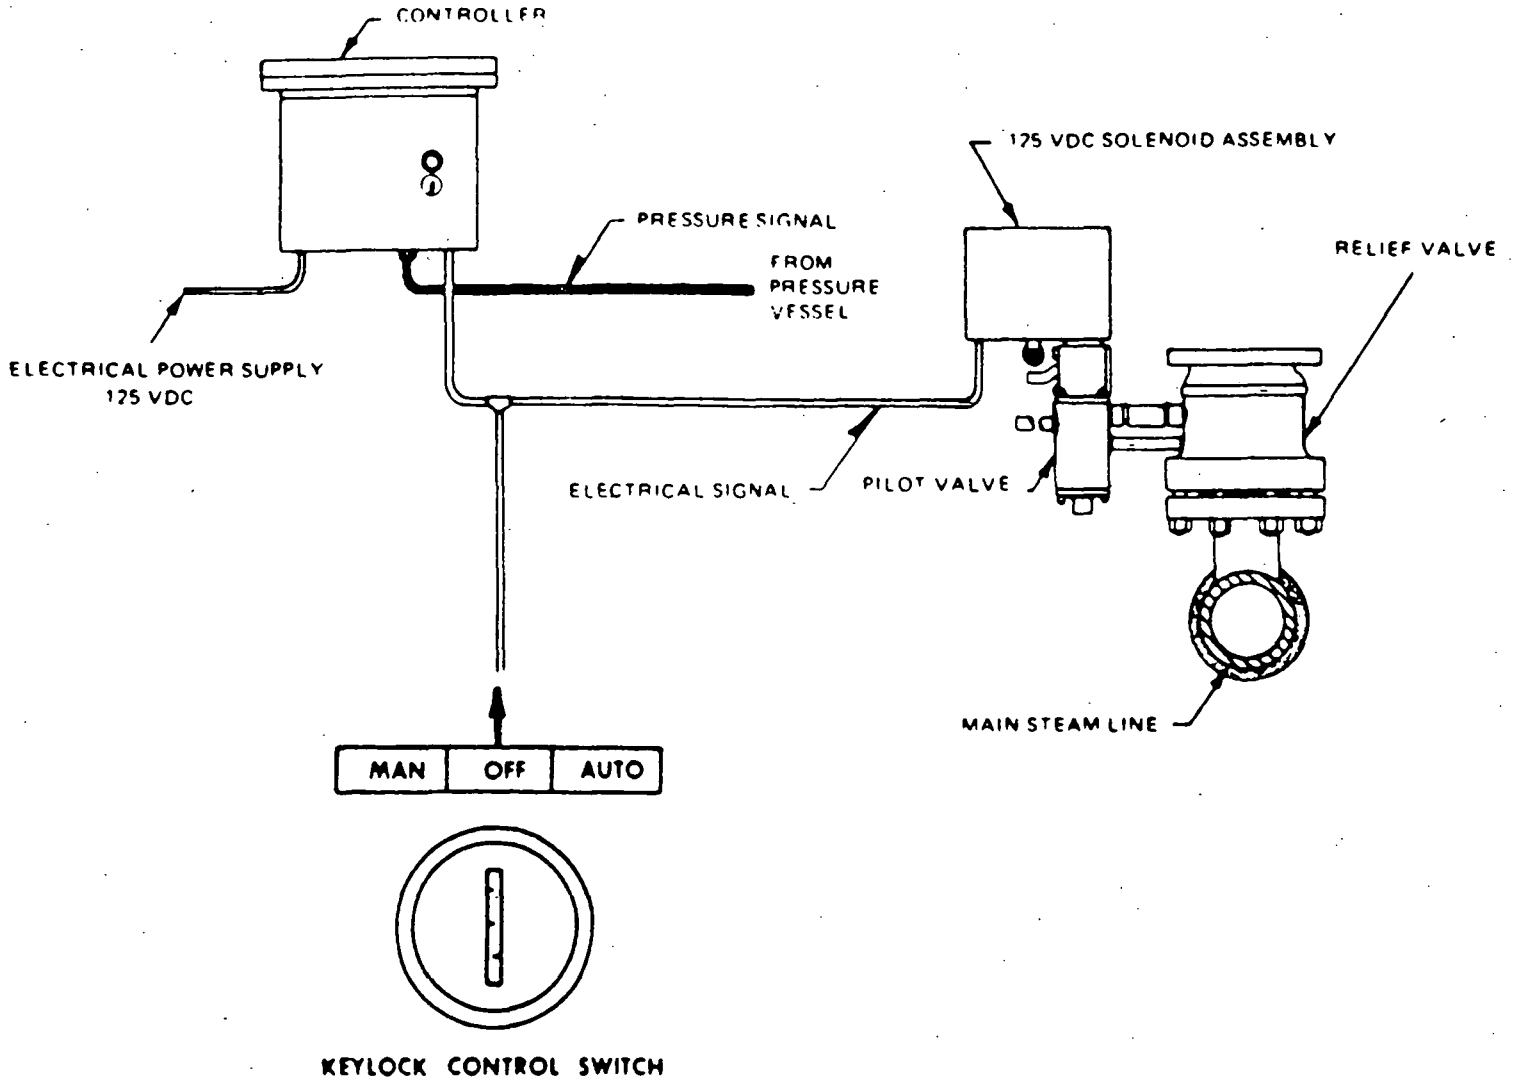
The ERVs are electrically actuated pressure relief devices. Figure 1 illustrates the manner in which the Electromatic and Target Rock Relief valve circuits are connected. The major difference in the Target Rock Relief valve is that it has the ability to function as a safety valve as well as a relief valve. The pressure controllers consist of a Bourdon Tube type pressure sensing element which actuates a snap-action dual control limit switch, which in turn energizes a heavy duty relay to switch the solenoid load. The pressure controller, in conjunction with the control switch and the Automatic Depressurization System (ADS) logic contacts, supplies 125V DC electrical power to the solenoid assembly in order to operate the pilot valve. The pilot valve in turn controls the opening and closing of the relief valve.

ELECTROMECANICAL RELIEF VALVE AND CONTROLS
