LICENSEE EVENT REPORT (LER)

Facility Name (1) Dresden Nuclear Power Station, Unit 2	Docket Number (2) 0 15 10 10 10 2 13 17	Page (3) 1 of 0 4
--	--	----------------------

Title (4)  
Inadvertant Injection of Emergency Core Cooling Systems Into the Reactor Vessel Due to a Leaking Test Valve

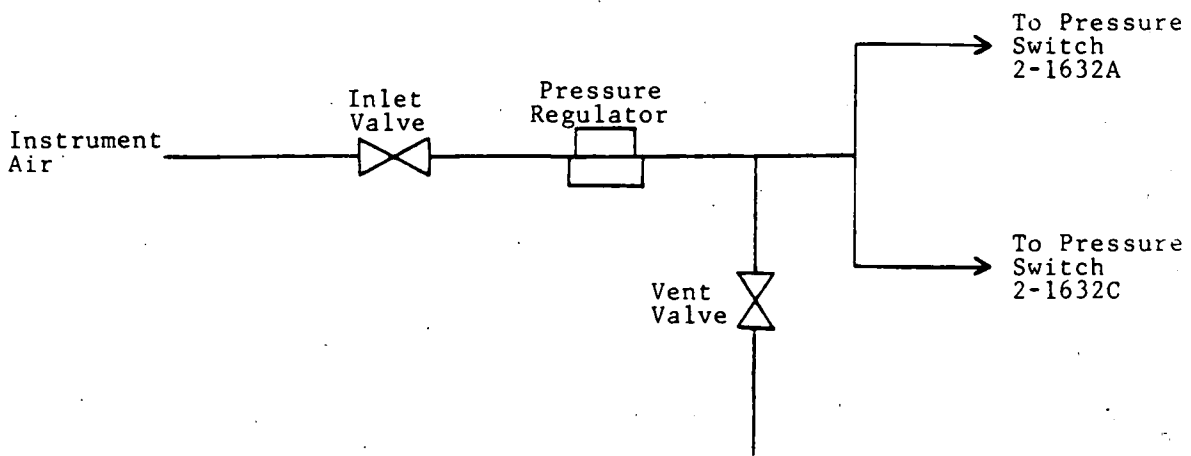
Figure 1

The test rig used to simulate drywell high pressure consists of an inlet valve, a pressure regulator set to 5 psig and a vent valve, as shown in Figure 1. The cause of the event was due to a leak in the test rig inlet valve. This leak allowed the pressure switches to be pressurized to 5 psig when the vent valve was inadvertently closed. The vent valve was originally open. However, during a valve lineup verification, an Operations Department Shift Foreman believed that the vent valve was closed. The Shift Foreman picked up the test rig and found the vent valve to be just short of full travel. The Shift Foreman completed the vent valve's travel and noticed a slight increase in pressure on the test gauge. He believed the valve to now be fully closed so he turned the vent valve in the opposite direction and observed the test gauge pressure drop to zero. The Shift Foreman verified that the pressure stayed at zero and then left the area to continue his duties. Within ten minutes the testing rig pressurized and exceeded the 2 psig setpoint on the pressure switches resulting in the inadvertant ECCS initiation.

HIGH DRYWELL PRESSURE TEST RIG

The immediate corrective action was to stop injection into the vessel by placing the control switches for the 2C LPCI pump, 2D LPCI pump and the 2B Core Spray pump in pull-to-lock. The 5 psig signal was then removed from PS2-1632A and PS2-1632C and the system logic was reset. Finally, all systems were returned to their normal lineups. As a long term corrective action, a new test rig will be fabricated to be used for undervoltage testing (237-200-89-02301). The test rig will have labels to indicate the open and close direction of the valves. In addition, DOS 6600-6 will be revised to require that the test rig be tested prior to installation (237-200-89-02302). DOS 6600-6 will also be revised to require that the instrument air supply isolation valve remain closed until the test assembly is required (237-200-89-02303). This event will be reviewed during the Licensed Operator Continuing Training Program (237-200-89-02304).
