LICENSEE EVENT REPORT (LER)

Facility Name (1) Dresden Nuclear Power Station, Unit 2/3 Doc Number (2) 0 5 10 10 10 12 13 17 Page (3) 1 of 0 6

Title (4) Possible Single Failure Loss of Both Standby Gas Treatment Systems Due to a Design Deficiency

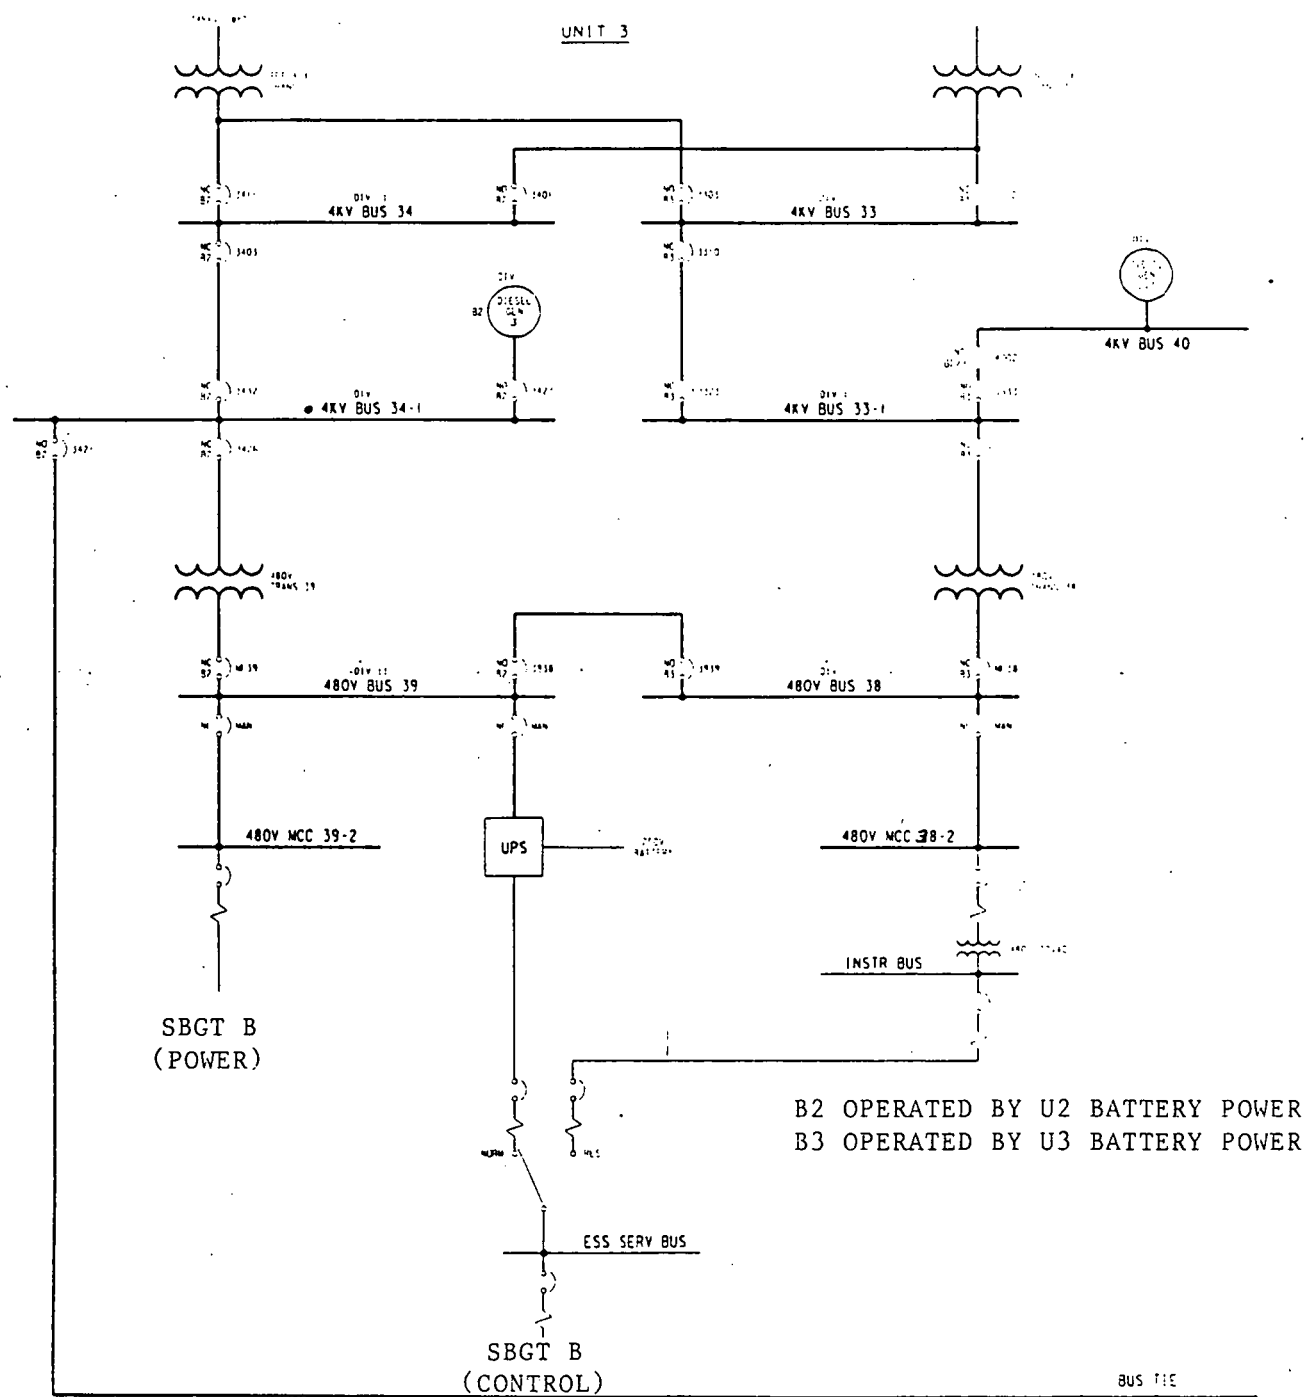
Figure 1

The loss of the B SBT System under the postulated scenario conditions would result because: the Unit 3 Diesel Generator [EK] would not automatically start since its control power is supplied by the Unit 2 125V DC battery system which is inoperable. The Bus 38 to Bus 39 [ED] and Bus 24-1 to Bus 34-1 [EB] cross-tie breakers could not close because they are also operated by the Unit 2 125V DC battery. Therefore, Bus 39 would be deenergized and the B SBT train would be inoperable. See Figure 1.

SBGT B POWER SUPPLY

The immediate corrective action included notifying Station Management personnel and Operations Department shift personnel of the design deficiency with the SBT System. A new procedure, DGA 4, was formalized by February 23, 1989. This procedure provides direction in restoring the 125V DC battery system to the appropriate Unit 3 circuits which permits restoration of AC power to the B SBT System. As a long term corrective action, a modification request will be issued to modify the AC feeds to the A SBT train (237-200-88-01301). This modification will ensure that at least one SBT train is operable under the postulated scenario.

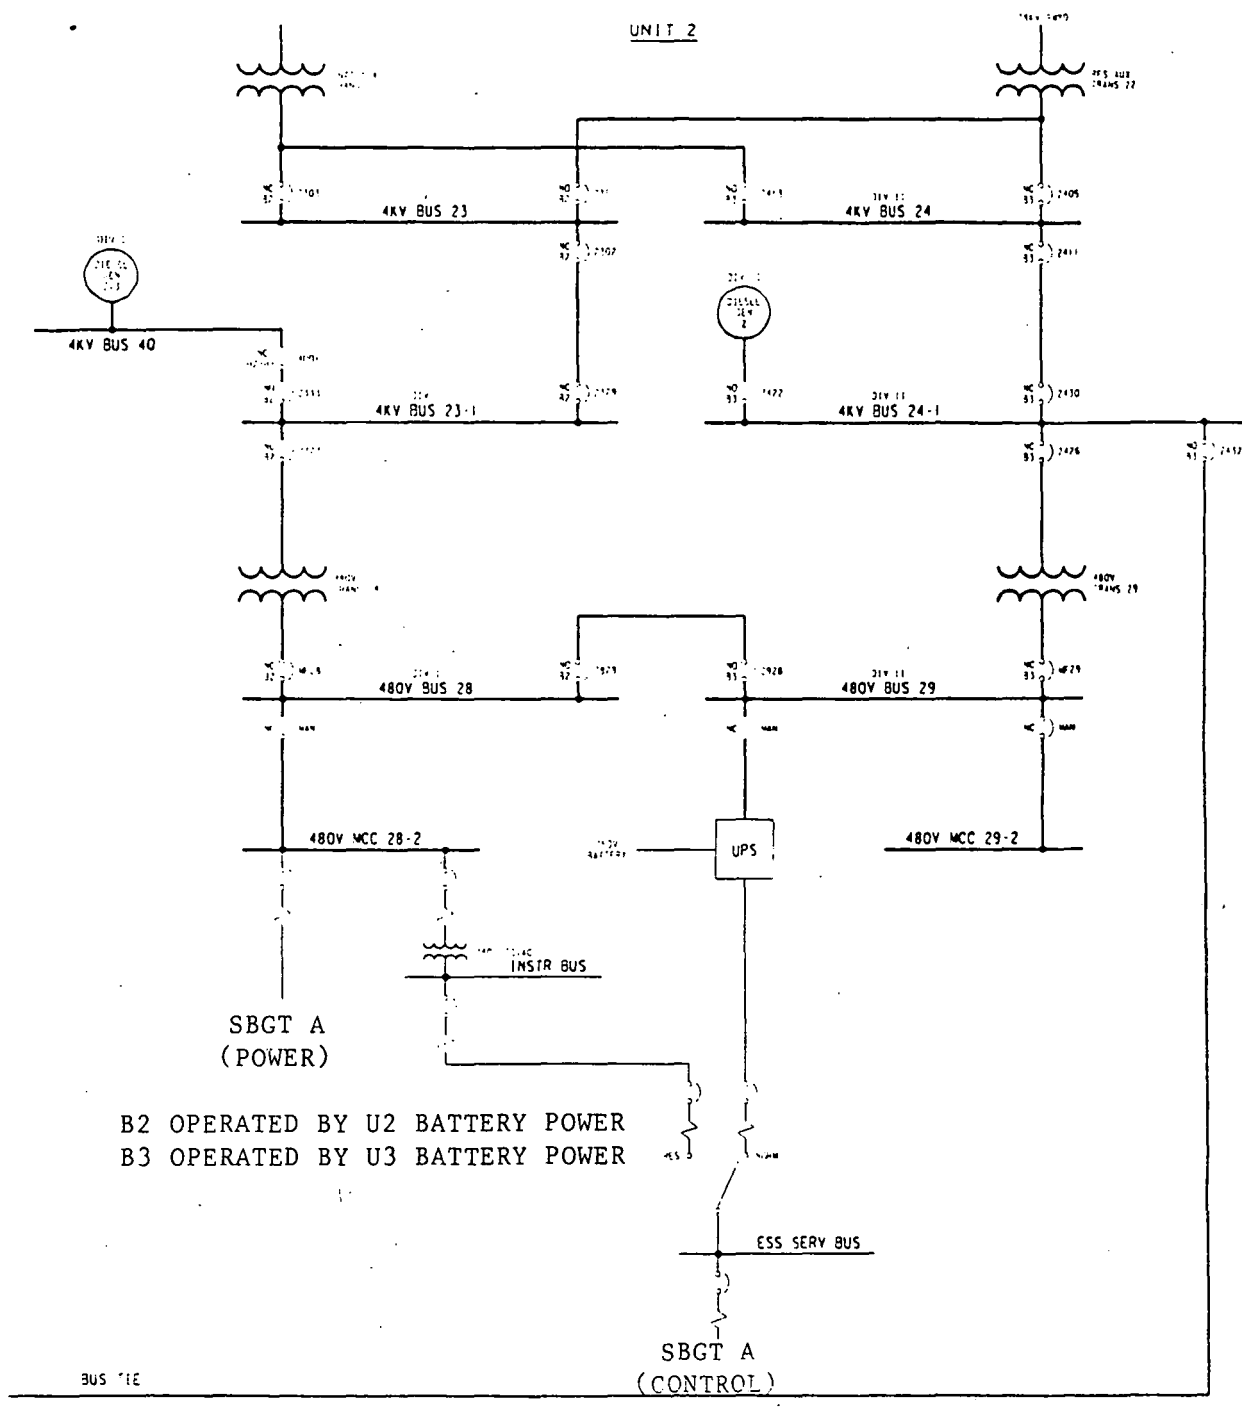
Figure 2

The loss of the A SBT System would result because: it is assumed that Unit 2 scrams when Unit 3 is experiencing a LOCA. The Unit 2/3 Diesel Generator would supply emergency power to Bus 33-1 since the LOCA occurred on Unit 3. The Bus 29 to Bus 28 and the Transformer 22 to Bus 23-1 cross-tie breakers would not close because the Unit 2 125V DC battery system is unavailable. See Figure 2. The root cause of this event has been attributed to a design deficiency.

SBGT A POWER SUPPLY
