Report No. SIR-89-004, Vol. 2  
Revision 0  
Project No. CECO-015Q  
March 14, 1989

Volume 2  
Flaw Evaluation and Repair  
Design Report  
Fall 1988 Refueling Outage  
Dresden Nuclear Power Plant Unit 2

Commonwealth Edison Company

Structural Integrity Associates, Inc.  
San Jose, CA

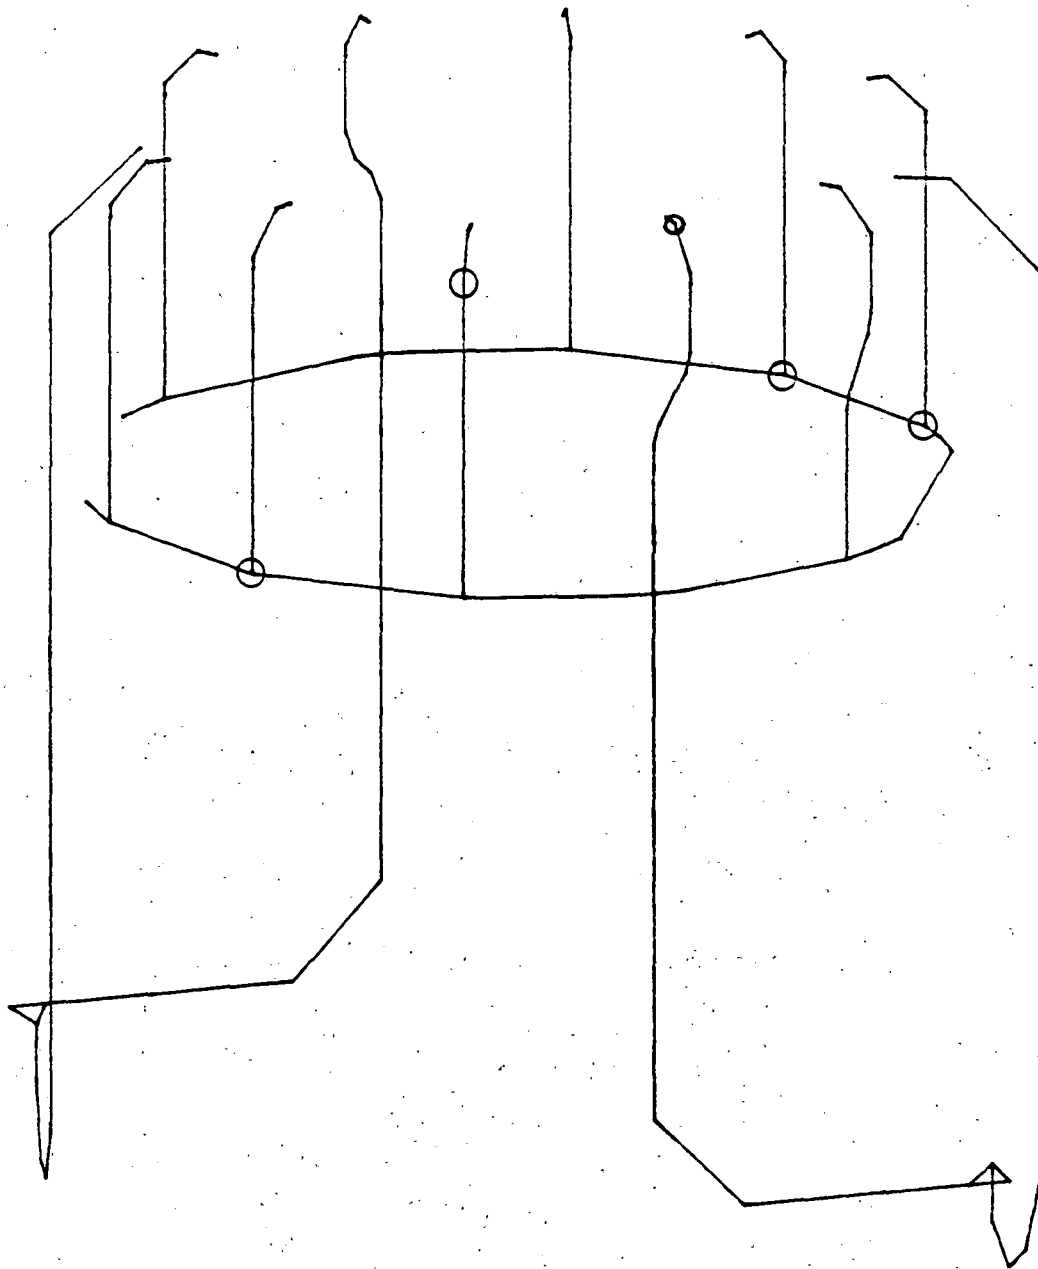
Table 4-4 presents weld overlay shrinkage stress results for the five highest stressed unrepaired ISI weld locations in the recirculation system, all of which occur in the 12-inch recirculation risers. Table 4-5 lists the stress at the only unrepaired ISI weld location in this run of the RWCU system. The

<u>Weld Location</u>	<u>Stress (ksi)</u>
PD1-D15	13.265
PD6-D19	11.099
PD5/L1	6.446
PD7/L4	5.420
PD8/L4	5.326

Figure 4-1. Finite Element Model of Dresden Unit 2 Recirculation System, with Five Highest Shrinkage Stress Locations Circled for Unrepaired (No Flaws) ISI Welds

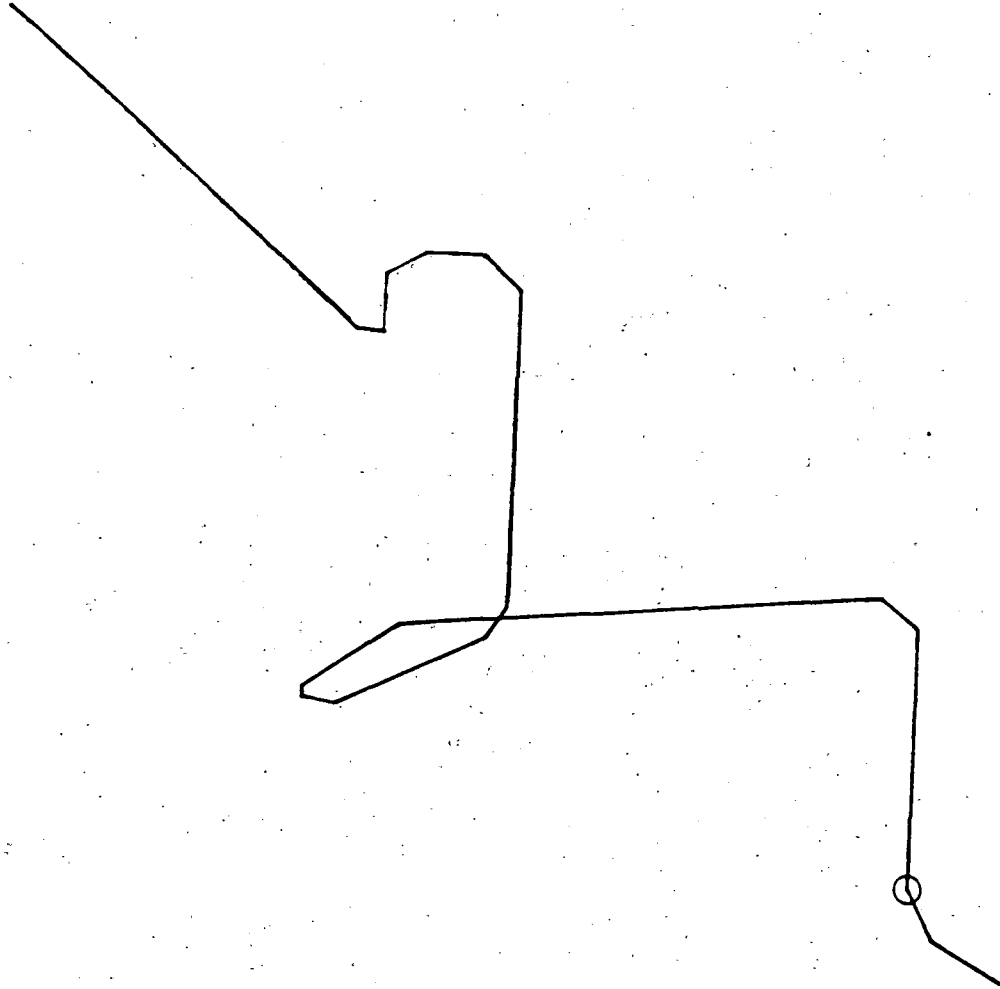
highest shrinkage stress at non-ISI weld locations is only 2.558 ksi in this RWCU piping.

<u>Weld No.</u>	<u>Stress (ksi)</u>
8-16	0.626

Note: The highest shrinkage stress at other locations (non-ISI weld) in this piping run is 2.558 ksi.

Figure 4-2. Finite Element Model of Dresden Unit 2 RWCU System, Inside Containment, from Shutdown Cooling Piping to Containment Penetration, With the Unrepaired (No Flaws) ISI Weld Location Circled
