LICENSEE EVENT REPORT (LER)

Facility Name (1) <p style="text-align:center;">Dresden Nuclear Power Station, Unit 2</p>	Docket Number (2) <p style="text-align:center;">0 5 10 10 10 12 13 17</p>	Page (3) <p style="text-align:center;">1 of 0 5</p>
--	--	--

HPCI Gland Seal Leakoff Condenser Drain Pump Failure Due to Degraded Motor Starting Circuit Capacitor

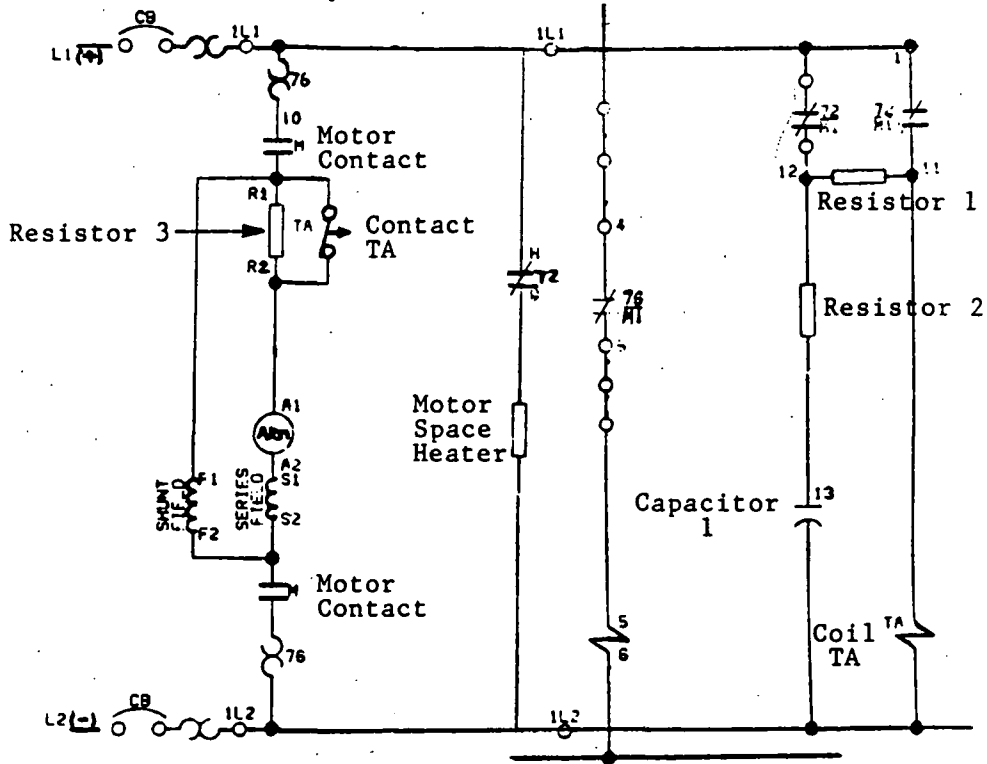
Investigation by the Electrical Maintenance Department (EMD) under Work Request 83160 revealed abnormalities within the GSLO condenser drain pump motor starting circuit. See Figure 1 for a simplified circuit diagram. It was discovered that GSLO condenser drain pump motor armature resistance short out contactor TA (Cutler-Hammer No. 538, Definite Time Armature Accelerating Contactor) was fused in the closed position. Carbon deposits were also found covering the contacts. The armature resistance short out contactor is normally closed only during the GSLO condenser drain pump motor start sequence. The GSLO condenser drain pump motor is a reduced starting voltage compound direct current (DC) motor. During its start cycle it draws an in-rush current greatly exceeding its normal operating current. To limit the in-rush current, a resistor (Resistor 3; Figure 1) is placed in series with the motor armature for the first four seconds of motor operation. Subsequent to four seconds of motor operation, Capacitor 1 (Figure 1) discharges fully and coil TA (Figure 1) becomes de-energized. With coil TA de-energized, contact TA closes, shorting out Resistor 3, allowing the GSLO motor to receive full running current.

During this event, Capacitor 1 discharged immediately, allowing contact TA to close instantaneously and experience an unreduced starting current. The excessive current fused the TA contact and momentarily fused the two motor contacts resulting in the initial inability to trip the GSLO pump. Therefore, the root cause of this anomaly was the degraded capacitor. The capacitor was tested and its "as found" capacitance was 3 microfarads. Design capacitance for Capacitor 1 is 50 microfarads.

SIMPLIFIED CIRCUIT DIAGRAM
GLSO CONDENSER DRAIN PUMP MOTOR
STARTING CIRCUIT

A Problem Analysis Data Sheet (PADS) was performed to evaluate the root cause and establish adequate corrective actions. The root cause was identified and the following corrective actions were established. The GSLO pump motor armature resistance short out contactor TA (Cutler-Hammer No. 538, Definite Time Armature Accelerating Contactor) was replaced. Additionally, a new capacitor was installed. The motor contacts were also inspected for pitting. No pitting was observed. Additionally, a logic check of the GSLO condenser drain pump circuit was performed. During this check, a local
