LICENSEE EVENT REPORT (LER)

| Facility Name (1)<br>Dresden Nuclear Power Station, Unit 3 | Docket Number (2)<br>0 15 10 10 10 12 14 19 | Page (3)<br>1 of 1 0 |

Title (4)  
Reactor Scram Due to the Failure of an Electrical Protection Assembly Breaker

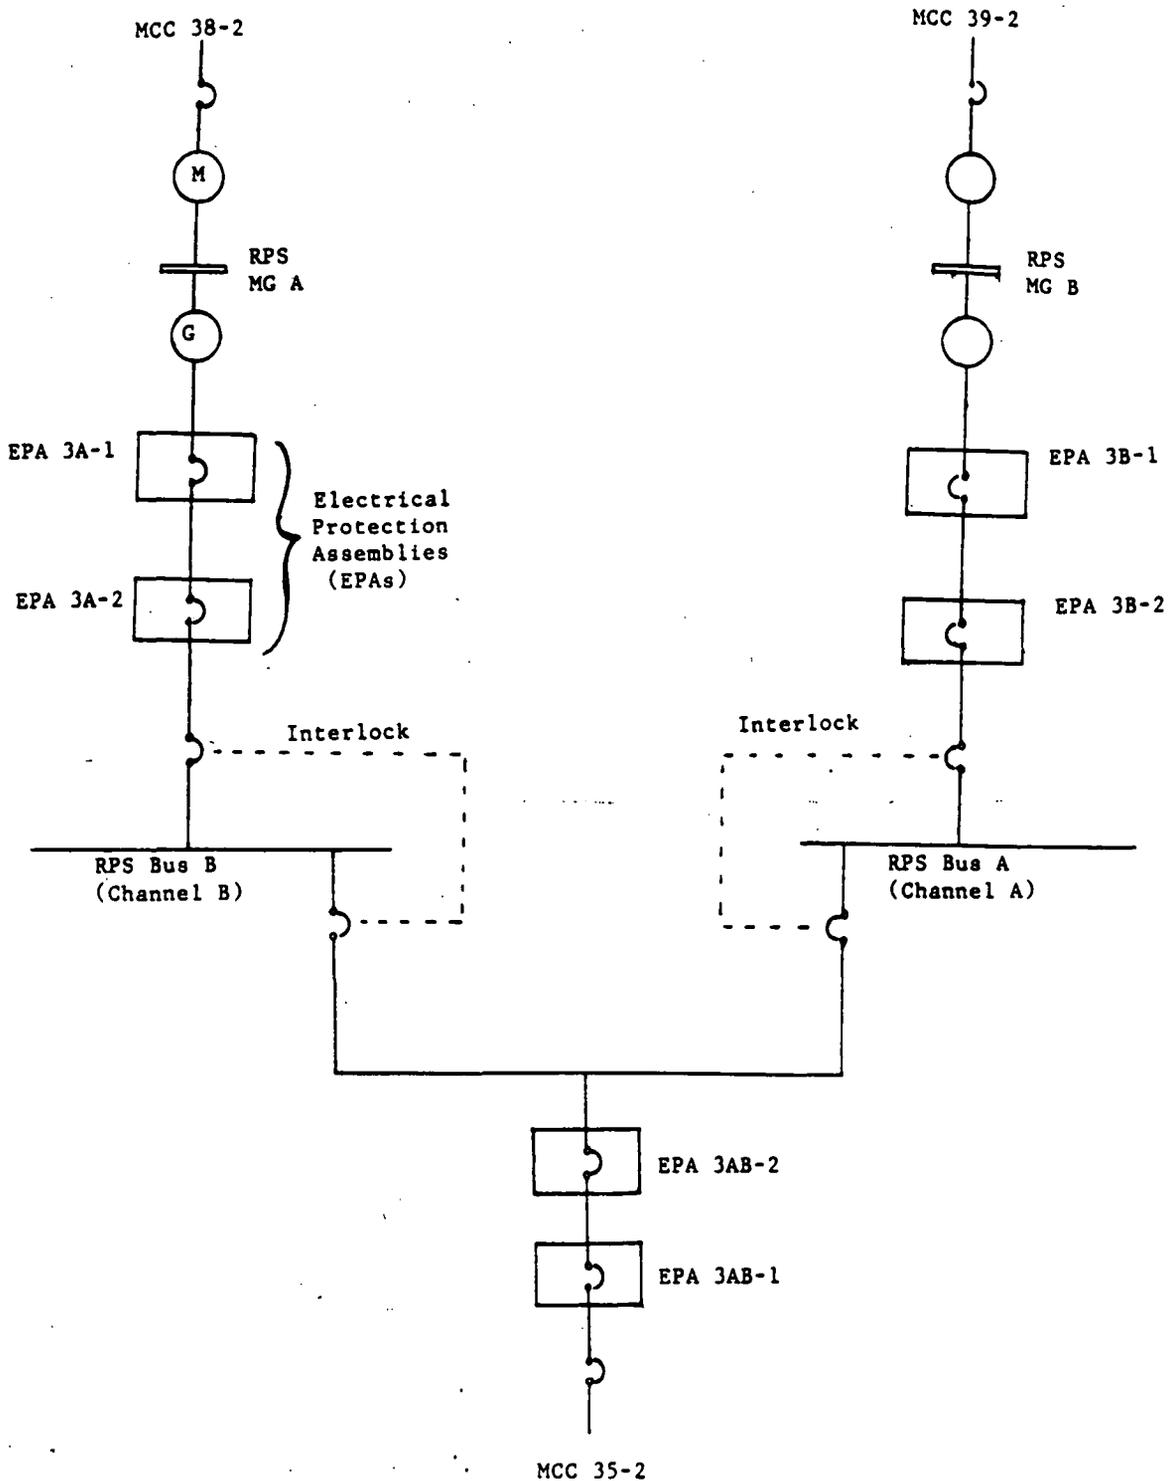
Figure 1

The cause of the initial reactor scram was due to a spurious trip of the EPA breaker 3A-1 (RPS Bus B) and the concurrent lock-up of the 3A MSL radiation monitor (RPS Bus A). Tripping of EPA breaker 3A-1 was also the root cause for the third reactor scram. To determine if any abnormalities existed with the EPA breaker, a calibration check was performed in accordance with DTS 500-3, Calibration of RPS MG Set and RPS Reserve Power Supply EPAs. However, no problems found during the calibration. Consequently, the cause of the breaker failure is currently unknown but it is expected to be determined following inspection of the EPA breaker by the General Electric Company.

Immediate corrective actions included resetting of the 3A MSL radiation monitor and removing from service the normal power supply to the RPS Bus B to prevent additional spurious trips of EPA breaker 3A-1. A calibration check was performed on the EPA breaker 3A-1, however, no abnormalities were found. In order to prevent further spurious trips, EPA breaker 3A-1 was replaced with the existing EPA breaker 3AB-2 from the reserve RPS Bus power supply since a spare was not readily available. An authorized jumper was temporarily installed in the EPA breaker 3AB-2 cubicle until a new EPA breaker could be obtained and installed. This replacement took place on March 31, 1989.

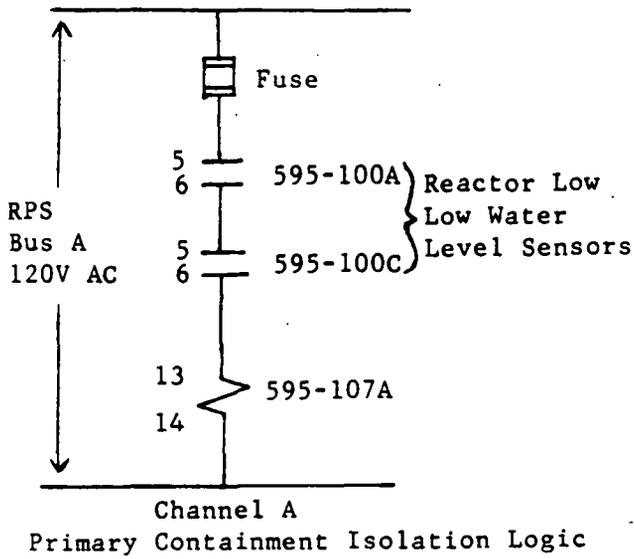
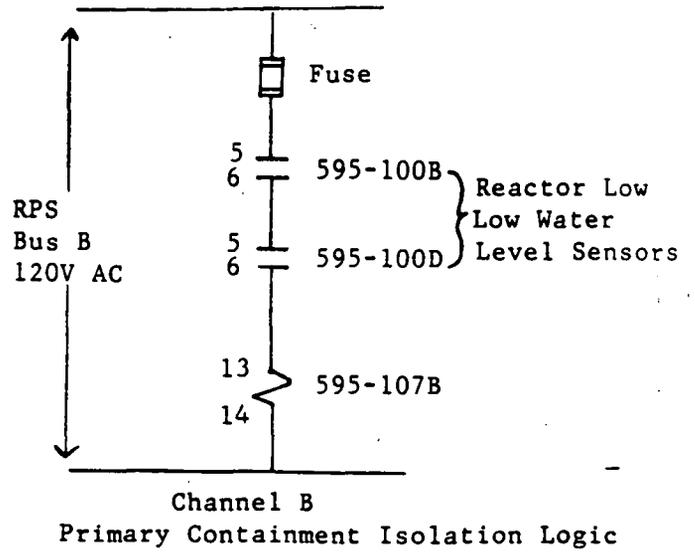
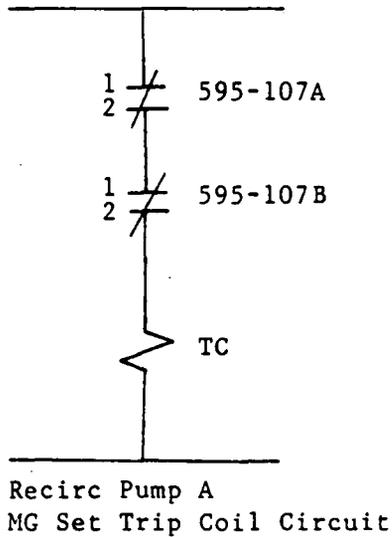
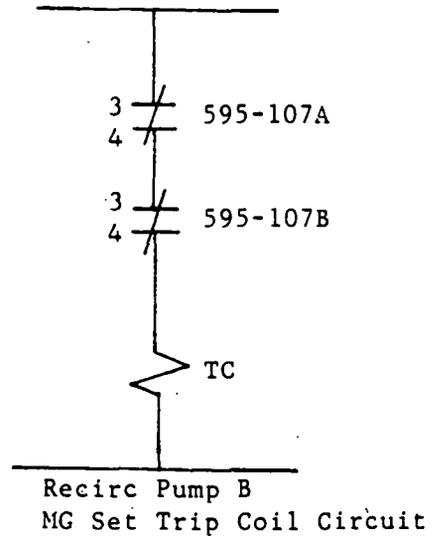
Figure 3

During this event, both recirculation pumps tripped following the de-energization RPS Busses A and B. As indicated in Figure 3, de-energizing RPS Busses A and B caused relays 595-107A and 595-107B in the Primary Containment Isolation logic to dropout thereby causing the closure of the appropriate relay contacts. Consequently, the trip coil of both recirculation pump MG sets energized which resulted in tripping of the recirculation pumps. The power loss to both RPS Busses also caused the Primary Containment Group II and III Isolations due to de-energization of the Primary Containment Isolation relays.
