FACILITY NAME (1)	DOCKET NUMBER (2)	LER NUMBER (3)						Page (3)		
		Year	///	Sequential Number	///	Revision Number				
Dresden Nuclear Power Station	0 5 0 0 0 2 4 9	8 9	-	0 0 6	-	0 0	0 3	OF	0 5

TURBINE STOP VALVE TEST LOGIC

Licensee Event Report #89-006-0, Docket #050249 is being submitted as required by Technical Specification 6.6, NUREG 1022 and 10 CFR 50.73(a)(2)(iv).

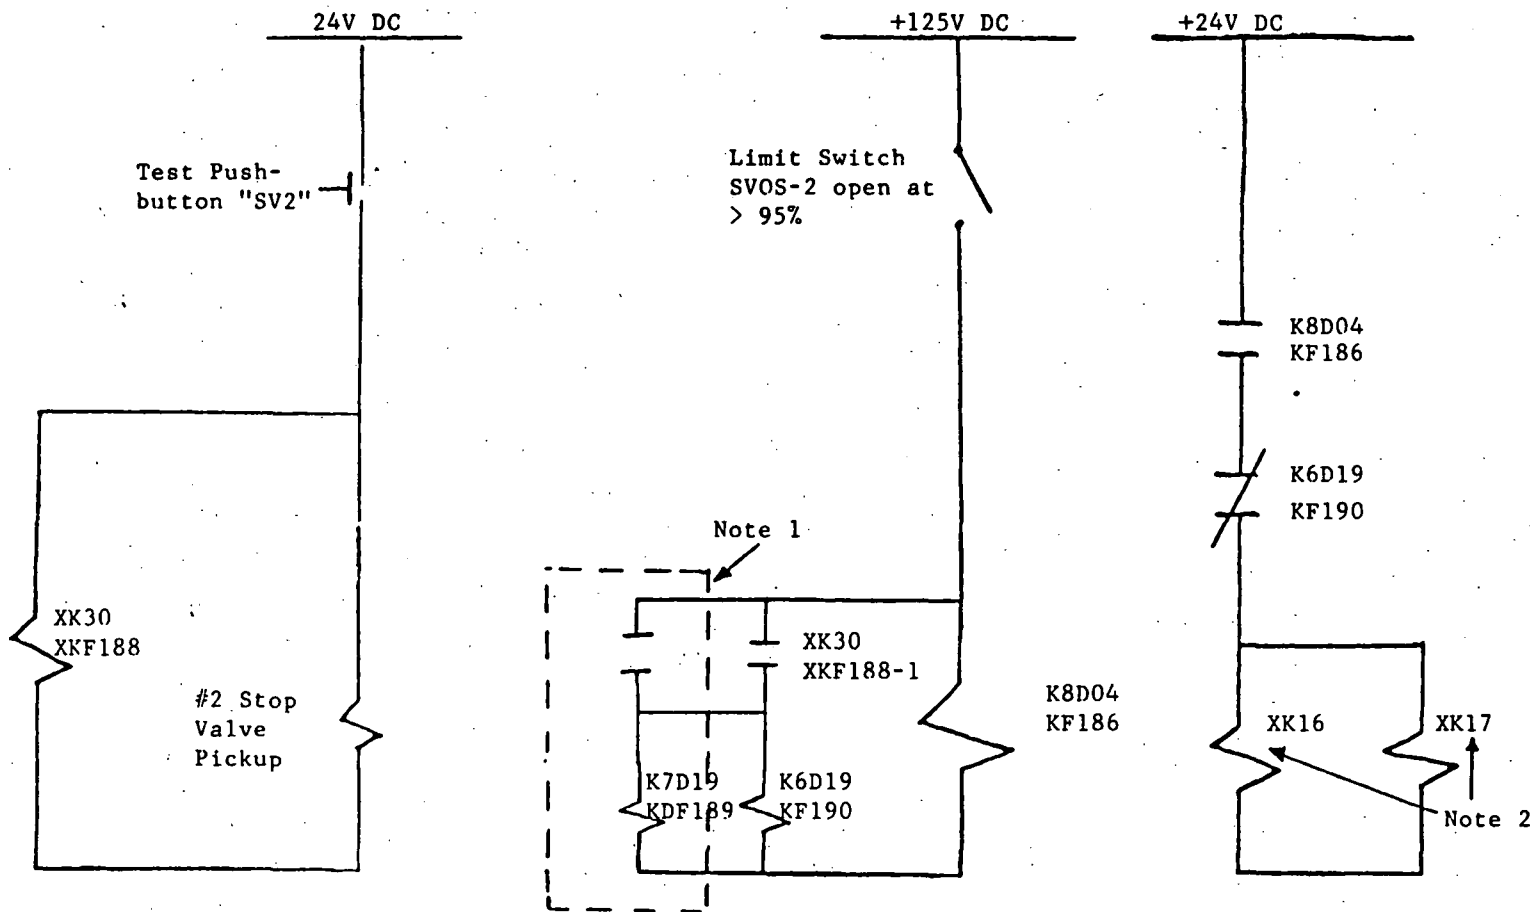
Figure 1

The high contact resistance on normally open contact XK30 XKF188-1 prevented the contact from closing when control relay XK30 XKF188 was energized (test pushbutton SV2 depressed). Consequently, relay K6D19 KF190 remained de-energized, its associated normally closed contact remained closed, and relays XK16 and XK17 remained energized. As a result, when #2 TSV reached 5% closed, the other three TSVs began closing and initiated a reactor scram.

Note 1: This contact is associated with seal-in circuit relay K7D19 KF189 and closes when the relay is energized.

Note 2: These relays when energized cause #1, 3 and 4 turbine stop valves to follow the action of #2 turbine stop valve.

Corrective actions for this event involved testing of control relays XK30 XKF188 and K6D19 KDF189. Although the only problem discovered was the contact high resistance on relay XK30 XKF188, both relays were replaced. This work was completed on April 18, 1989 under Work Request 84112.
