Commonwealth Edison
Dresden Nuclear Power Station
R.R. #1
Morris, Illinois 60450
Telephone 815/942-2920

Licensee Event Report #89-015-0, Docket #050237 is being submitted as required by Technical Specification 6.6, NUREG 1022 and 10 CFR 50.73(a)(2)(iv).

FACILITY NAME (1)	DOCKET NUMBER (2)	LER NUMBER (6)						Page (3)		
		Year	/	Sequential Number	/	Revision Number				
Dresden Nuclear Power Station	0 5 0 0 0 2 3 7	8 9	-	0 1 5	-	0 0	0 3	OF	0 4

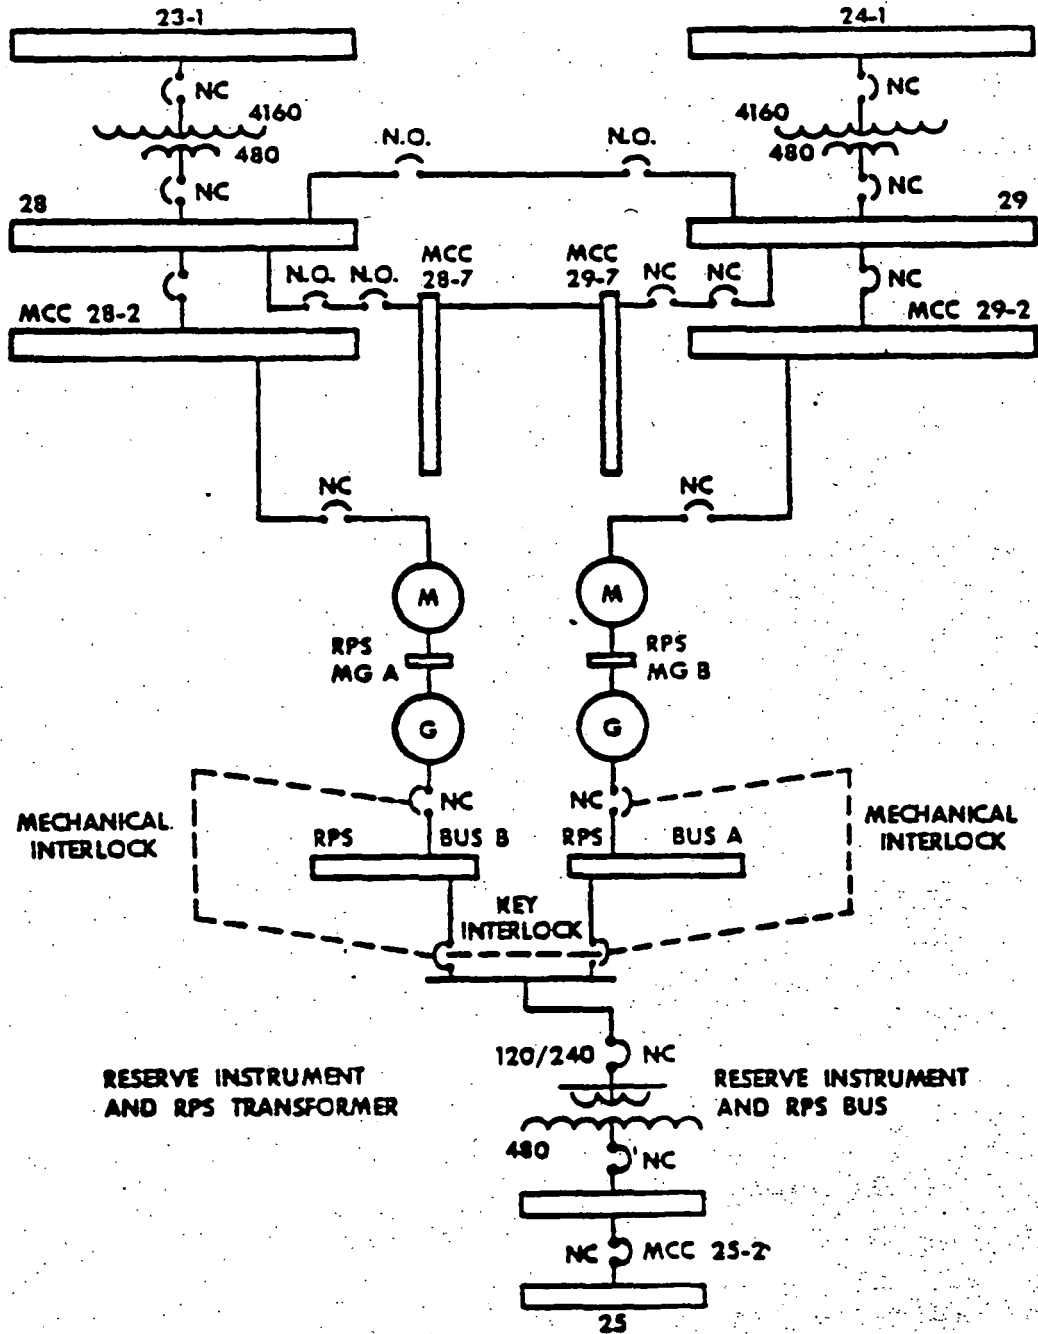
Figure 1

REACTOR PROTECTIVE SYSTEM DISTRIBUTION
