LICENSEE EVENT REPORT (LER)

Dresden Nuclear Power Station, Unit 2

Title (4) High Pressure Coolant Injection Piping Found in Violation of FSAR Design

Criteria Due to Management Deficiency

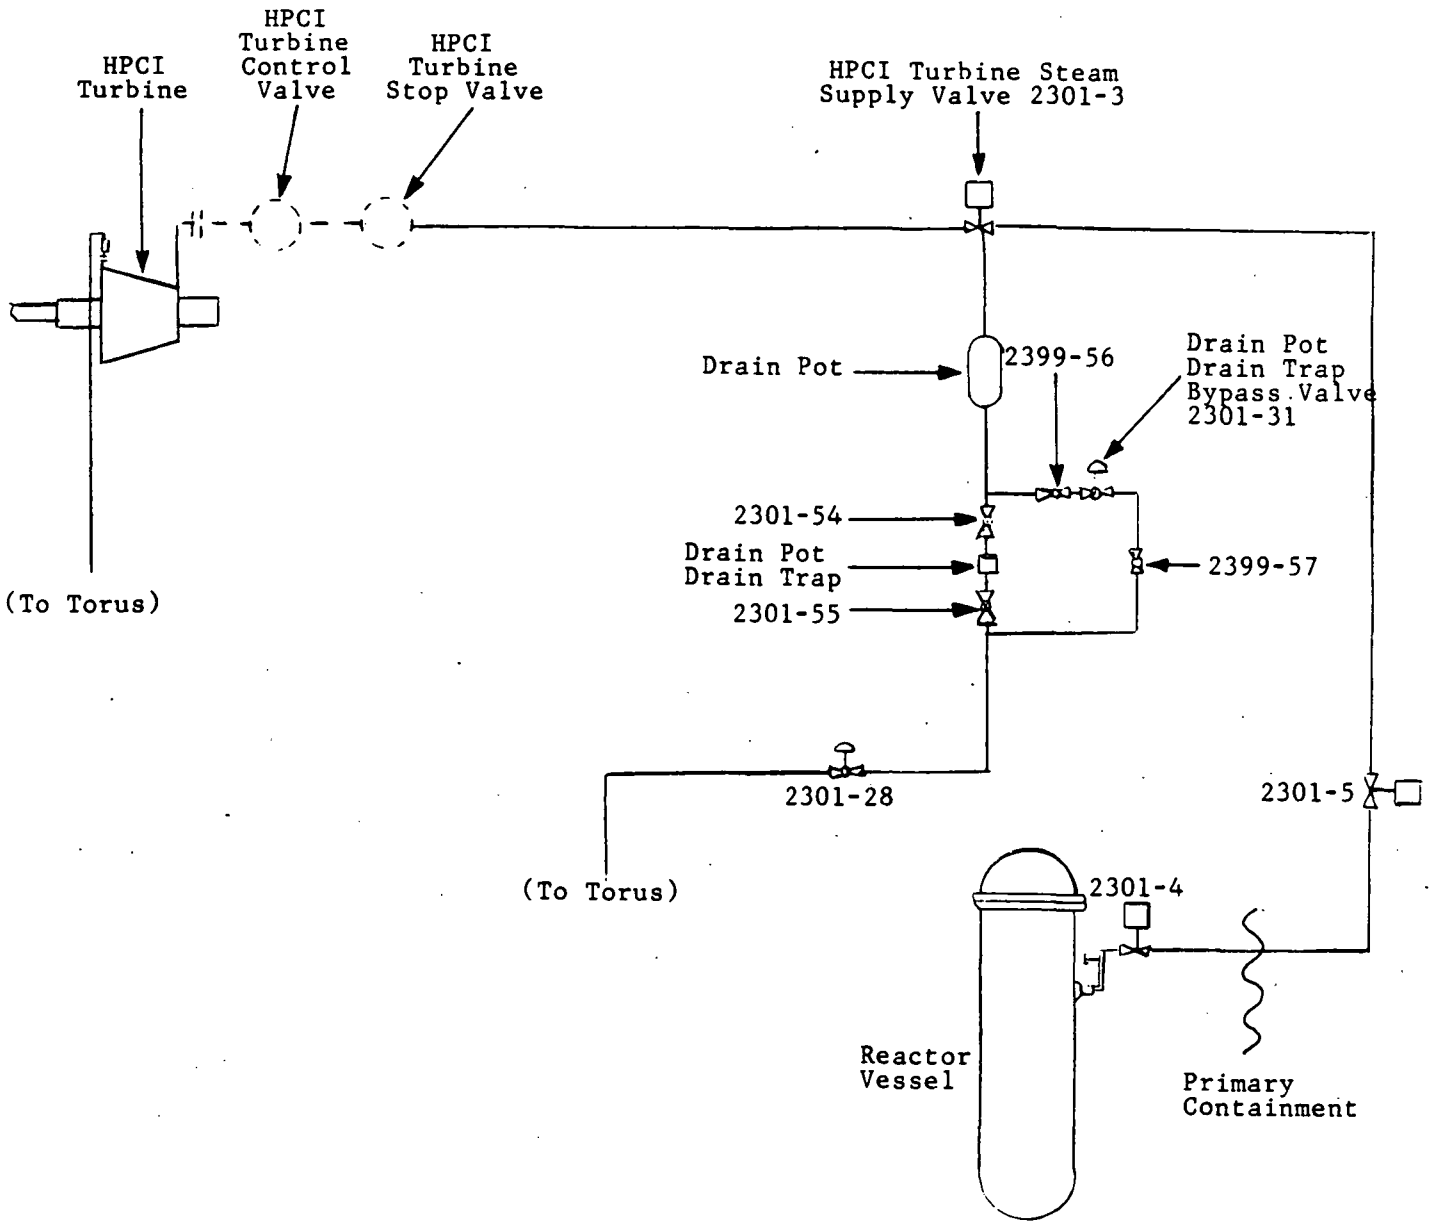
Figure 1

The root cause of this event has been attributed to an engineering and technical support management deficiency. The 1982 Unit 2 Modification M12-2-82-41 which involved installation of the drain pot bypass isolation valves was performed as a Station engineered project without formal thermal and seismic analysis. Similar work was performed on Unit 3 under 1982 Modification package M12-3-82-41 without formal thermal and seismic analysis. These projects were Station engineered because it was believed that the relatively minor weight of the valves to be installed would not significantly affect the existing design configuration margins, and such engineering judgements were acceptable under the existing modification program procedure.

Although the Unit 2 and Unit 3 HPCI steam supply valve 2301-3 drain pot piping configuration was determined by analysis in September, 1984 to exceed FSAR design criteria, it was determined by analysis that the piping involved would remain operable under all design basis events. Additionally, failure of the HPCI steam supply valve 2301-3 drain pot piping would not prevent automatic or manual operation of the HPCI system, but could result in elevated radiation levels in the HPCI rooms. Therefore, this event was judged to have minimal safety significance.

SIMPLIFIED HPCI SYSTEM PIPING

Modification M12-2(3)-89-19 has been initiated to install four thermally and seismically analyzed supports on Unit 2 and five on Unit 3. The installations will be performed under Work Requests 84964 and 84965 for Units 2 and 3 respectively. The new supports will bring all the involved piping into compliance with FSAR design criteria.
