Dresden Nuclear Power Station

Licensee Event Report #89-001-1, Docket #050249 is being submitted as required by Technical Specification 6.6, NUREG 1022 and 10 CFR 50.73(a)(2)(iv). This revised report is provided to correct an error concerning nomenclature of the Motor Control Center (MCC) 38-7/39-7 Reserve Feed Breakers and provide an updated status of corrective actions in progress.

Title (4) Turbine Trip and Reactor Scram on Stop Valve Closure Due to Slow

Transfer of House Loads During Loss of Offsite Power

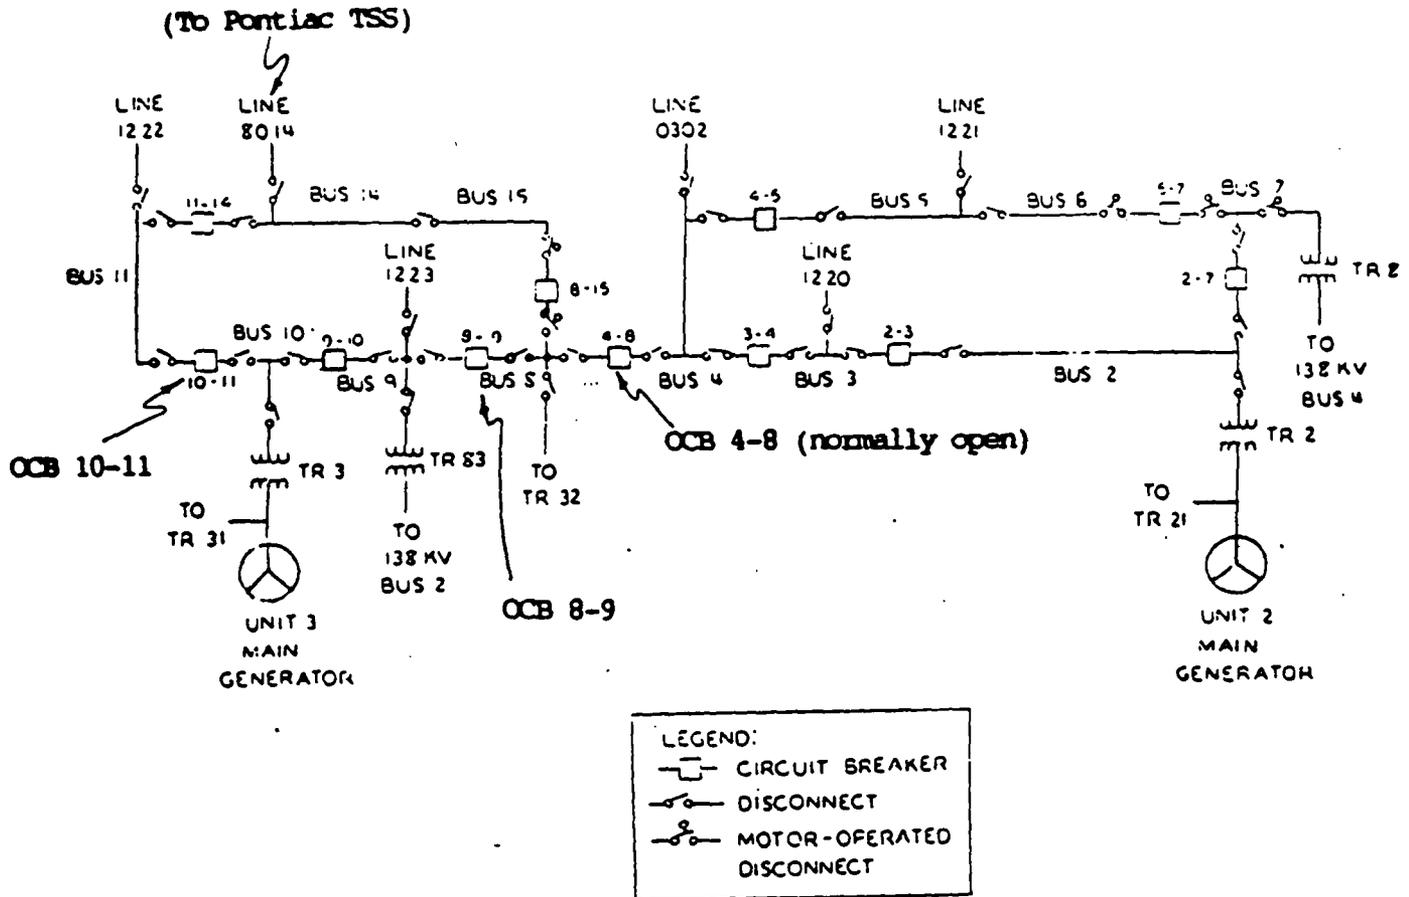
Figure 1. 345 KV Switchyard Configuration

PCB 6-7 (see Figure 1) previously failed in a similar manner to the failure that initiated the March 25, 1989, Unit 3 scram. PCB 6-7 is the same type of circuit breaker as PCB 8-15. Because of the 138 KV bus configuration, power to TR 22 was not lost during that previous event; however, as a corrective action the ground capacitors on PCB 6-7 and PCB 8-15 were replaced with a different model.

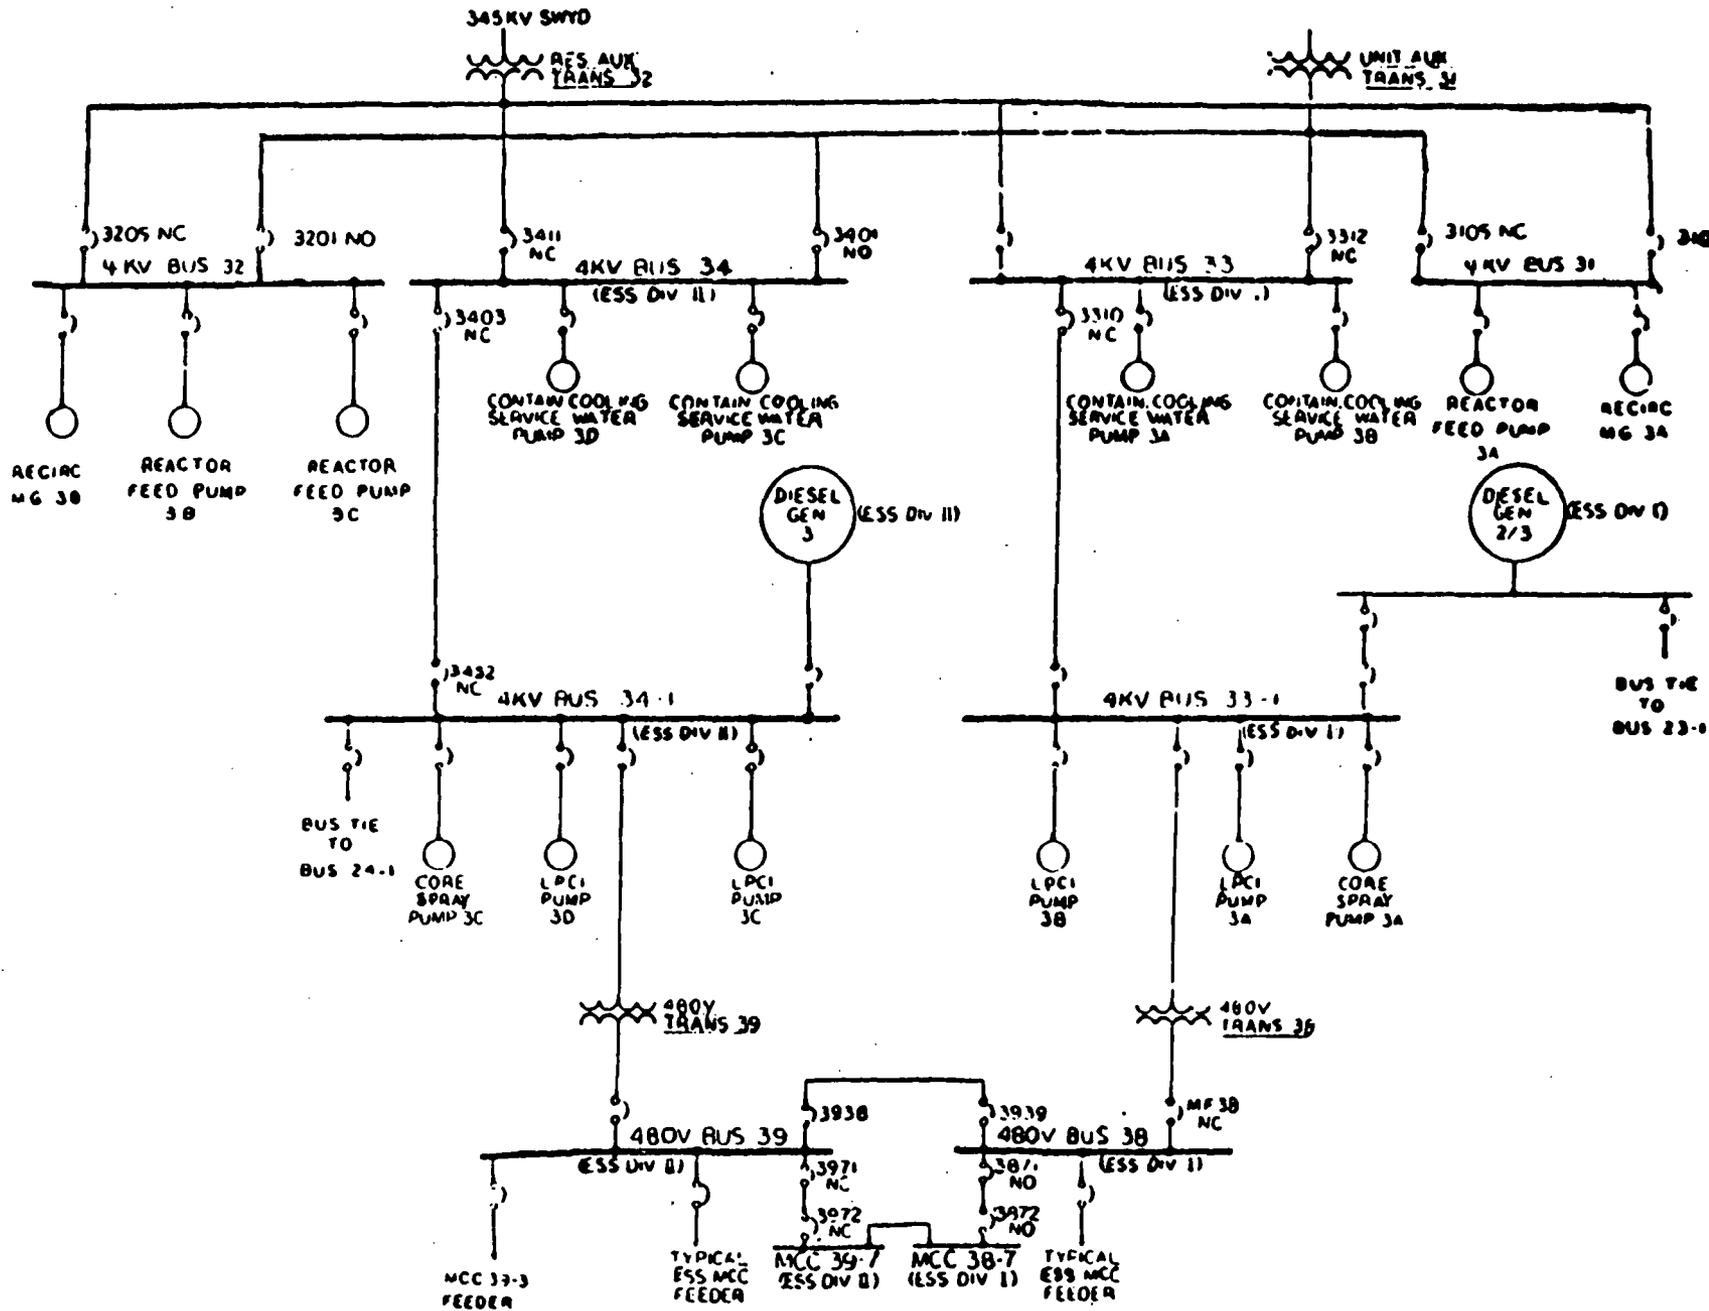
Figure 2. Unit 3 Electrical Configuration Simplified Schematic

The clean demineralized water shell side supply valve M03-4399-77 is powered by MCC 39-3 (see Figure 2). The reason that this valve was initially de-energized during this event is that MCC 39-3 is designed to automatically trip during undervoltage conditions to limit loads on the emergency Diesel Generators.

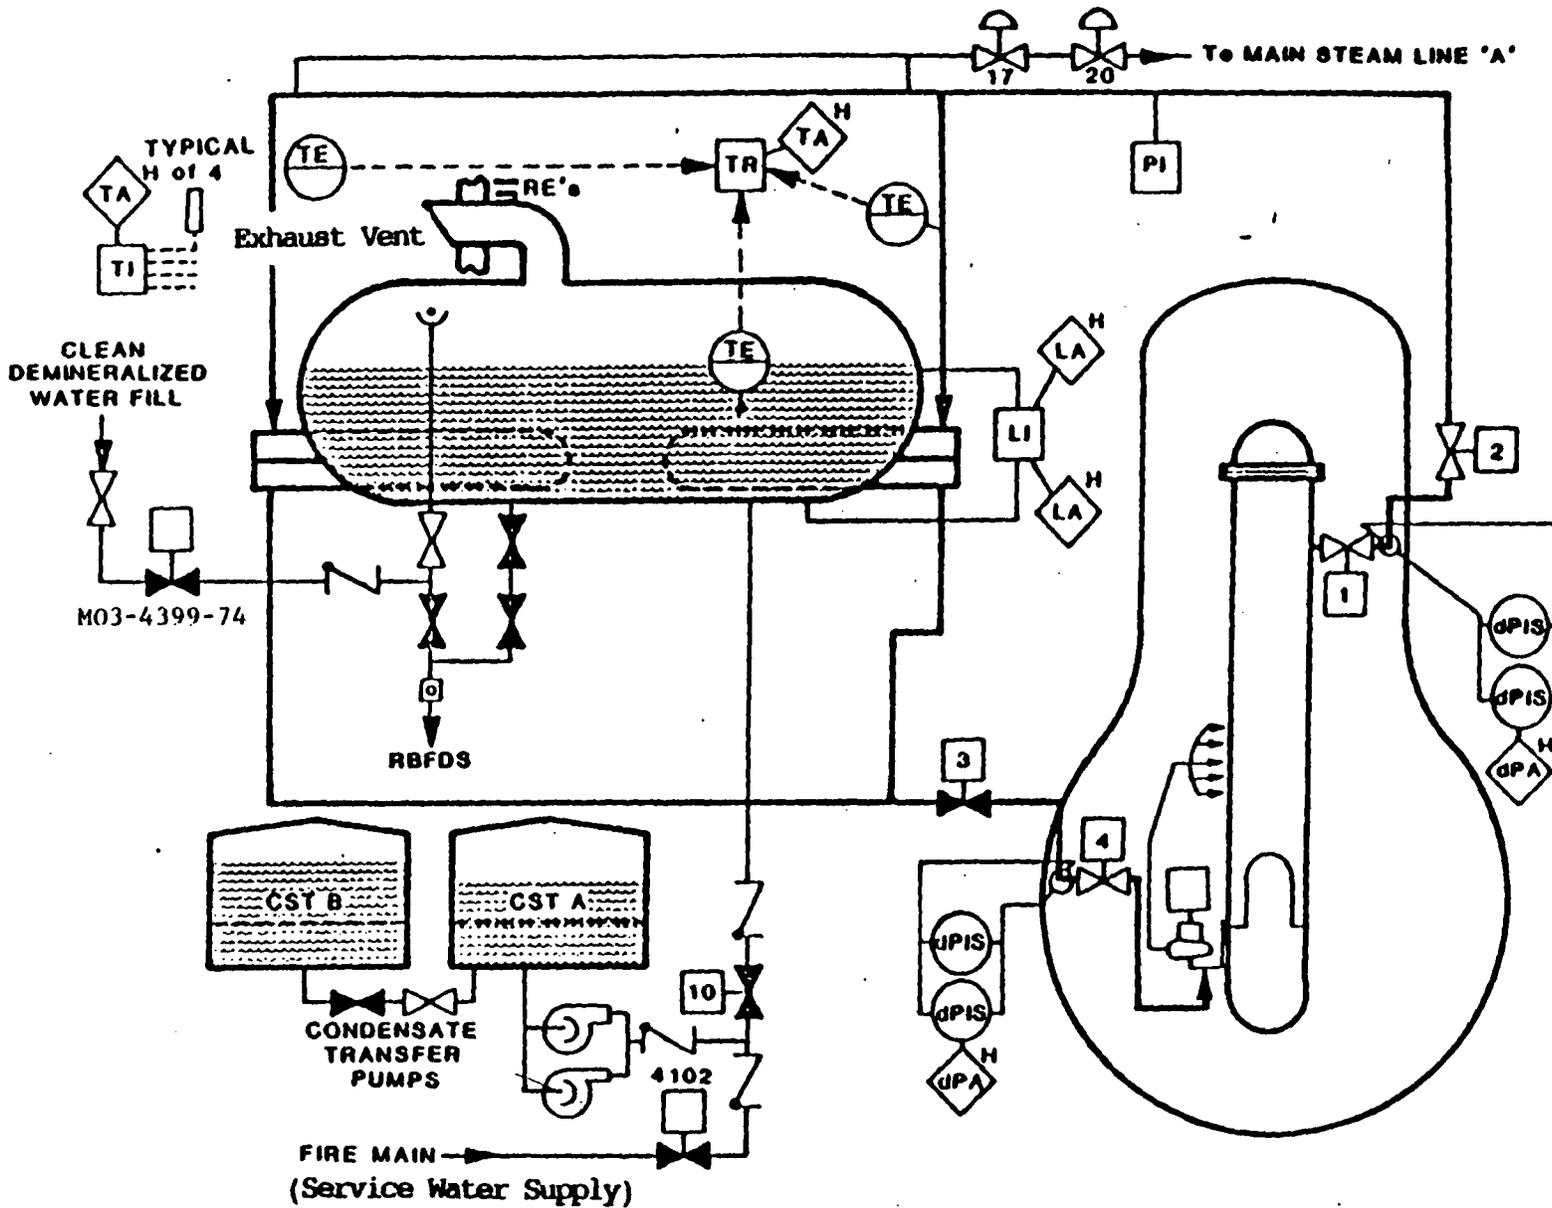
Figure 3. Isolation Condenser System

During the first initiation of the Isolation Condenser, the Nuclear Station Operator (NSO) observed that the clean demineralized water [KC] shell side supply valve M03-4399-74 was de-energized (see Figure 3). Consequently, the NSO initiated use of the mildly contaminated condensate Isolation Condenser shell side supply under direction of Shift Supervision.

After power was restored to MCC 39-3, the one available clean demineralized water pump could not keep up with the Isolation Condenser demand. Based on this event and previous experience with operation of the Isolation Condenser for reactor pressure control following a Unit scram, the clean demineralized water supply to the Isolation Condenser is judged to be undersized; the root cause of the need to use contaminated condensate Isolation Condenser shell side supply is therefore attributed to design deficiency.

The Operations Staff has also implemented short term revisions to Isolation Condenser operating procedures regarding limiting the use of contaminated condensate to supply the Isolation Condenser shell side. These revisions concern use of alternate systems for decay heat removal (e.g. ADS, HPCI, RWCU) and/or use of service water to supply the Isolation Condenser shell side (249-200-89-01908).

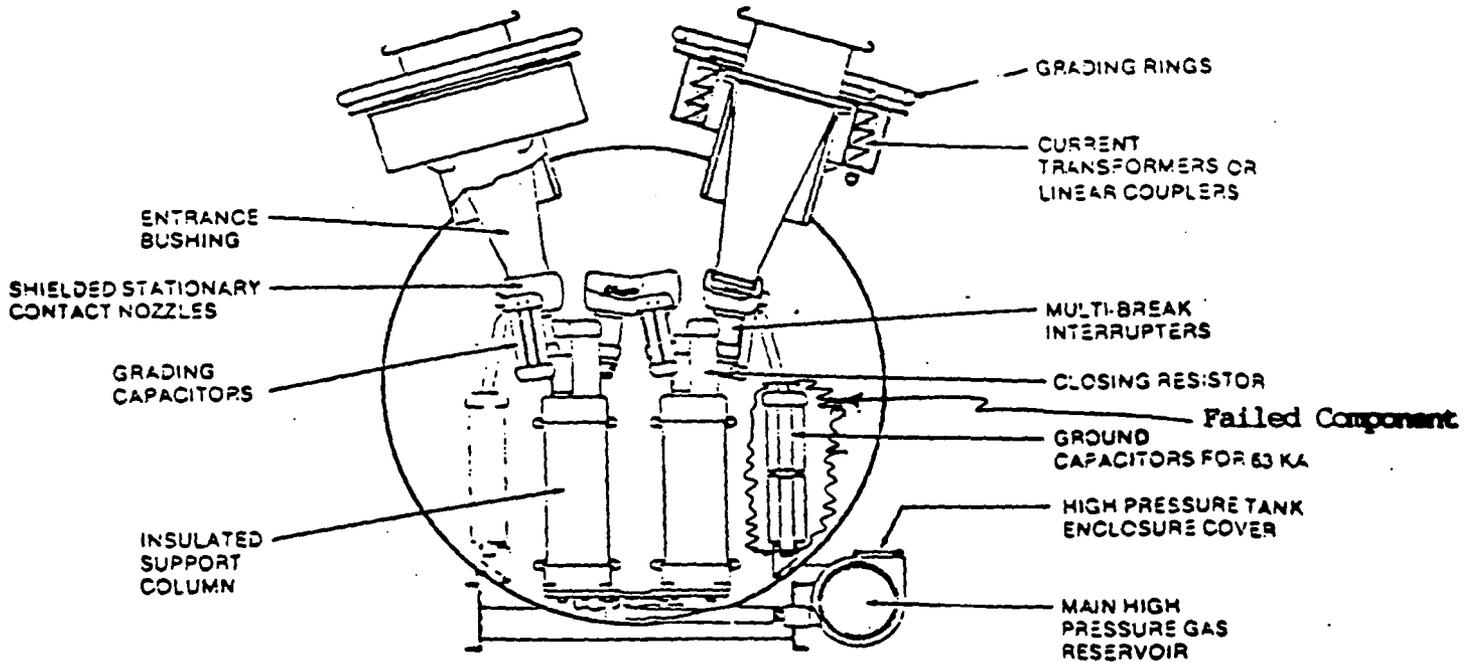
Figure 4. Cross Section View of PCB 8-15

Inspection of PCB 8-15 revealed that a ground capacitor in the A phase of the circuit breaker had failed and that a phase-to-ground fault had occurred across an adjacent insulated support column (see Figure 4). The phase compartments of PCB 8-15 are pressurized with sodium hexafluoride gas (SF₆). The failed ground capacitor (which was mounted within the A phase pressure vessel) utilized a mineral oil dielectric fluid which contained no polychlorinated biphenyls. As the phase compartment pressure vessels remained intact, no release of SF₆ gas or ground capacitor dielectric fluid occurred. Debris from the capacitor included pieces of insulation and metal plates. Most of the oil and debris from the failed capacitor remained in the A phase pressure vessel, but some passed through a connecting duct to the B and C phase pressure vessels. The apparent cause of the phase-to-ground fault within the A phase circuit breaker was the capacitor failure and resultant debris.

All three phases of PCB 8-15 will be cleaned and repaired as necessary prior to returning PCB 8-15 to service. As part of the repairs, the internal ground capacitors will be removed. This change will lower the rated capacity of PCB 8-15 from 63 KVA to 50 KVA, however, and ground capacitors may be added in the future (possibly external to PCB 8-15) should system requirements dictate.

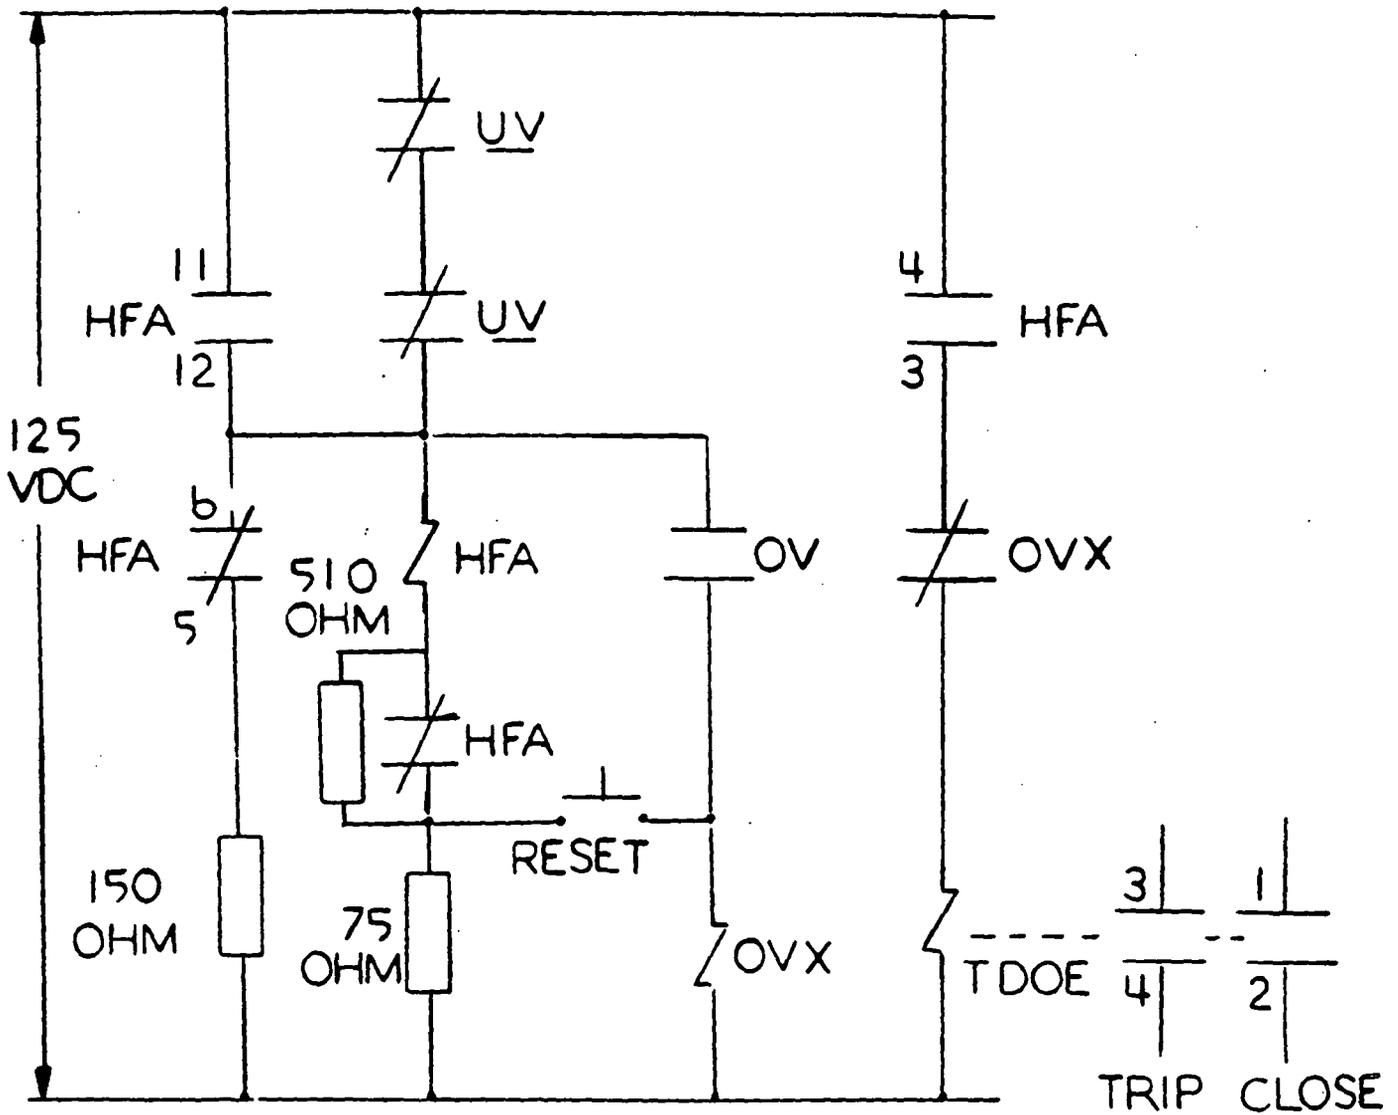
Figure 5. Simplified MCC 38-7/39-7 Logic Diagram

A General Electric (GE) CR122AT Time Delay on Energization (TDOE) relay transfers the power feed to the LPCI swing bus from Bus 39 to Bus 38 (see Figure 2). The root cause of the spurious trip of breakers 252-3971 and 252-3972 has been attributed to an original construction design deficiency in that the model TDOE relay used was not suitable for this application. This conclusion is based on the investigation discussed below.

When an undervoltage condition exists on Bus 39, the UV contacts (see Figure 5) pick up and the "HFA" (227B39X1) relay becomes energized. HFA (227B39X1) contacts 11-12 and 5-6 close sealing in the coil while contact 3-4 closes starting the 15 second timer on the TDOE relay. If the undervoltage on Bus 39 remains for 15 seconds, TDOE contacts 3-4 and 1-2 close, tripping feed breakers 252-3971 and 252-3972 while closing reserve feed breakers 252-3871 and 252-3872. If voltage is restored to the bus before the 15 second time delay expires, the OVX contact closes, the OVX coil energizes, and the OVX contact opens. With the OVX contact open, power to the TDOE is lost and the timer should reset. During this event an undervoltage existed on Bus 39 for only seven seconds; nevertheless, the circuit responded as if the 15 second delay had been reached.

The OVX and TDOE relays were tested in accordance with Work Request 83559. The OVX contact was verified to open properly for simulated undervoltage conditions of two, five, seven, and 10 seconds. The TDOE relay was then tested for the same simulated undervoltage conditions by monitoring the voltage across TDOE contacts 3-4 and 1-2. The results of the test are contained in Table 2.

When a simulated undervoltage condition existed for greater than 15 seconds, breaker 252-3971 tripped and breaker 252-3871 closed as expected. When the simulated undervoltage condition existed for two seconds, the breakers were unaffected and the TDOE relay reset as expected. However, when the simulated undervoltage condition was present for five, seven, or 10 seconds, breakers 252-3971 and 252-3871 did not respond as expected.

The immediate corrective action was to replace the GE CR122AT TDOE relay with an Agastat ETR1403C002 time delay relay as a temporary alteration. The Agastat relay will be removed during refuel outage D3R11 under LPCI Swing Bus Modification M12-3-88-005 (249-200-89-01906). A walkdown was conducted to determine if a GE CR122AT relay was being used in any other applications for Unit 3; none were found. A GE CR122AT TDOE relay was previously removed from Unit 2 under LPCI Swing Bus Modification M12-2-88-005. Based on the close similarity of Units 2 and 3, it was concluded that a walkdown of Unit 2 was unnecessary.

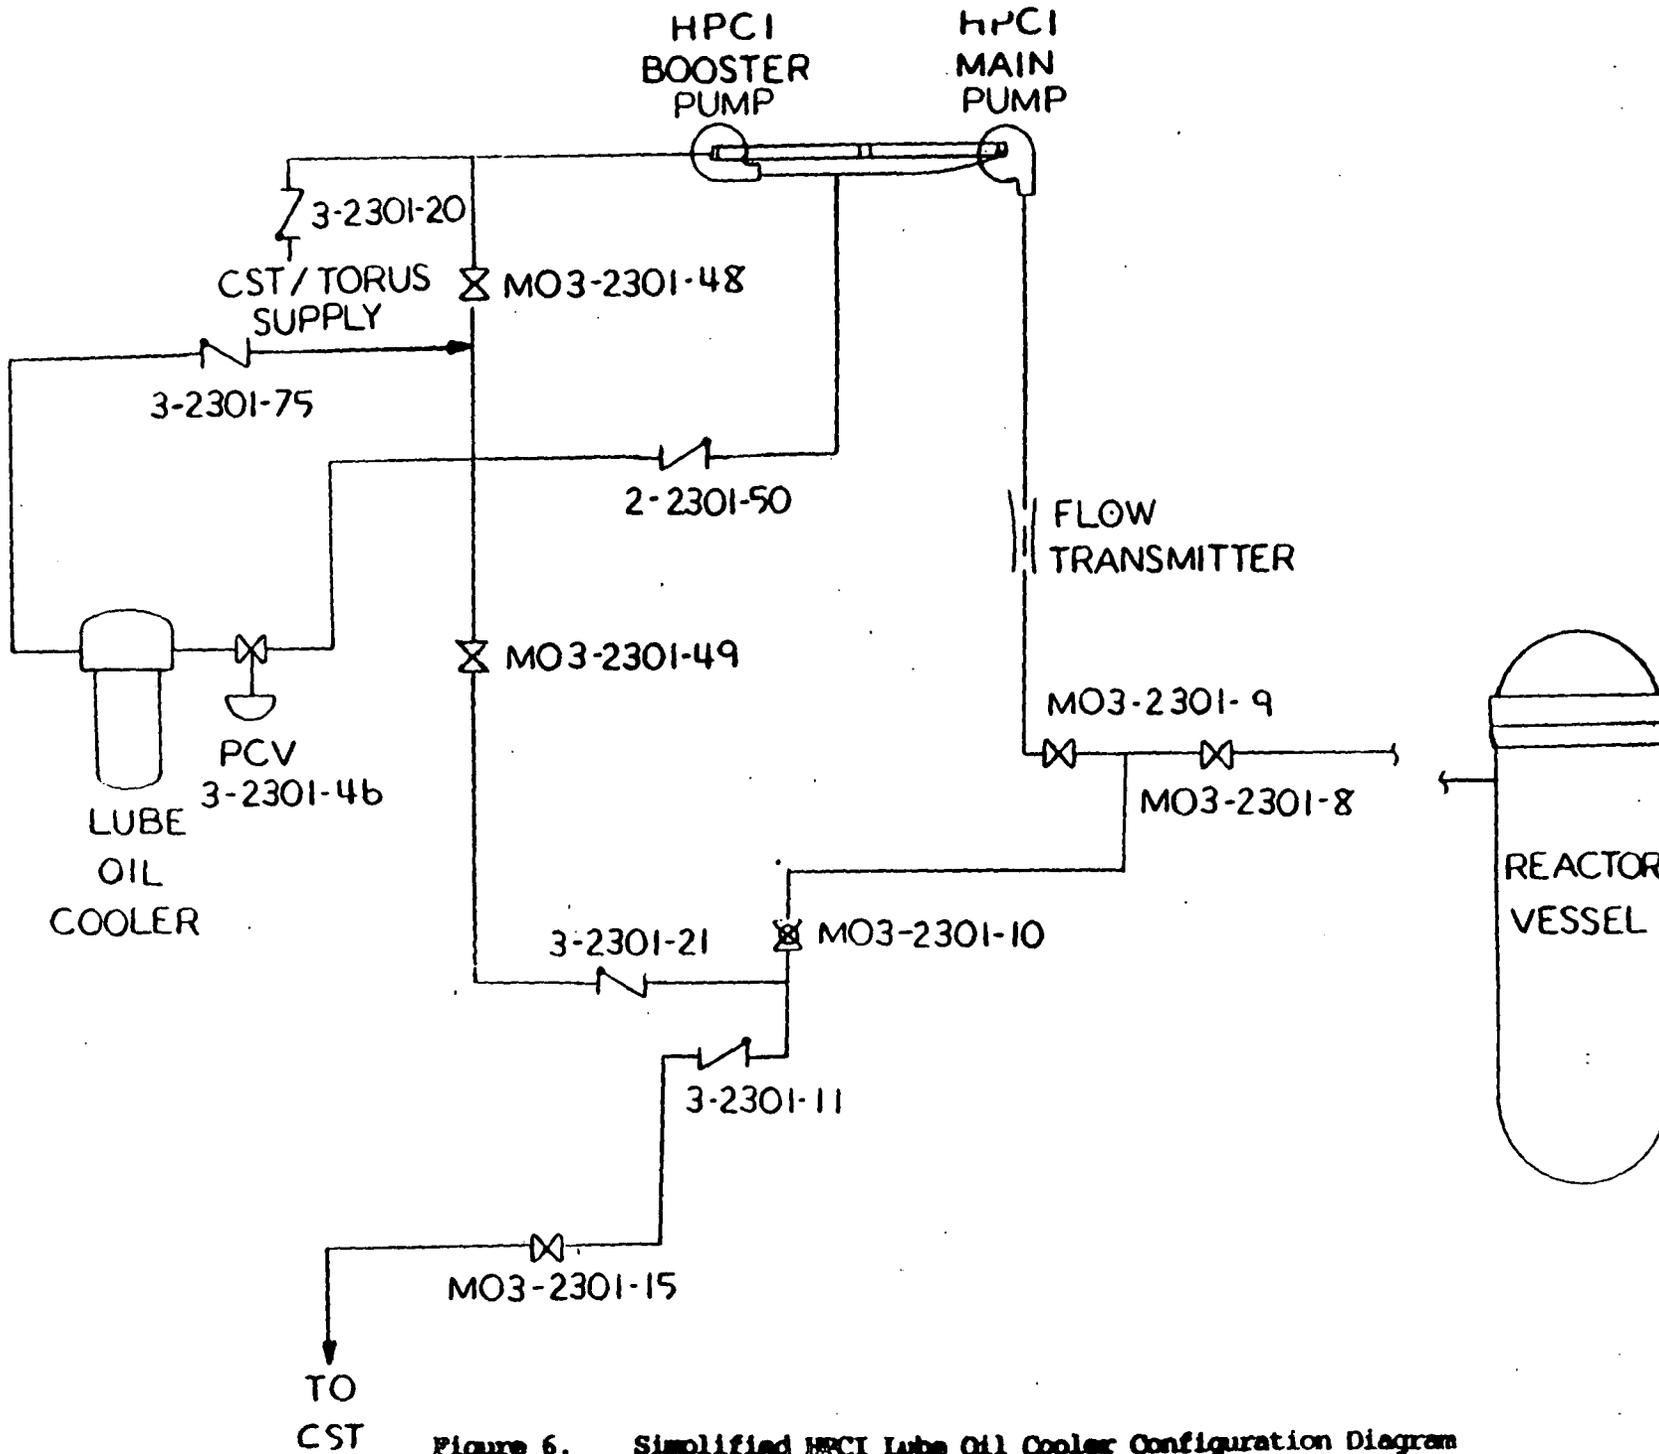
Figure 6. Simplified HPCI Lube Oil Cooler Configuration Diagram

During a HPCI System automatic initiation, the M03-2301-48 valve is automatically opened and the M03-2301-49 valve is automatically closed (see Figure 6). This allows lube oil cooling water to be supplied by the HPCI booster pump discharge and returned to the suction. During normal operation with HPCI in the standby mode, the M03-2301-48 valve is closed and the M03-2301-49 valve is open. This allows a flow path to the Condensate Storage Tank [KA], through the M03-2301-15 valve for the Gland Seal Leak Off Drain pump.

In conclusion, the root cause for HPCI lube oil cooling problem is attributed to procedural deficiency as DOP 2300-3 did not require prompt repositioning of the M03-2301-48 and M03-2301-49 valves upon manually initiating the HPCI system for purposes of reactor pressure control.
