**Commonwealth Edison**  
Dresden Nuclear Power Station  
R.R. #1  
Morris, Illinois 60450  
Telephone 815/942-2920

LICENSEE EVENT REPORT (LER)

Facility Name (1) Dresden Nuclear Power Station, Unit 2 Docket Number (2) 0 5 0 10 10 12 13 17 Page (3) 1 of 0 7

Title (4) Scram/Group I Isolation Due to Main Steam Line Radiation Monitor Lockup and Spurious Steam Tunnel Temperature Trip

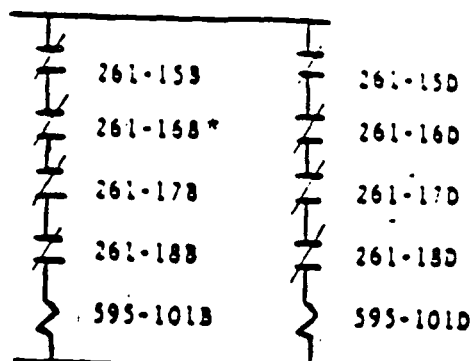
Channel B  
MSL Tunnel Temperature Switches  
and Sensor Relays

In this event, a spurious Channel 'B' MSL tunnel area temperature signal was initiated by one of the temperature switches which drives relay 595-101B. This in turn resulted in de-energization of relay 595-106B, which made up the Channel 'B' primary containment Group I isolation logic. Because a Channel 'A' primary Group I isolation signal was pre-existing due to difficulties in resetting the 'A' MSL LRM "lockup unknown" alarm (MSL high radiation is also a Group I initiation signal), a full Group I isolation and reactor scram on MSIV closure occurred.

As corrective action for the temperature switches, all four MSL tunnel switches from the channel involved with the spurious MSL tunnel high temperature trip (switches 261-15B, 261-16B, 261-17B, and 261-18B) were immediately replaced. All four switches were replaced since it was impossible to determine which switch was the source of the spurious trip. During the replacement of the switches, the connectors were examined and cables agitated slightly to rule out any connector deficiencies. No abnormalities were observed. The removed switches were then tested to determine their as-found trip setpoints. All were in compliance with Technical Specification Table 3.2.1, which requires a trip setpoint of <math>\leq 200^{\circ}</math> Fahrenheit, but had drifted lower than their normal setpoint bands. Temperature switch 261-16B was observed to have the lowest as-found trip setpoint, and as such may have been responsible for the spurious trip. The previous calibration of these temperature switches (performed on February 5, 1989) used a new calibration technique which was modified using manufacturer's recommendations to reduce the possibility of setpoint drift and produce a more repeatable setpoint trip.

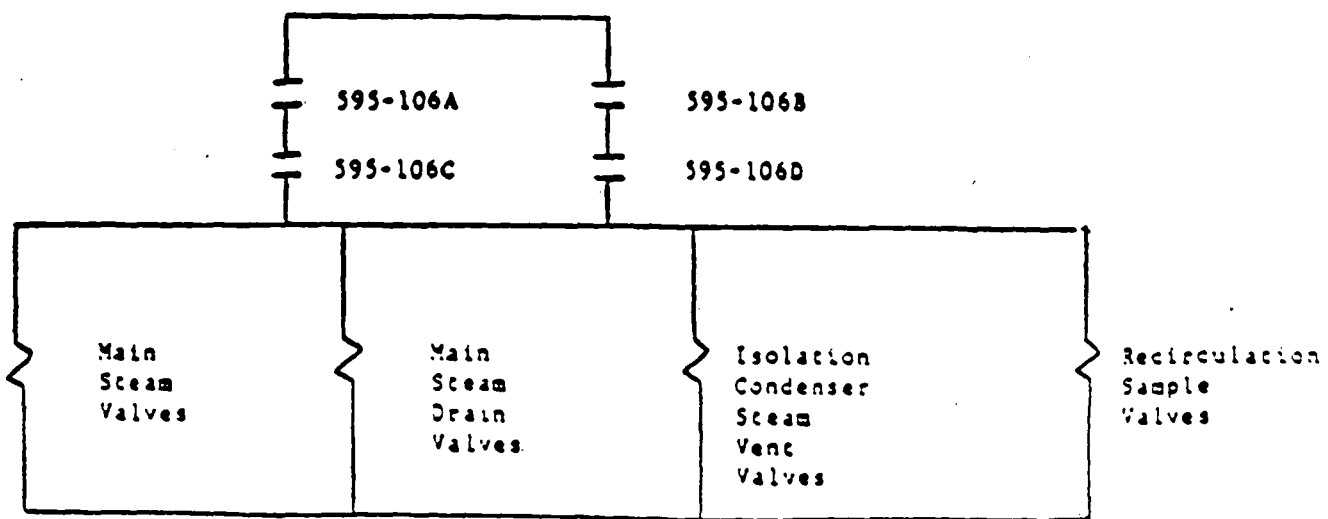
Figure 1

Simplified Group I Valve  
Actuation Relay Logic
